FINAL DRAFT

# BEAVERTAIL STATE PARK MASTER PLAN 2025

The beavertail State Park Master Plan is intended to re-imagine the future of Beavertail State Park and addresses the following:

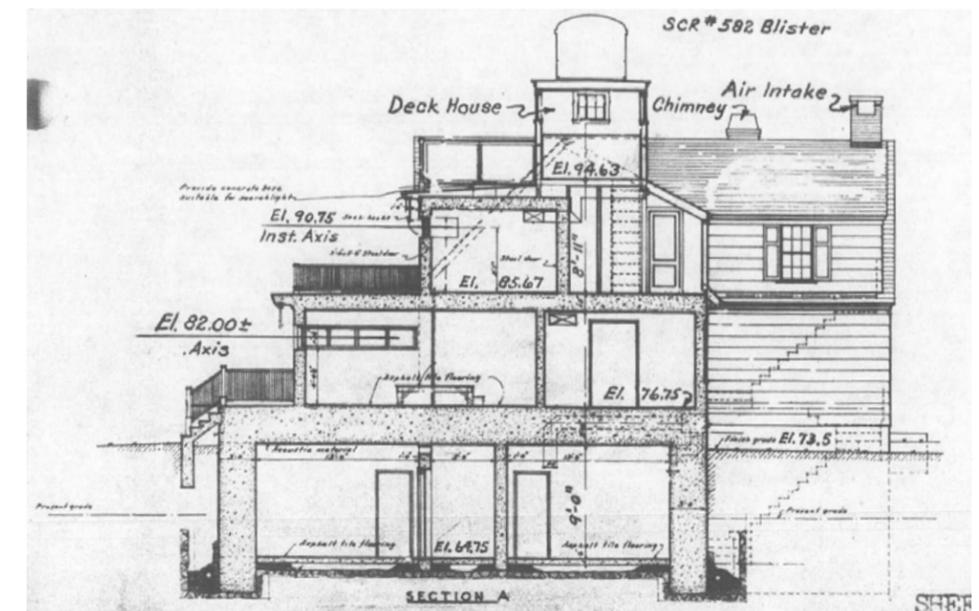
FIGURE 2.2

The interior conditions of the HECP at Fort Burnside further distinguish the structure from other harbor command post facilities.

Cross section of HECP from US Naval Archives

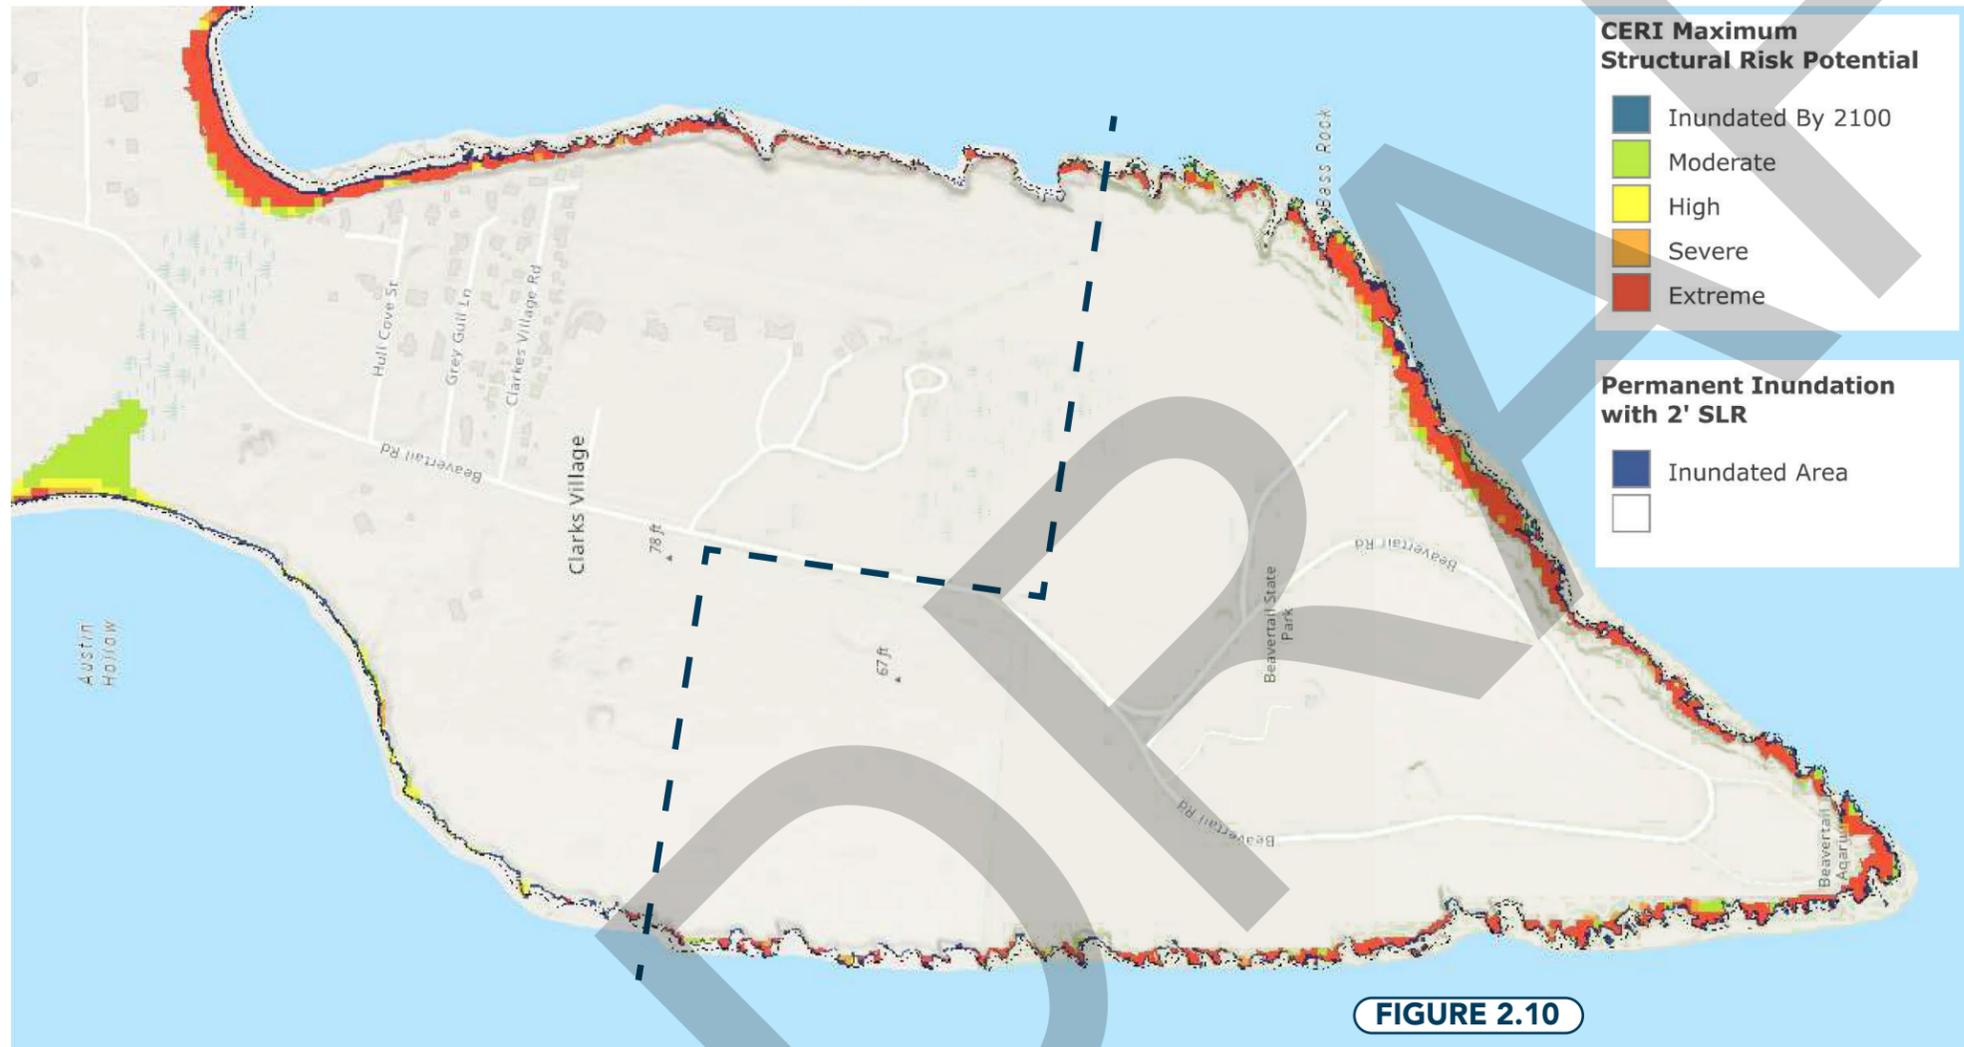
FIGURE 2.10

RI CER Analysis and Output

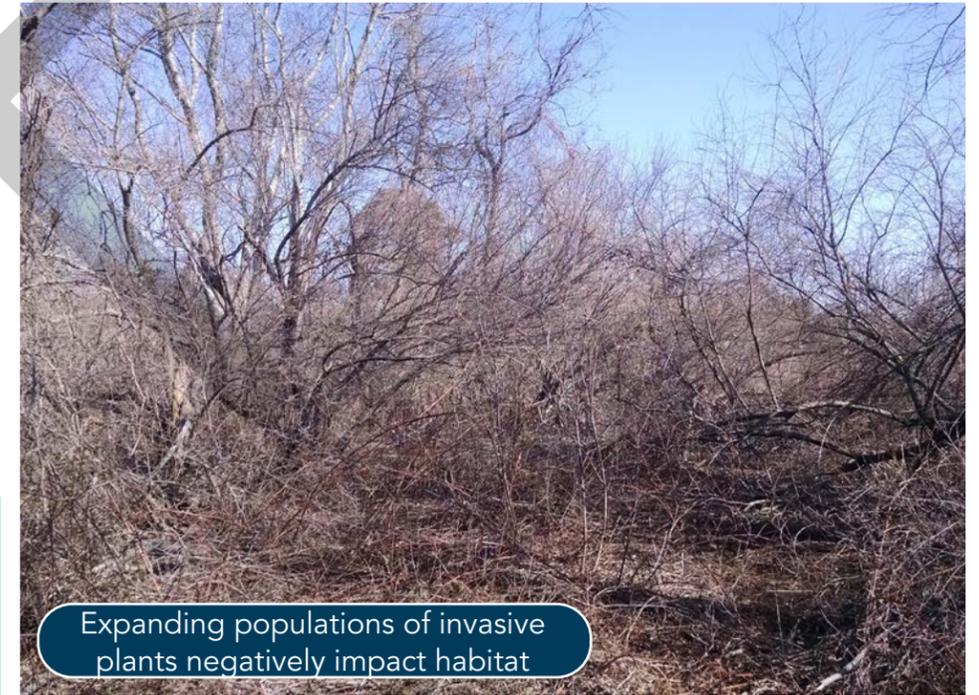
Expanding populations of invasive plants negatively impact habitat

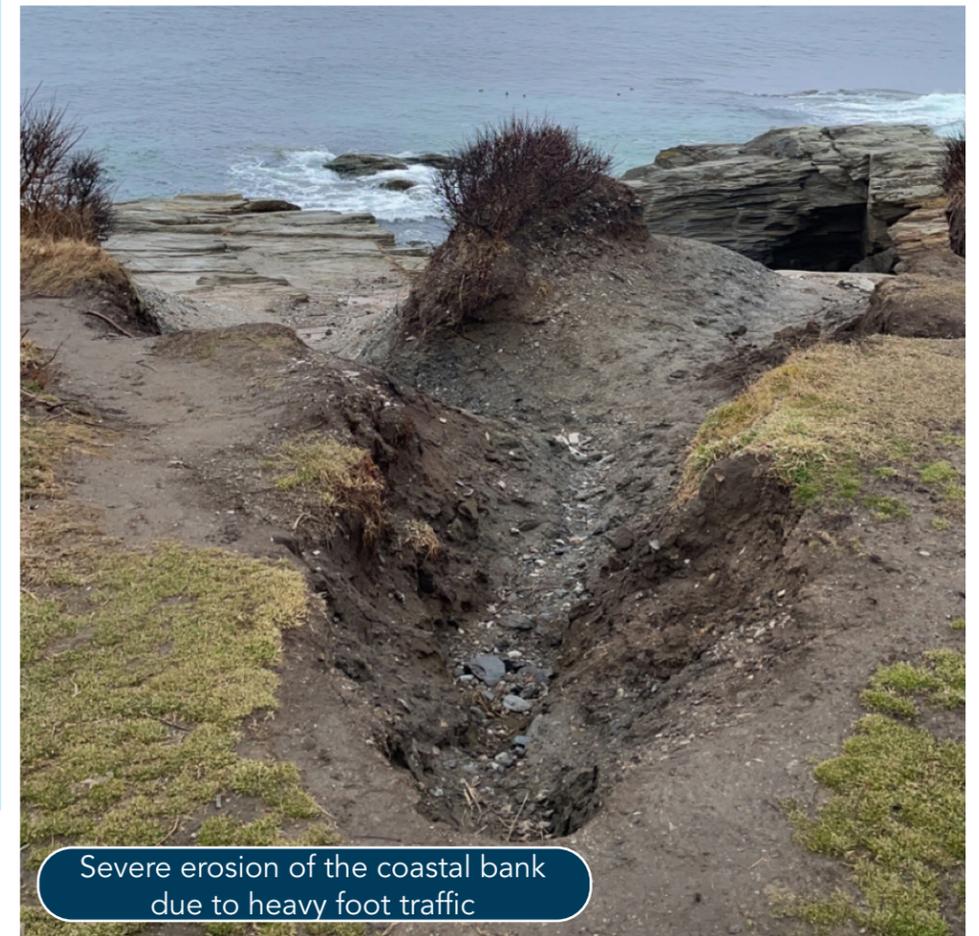
Severe erosion of the coastal bank due to heavy foot traffic

The second erosive pattern is caused by pedestrian foot traffic over the coastal bluff down into the intertidal zone below. Heavy visitation in this area led to excessive compaction on the mown grass at the top of the coastal bank, and deeply worn and highly eroded footpaths on steep slopes to the intertidal zone.

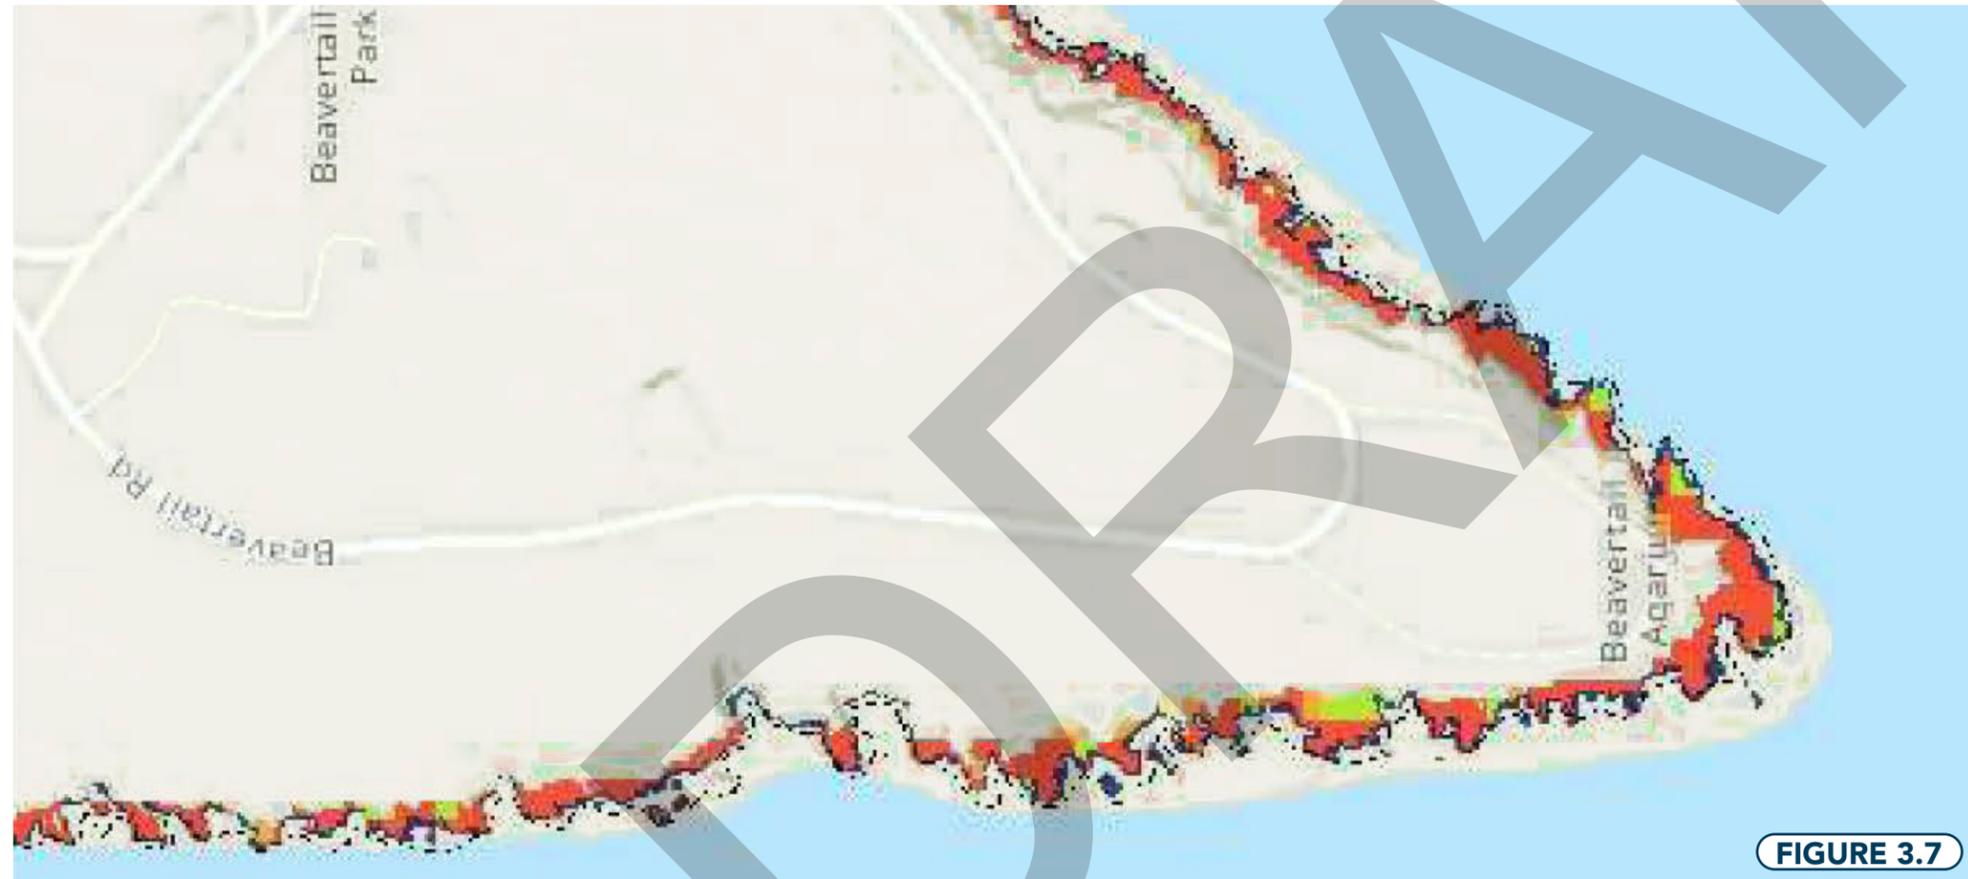
FIGURE 3.7

The third erosion pattern is a combination of man-made and natural conditions. Visual inspection of the seawall reveals the undercutting of sections of the wall, severe abrasion to the face of the southern section of the wall, and evidence of over-wash and erosion above the wall (over-topping), as well as erosion at the ends of the wall. The 65-foot cast-in-place seawall curves outward, deflecting the wave energy. The ends of the wall show erosion patterns typically encountered when shoreline installed to hardening terminate. Both the north and south ends of the wall show signs of scour, due to possible displacement of rip rap at each end. Runoff from the Park loop road above the wall further accelerates erosion on the northwest side of the seawall. While the seawall provides protection for the Light Station as demonstrated by the intact vegetation remaining in-situ above the wall itself, the seawall and the ends of the wall require attention to stabilize and slow the loss of land.

The southwest corner of the Assistant Keeper's Quarters is approximately 35 feet from the top of the coastal bank as of January 1, 2024. Unchecked, the position of the bank in less than 100 years is forecasted to be within a few feet of the foundation while continuing at an erosive loss rate of four inches per year.

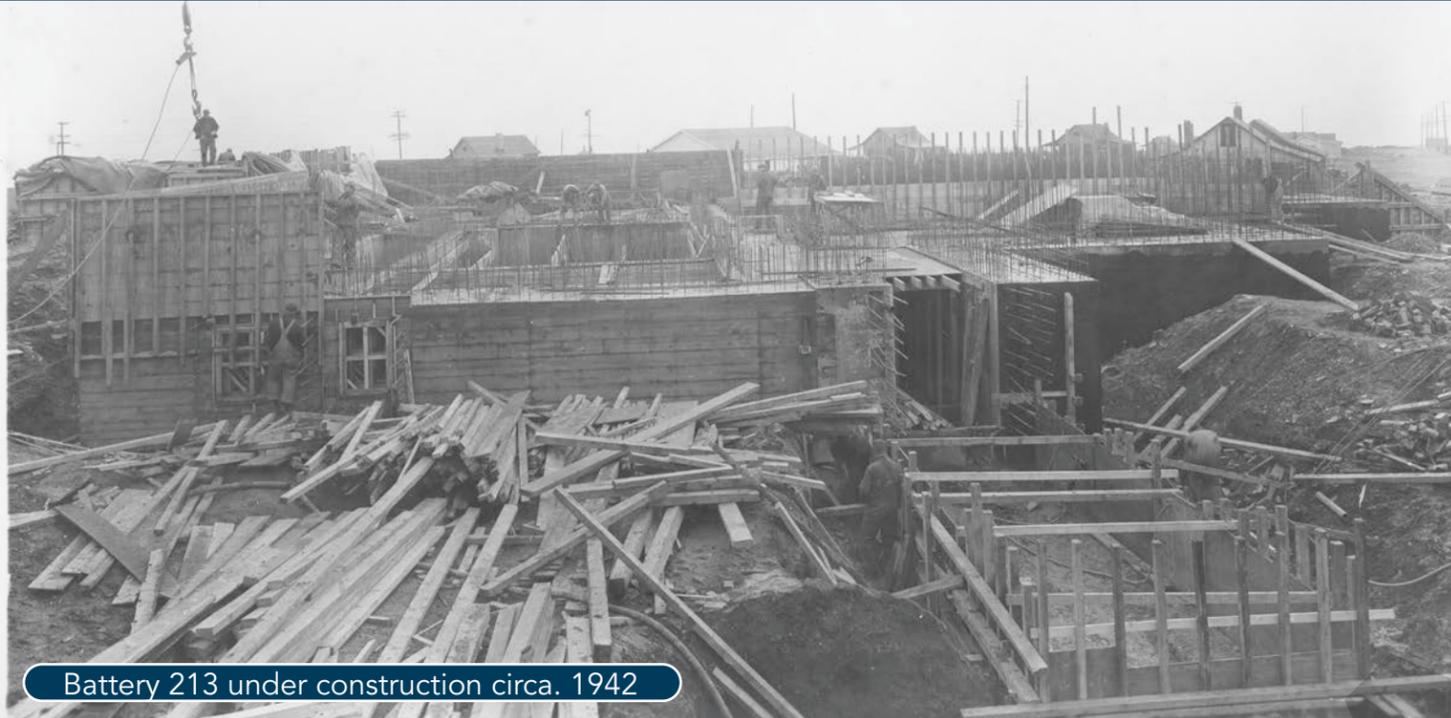
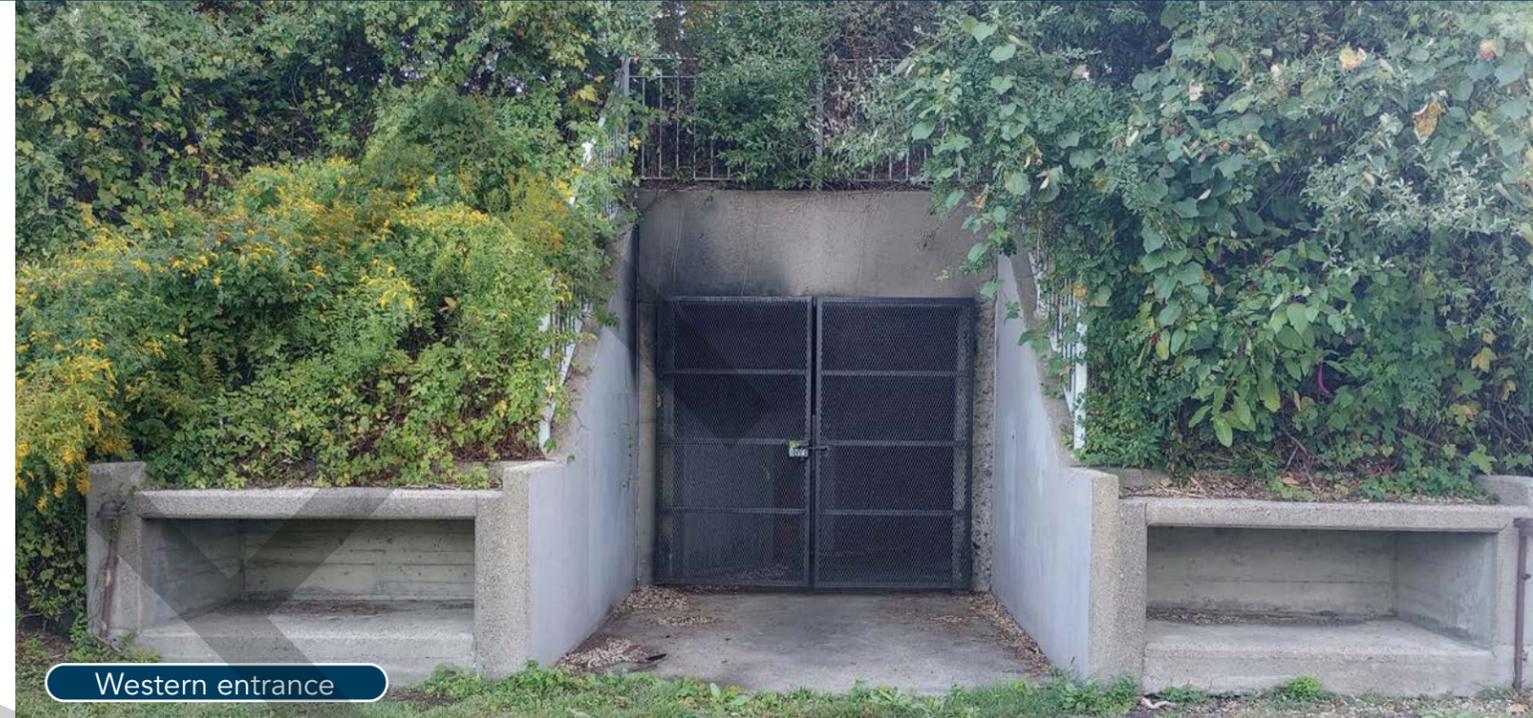
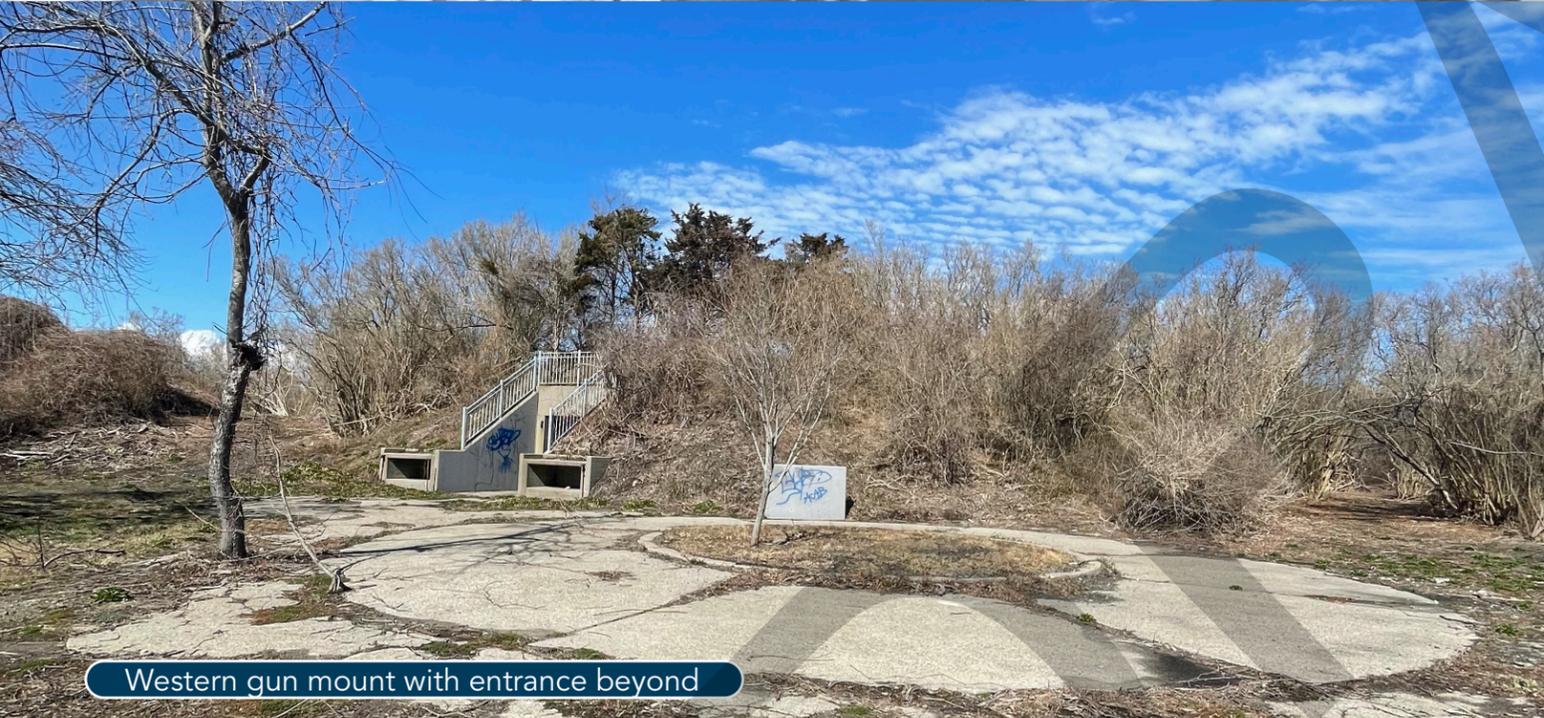
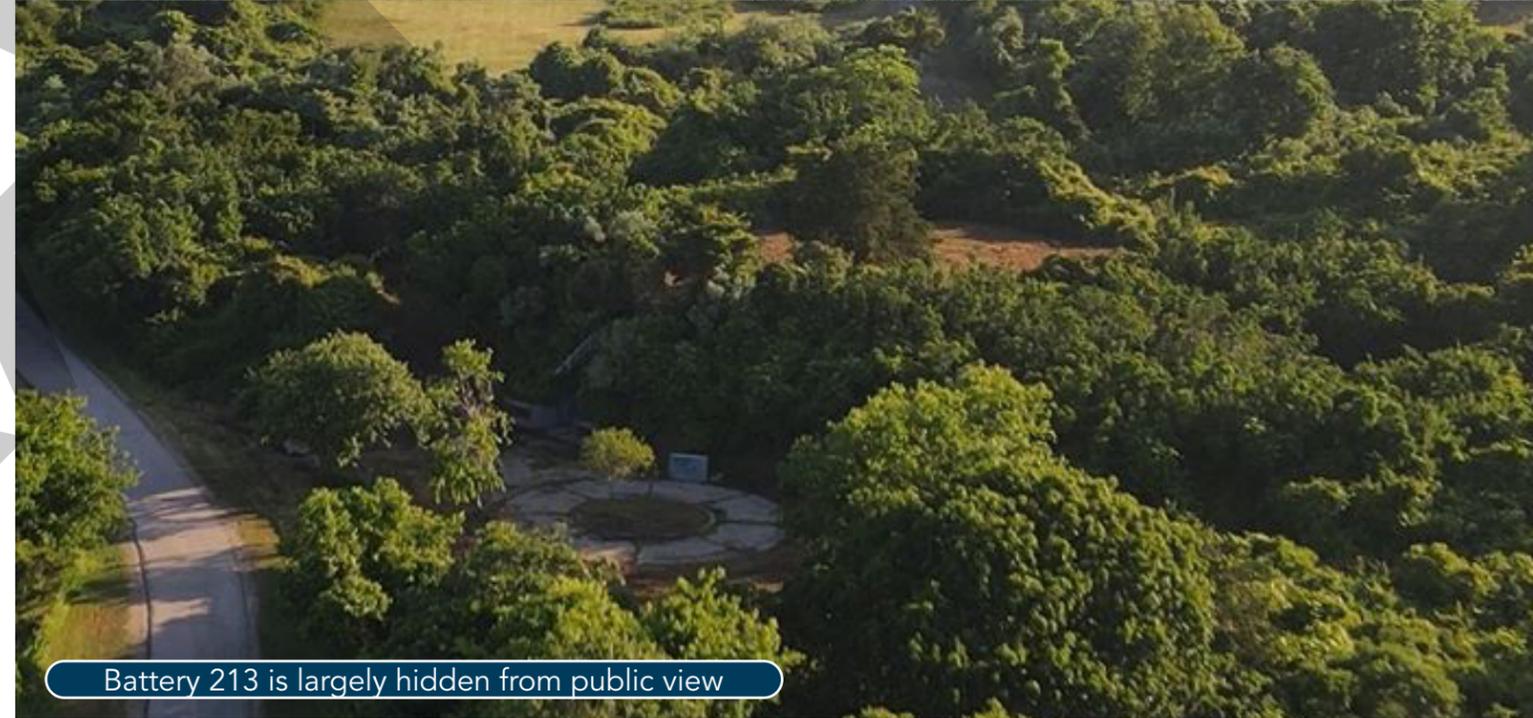
FIGURE 3.11

Original site plan

Battery 213 is on the east side of the entrance drive between Parking Lots 1 and 2. From the entrance drive, you can see one of the two concrete gun mounts and the entrance to the battery. The other concrete gun mount is to the east of the battery. The doors that lead inside are blocked and gated.

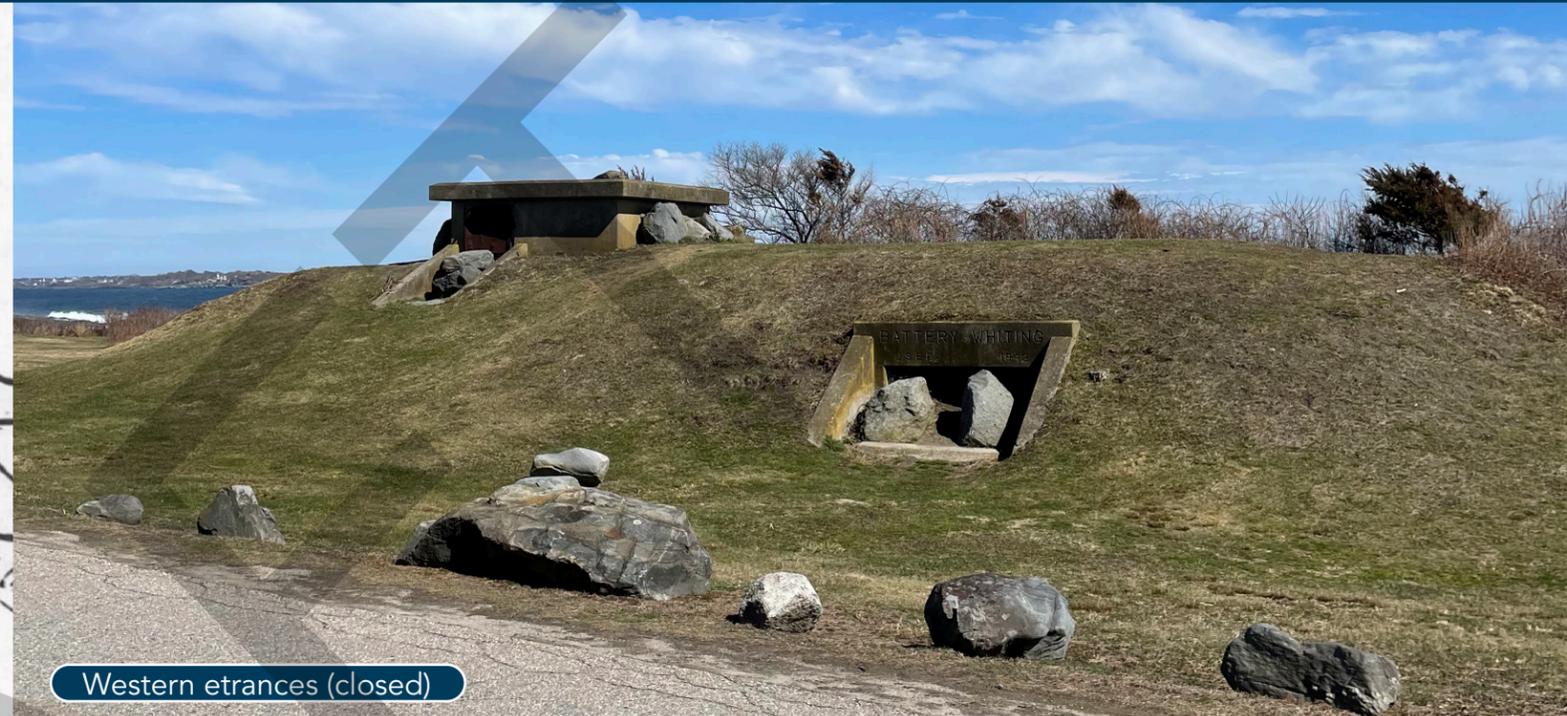
Western entrances (closed)

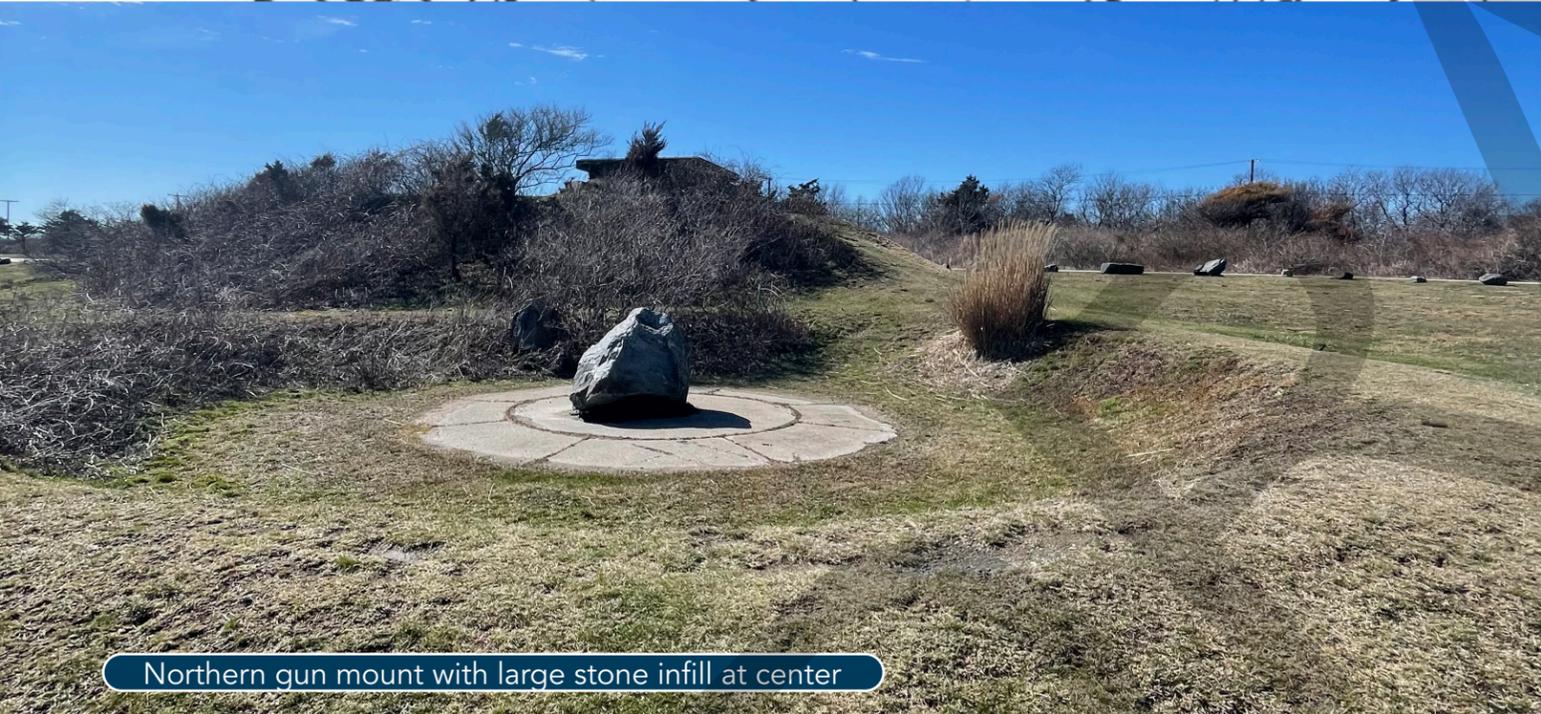
Northern gun mount with large stone infill at center

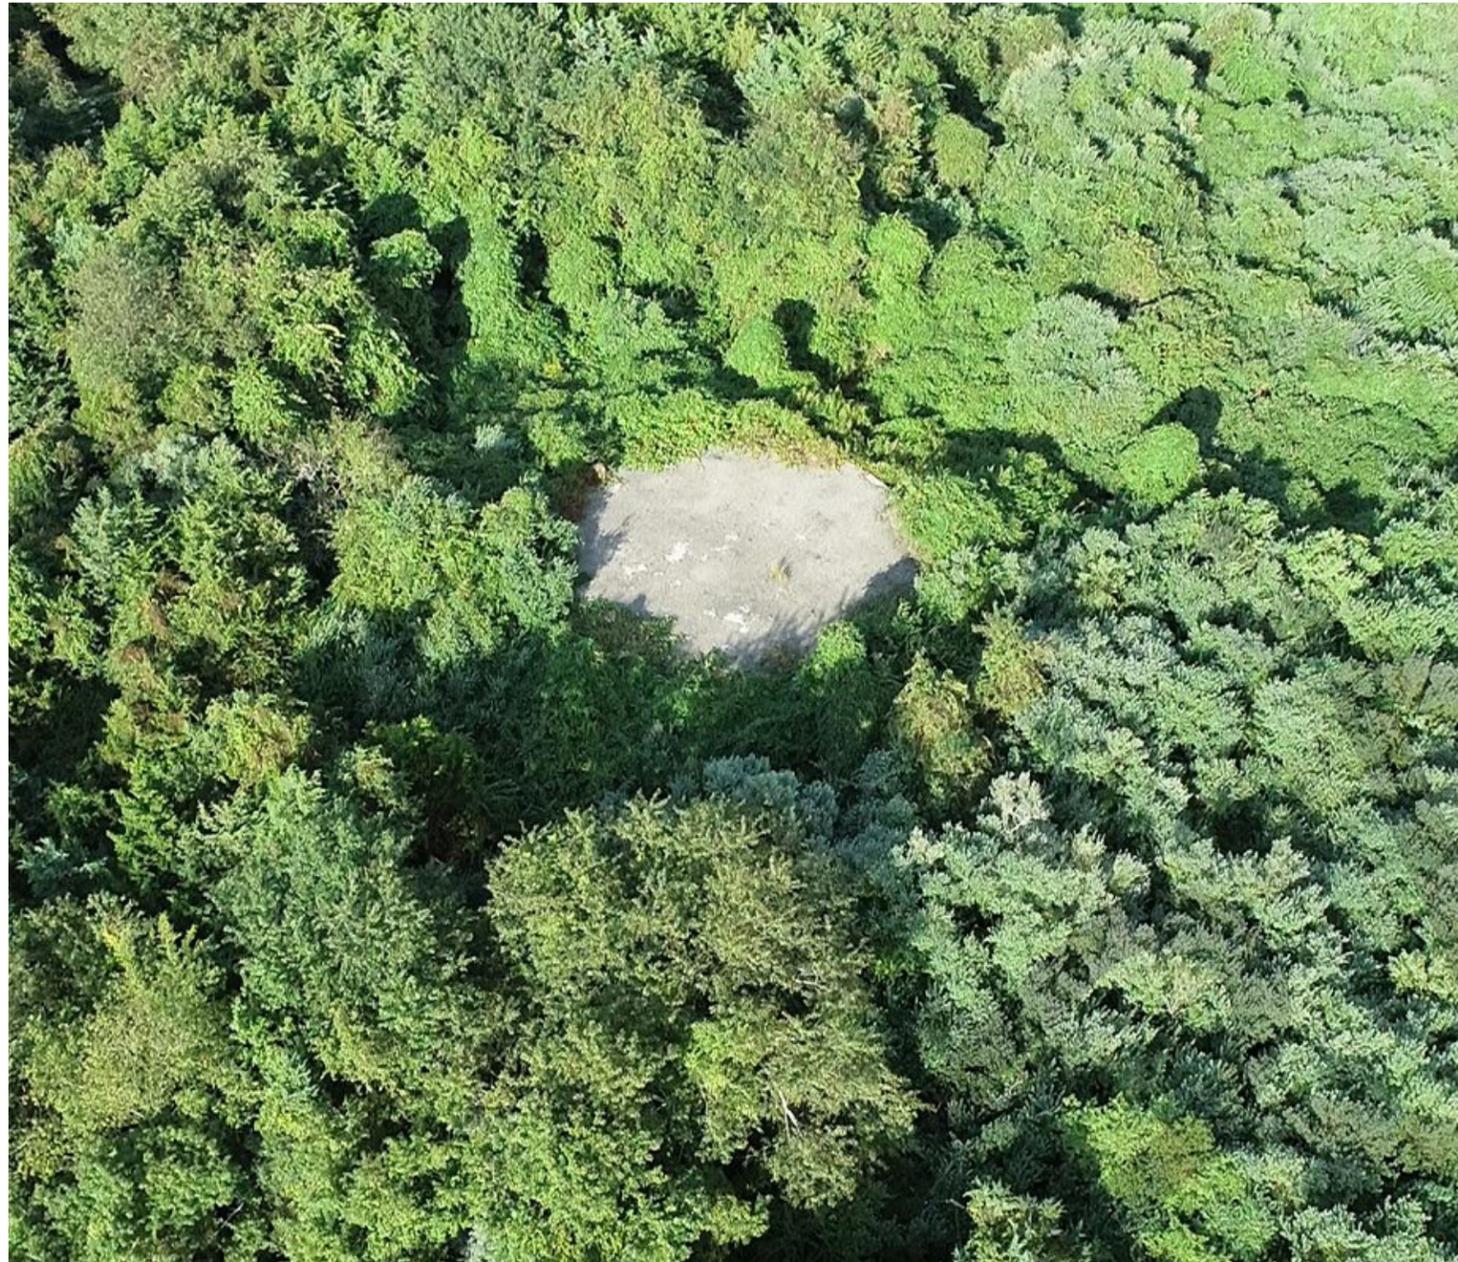
Battery Whiting is located on the eastern side of the Park on the waterfront and adjacent to Parking Lot 3. Access to the inside of the battery is blocked with boulders to prevent the public from entering. Similar to Battery 213, there are two concrete gun mounts.

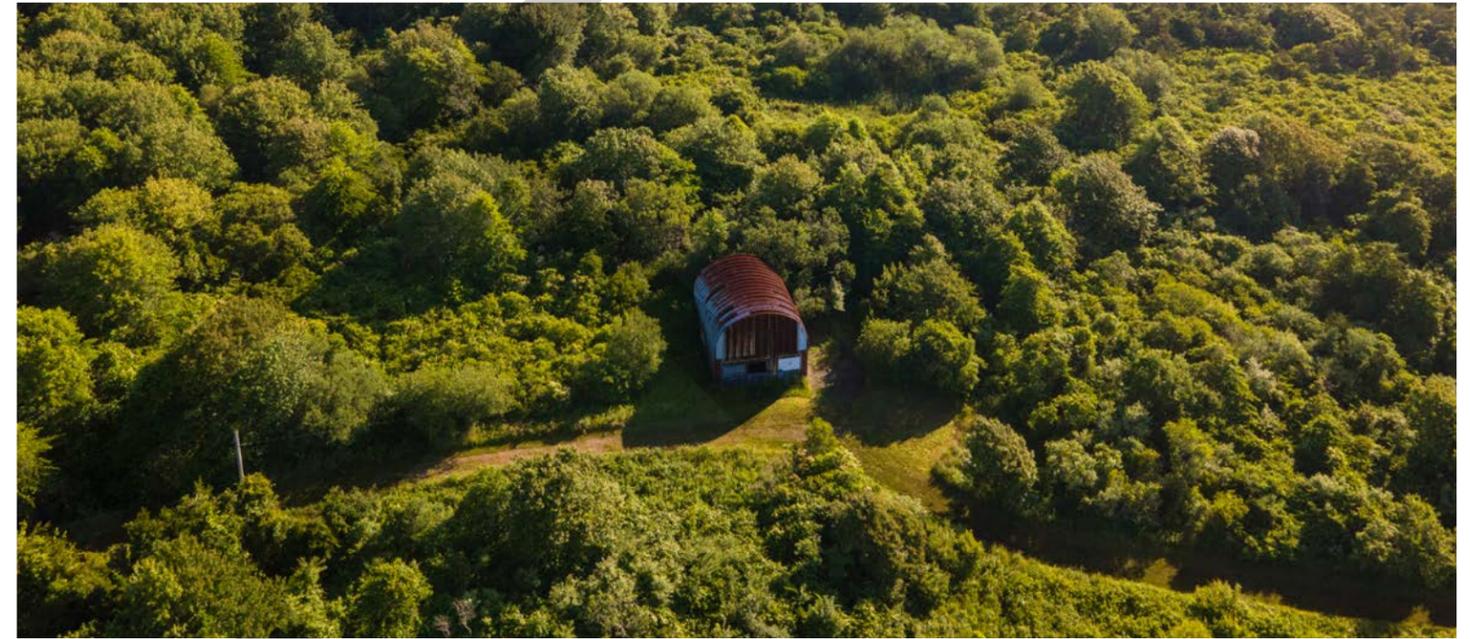
The Spraycliff concrete water cistern is in the northern corner of the west side of the Park. It nearly disappears into the surroundings of the forested area around it and is not accessed by the public often, especially in the growing season when the area is overgrown with brush and invasive species. The cistern is the only standing structure left from Spraycliff other than remnants of a paved roadway that leads out to Beavertail Road. It sits about 10 - 15 feet higher than the surrounding grade, reaching up into the canopy of the surrounding trees. It is approximately 60 feet in diameter.

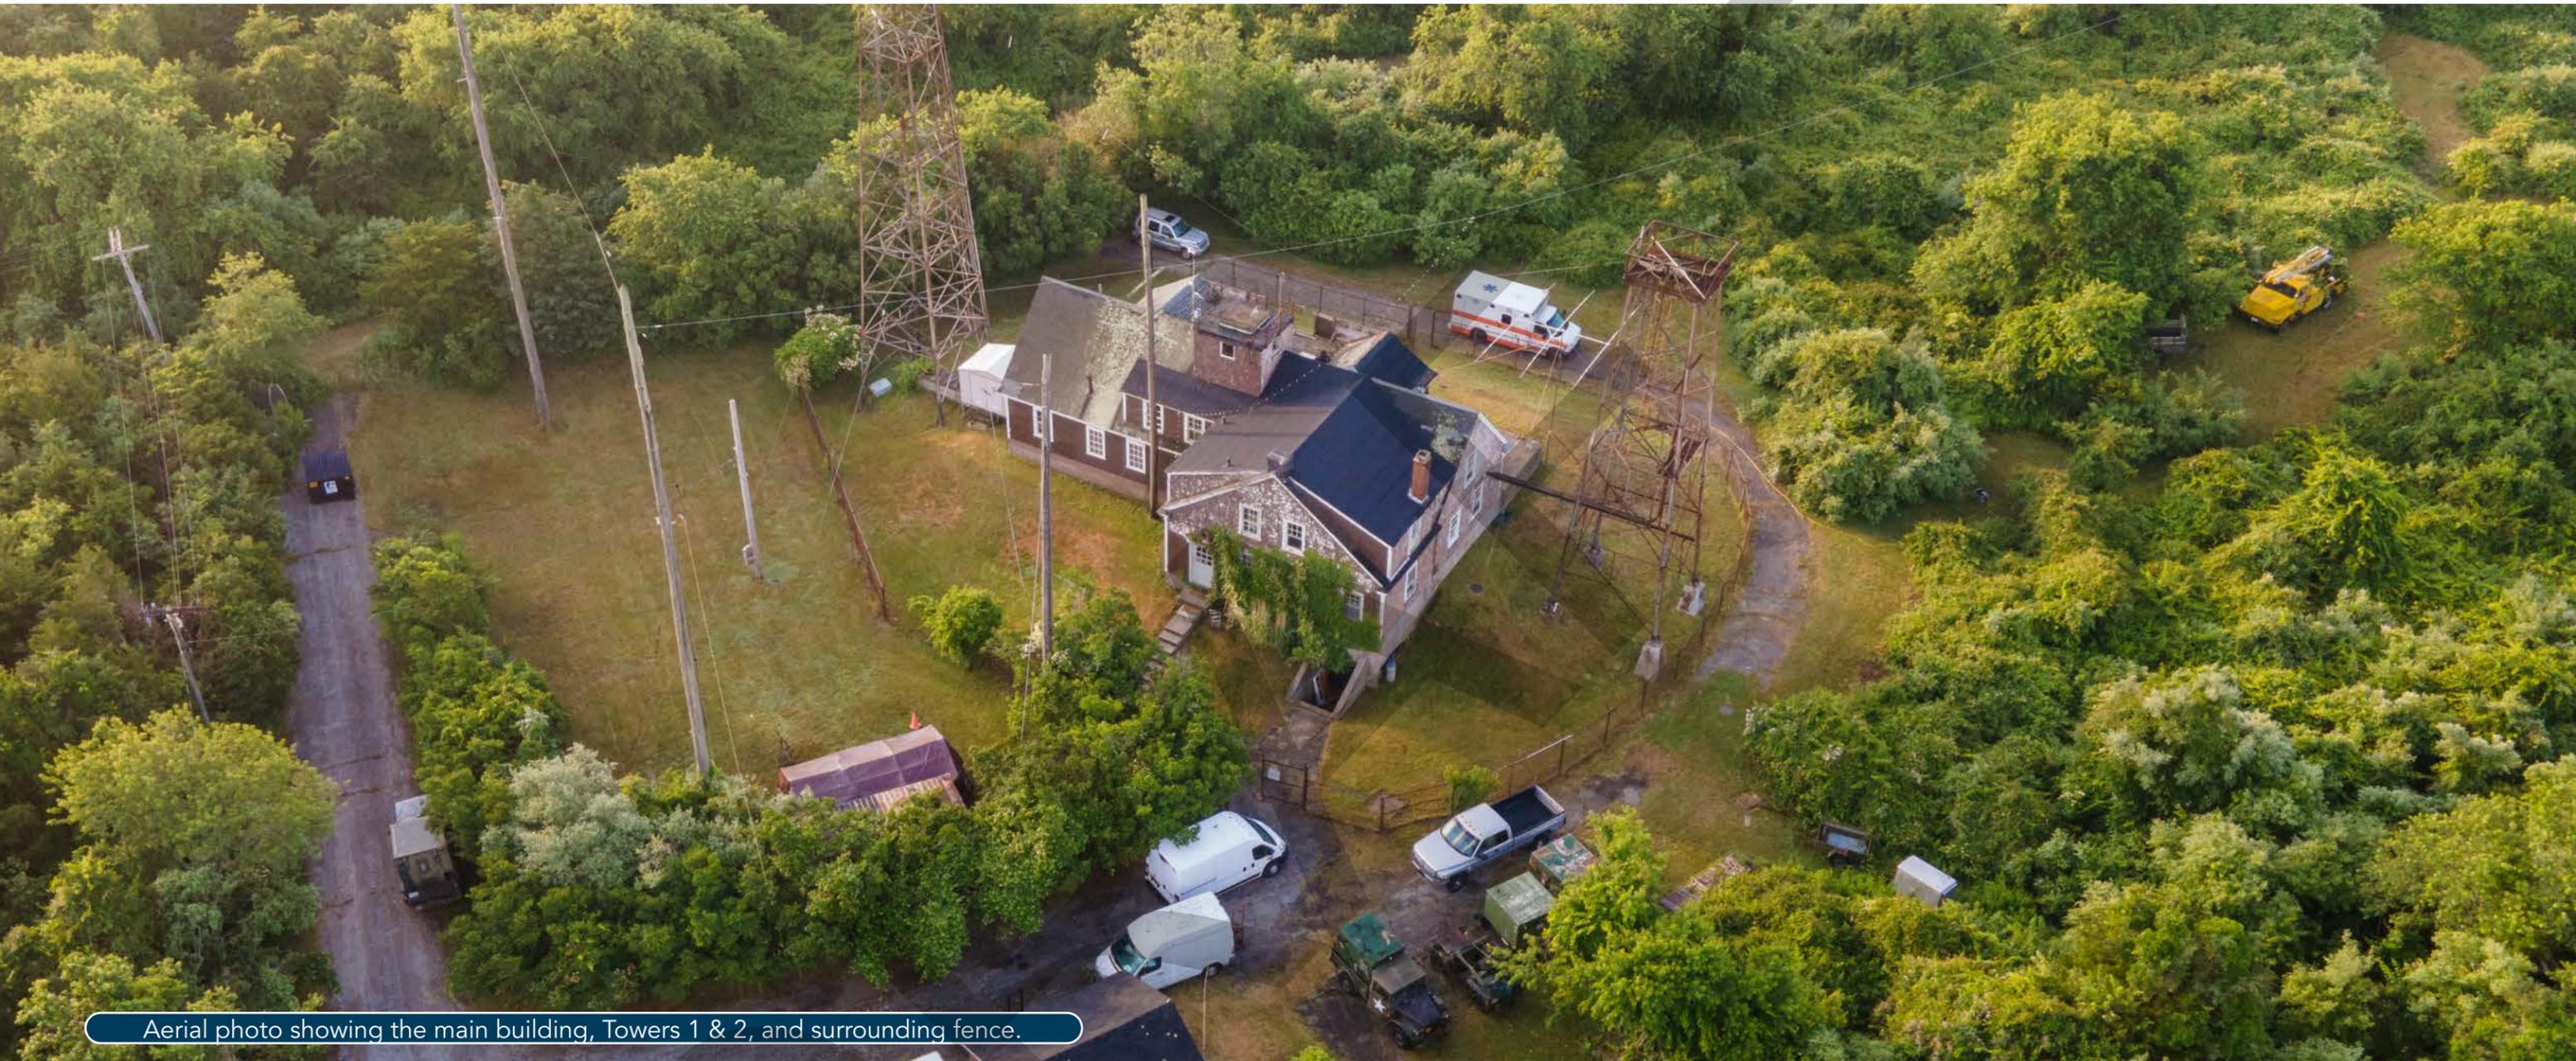
Aerial photo showing the main building, Towers 1 & 2, and surrounding fence.

The HECP is central to Beavertail State Park. It is visually hidden from the entrance drive by trees and brush and is open to the public by appointment on a limited basis. The building sits on elevated grade with the intention to see out into the bay, specifically during WWII when it was used to monitor traffic coming in and out of the bay. Its footprint, including the concrete deck on the southern side, is about 3,400 square feet and is accompanied by towers to the east and the west sides of the building. There is also a garage adjacent to the building on the west side that is about 800 square feet. Currently, there is no ADA access into the building.

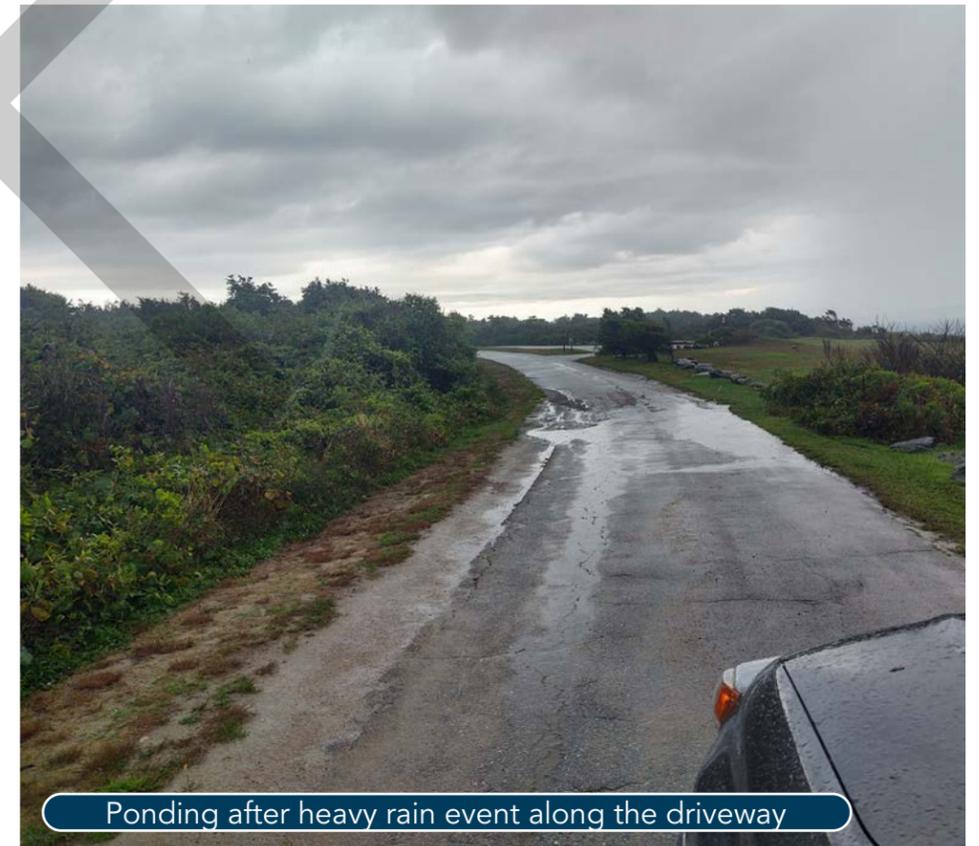
Ponding after heavy rain event along the driveway

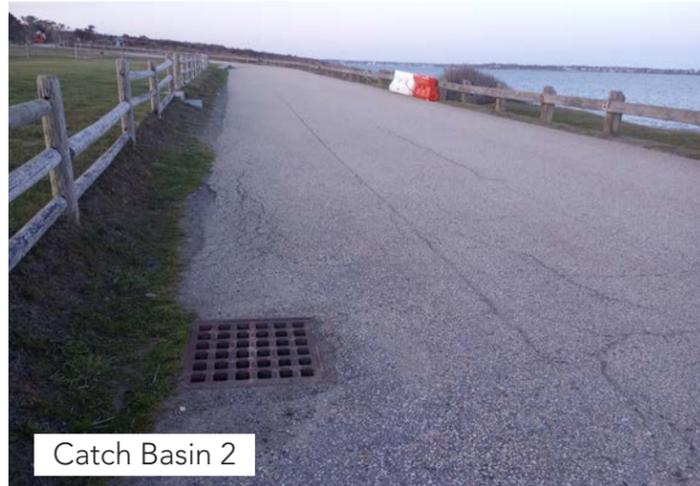
Catch Basin 2

concrete pipe and discharge at headwalls above the intertidal zone to the east and southwest of the lighthouse. Most of the headwalls are damaged or dislocated. These catch basins and drainage pipe network near the lighthouse are approximately 400 feet in length.

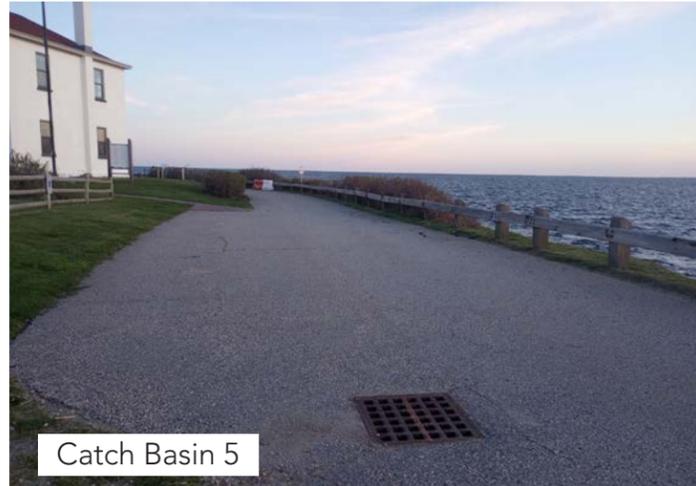
Catch Basin 5

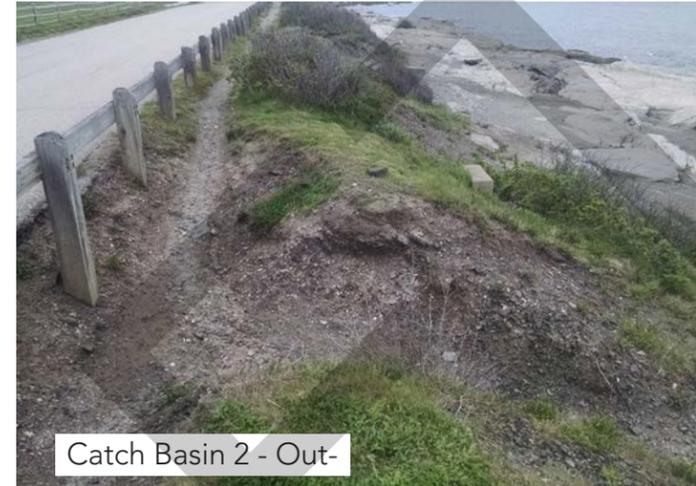
Catch Basin 2 - Out-

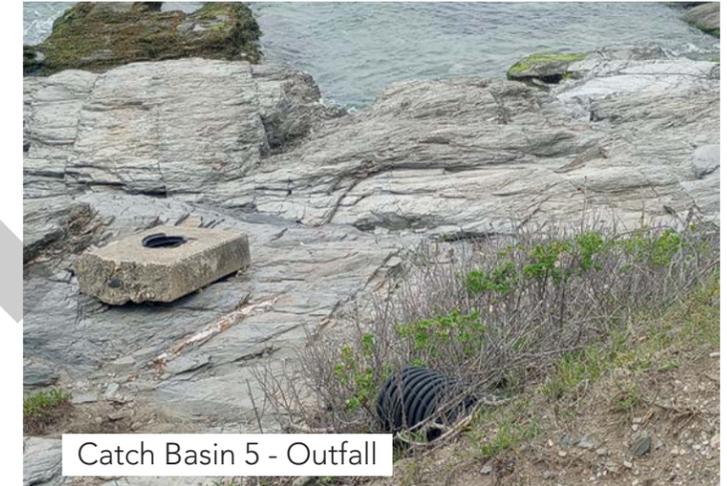
Catch Basin 5 - Outfall

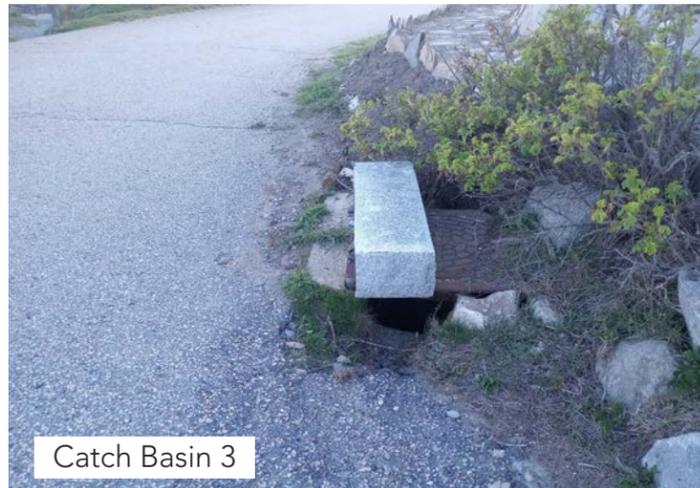
Catch Basin 3

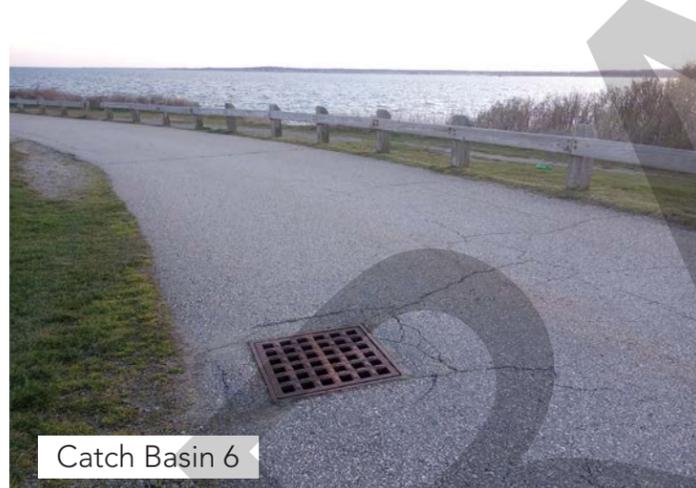
Catch Basin 6

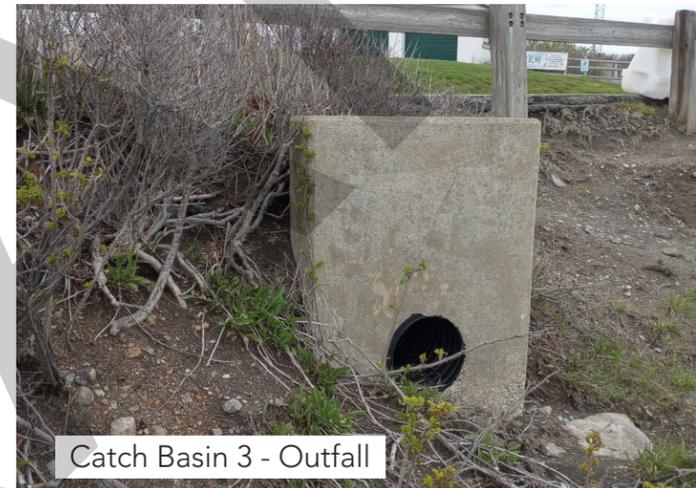
Catch Basin 3 - Outfall

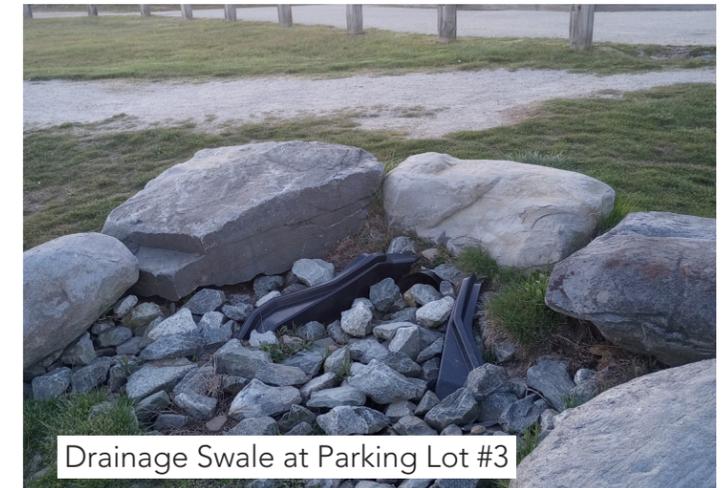
Drainage Swale at Parking Lot #3

The Park loop road is not curbed, so roadway drainage consists of largely overland flow to grassed areas without swales or collection structures. A notable exception is found at the southern apex of the inner loop road where a park roadway runoff is directed to a rip-rap lined drainage swale on the southern edge of the road beyond the northwestern edge of the original lighthouse property. The swale system adjacent to the existing stone wall is linked with a pipe under the roadway to a second swale, west of the loop road. This system is largely overgrown. An isolated catch basin is located to the west of the lighthouse loop road.
