FINAL DRAFT

# BEAVERTAIL STATE PARK MASTER PLAN 2025

The beavertail State Park Master Plan is intended to re-imagine the future of Beavertail State Park and addresses the following:

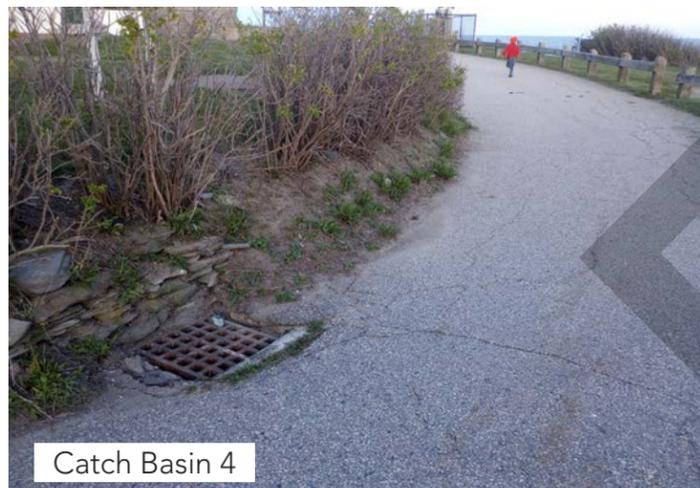
Catch Basin 4

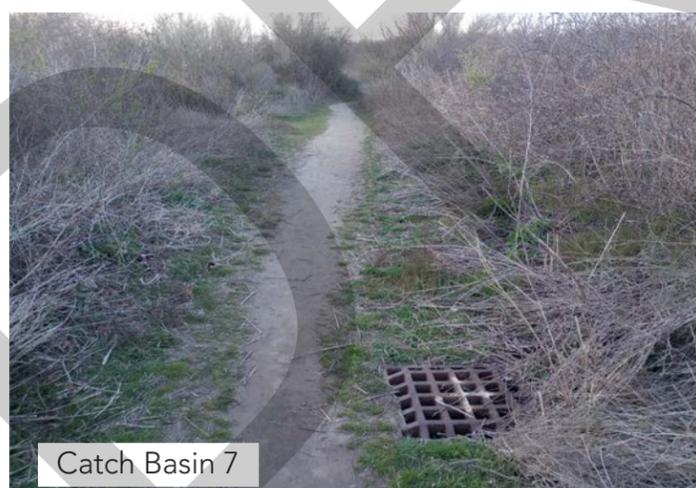
Catch Basin 7

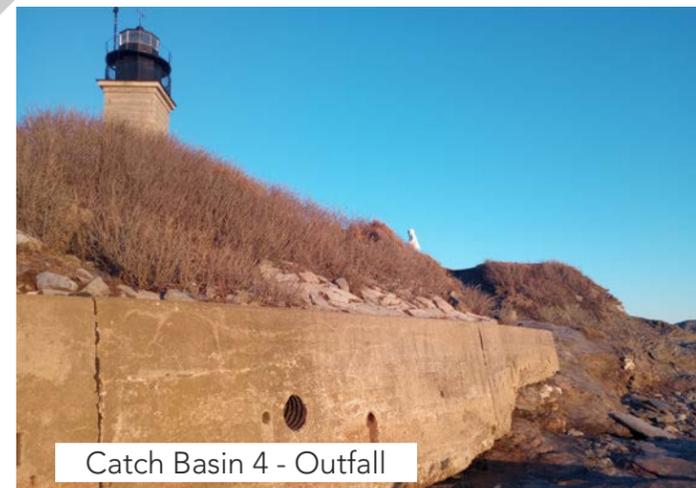
Catch Basin 4 - Outfall

concrete pipe and discharge at headwalls above the intertidal zone to the east and southwest of the lighthouse. Most of the headwalls are damaged or dislocated. These catch basins and drainage pipe network near the lighthouse are approximately 400 feet in length.

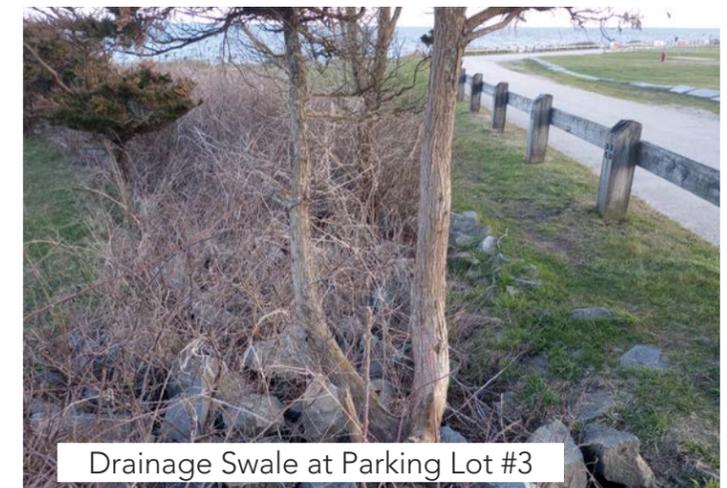
Drainage Swale at Parking Lot #3

The Park loop road is not curbed, so roadway drainage consists of largely overland flow to grassed areas without swales or collection structures. A notable exception is found at the southern apex of the inner loop road where a park roadway runoff is directed to a rip-rap lined drainage swale on the southern edge of the road beyond the northwestern edge of the original lighthouse property. The swale system adjacent to the existing stone wall is linked with a pipe under the roadway to a second swale, west of the loop road. This system is largely overgrown. An isolated catch basin is located to the west of the lighthouse loop road.

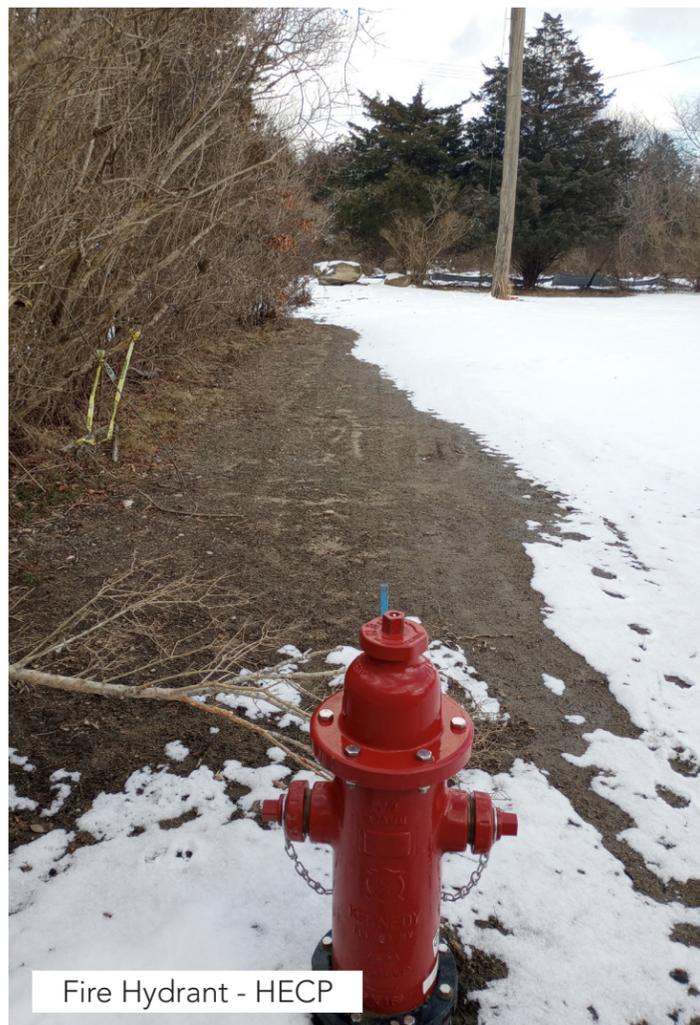
Fire Hydrant - HECP

As noted previously, the roadway from the north to the lighthouse was originally a direct, straight line. The water and electric utilities follow this corridor. Water service extends to the HECF and the lighthouse. RIDEM upgraded the water service in 2023. A new four inch line was installed from Beavertail Road to the Light Station.

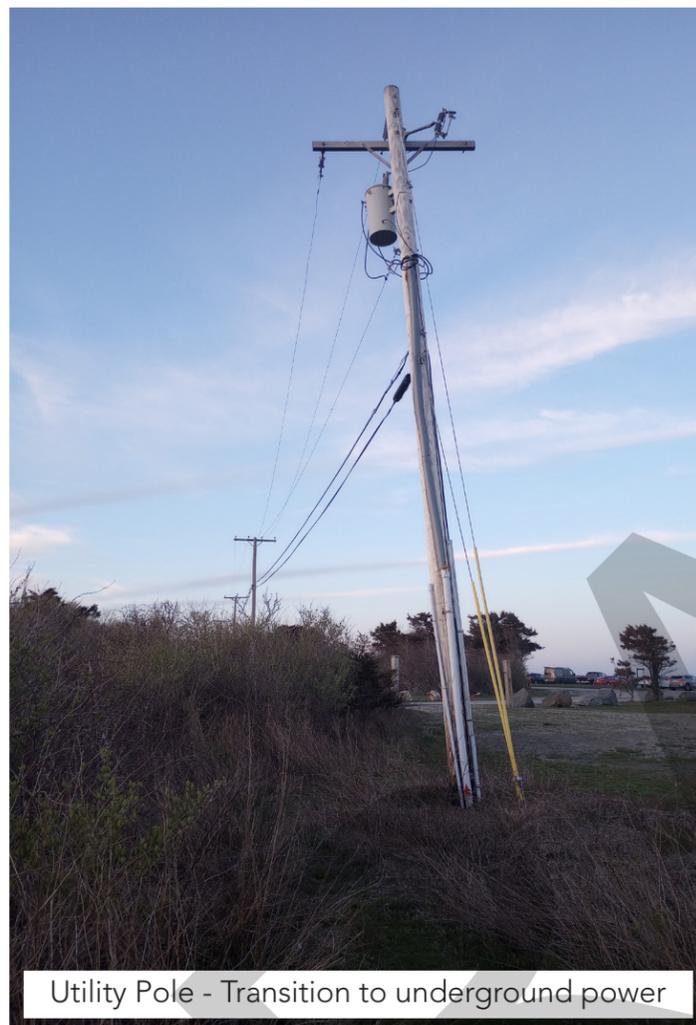
Utility Pole - Transition to underground power

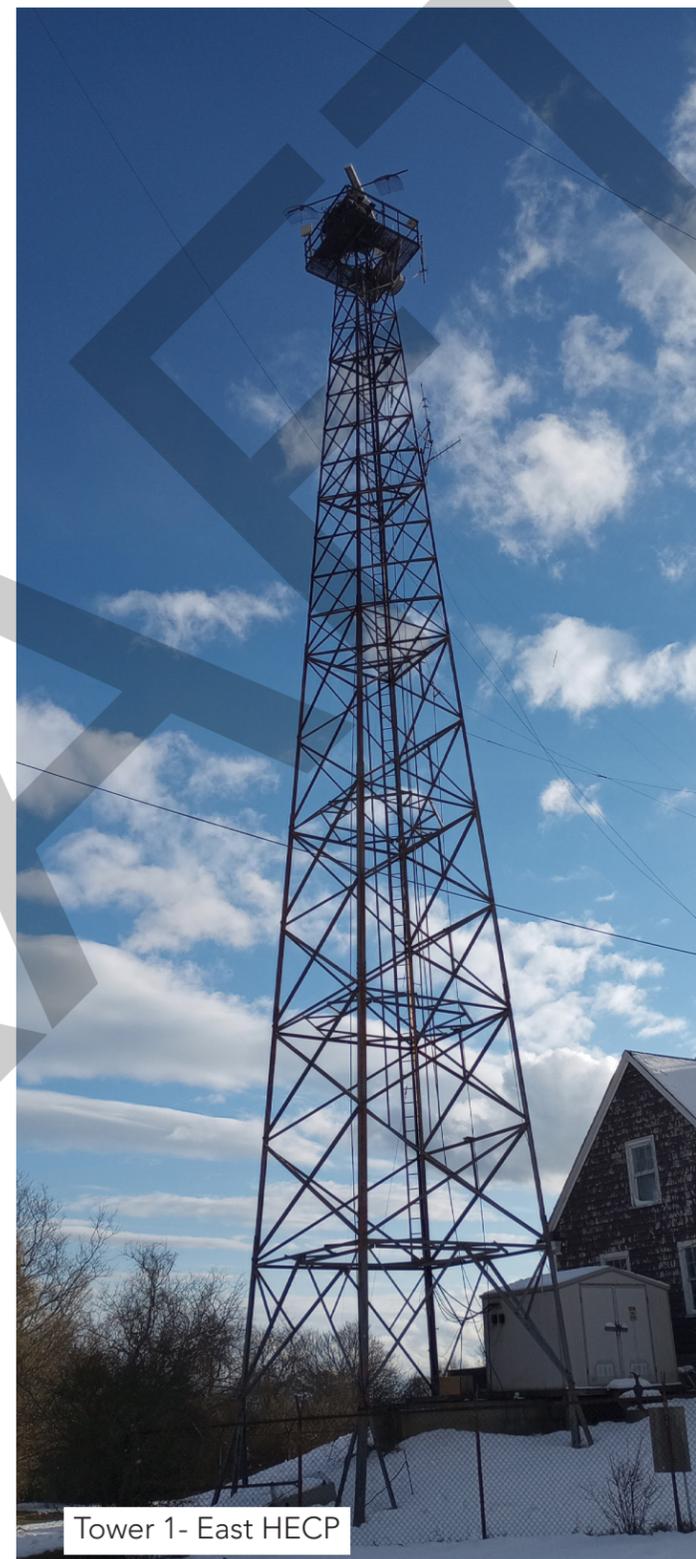
Tower 1- East HECP

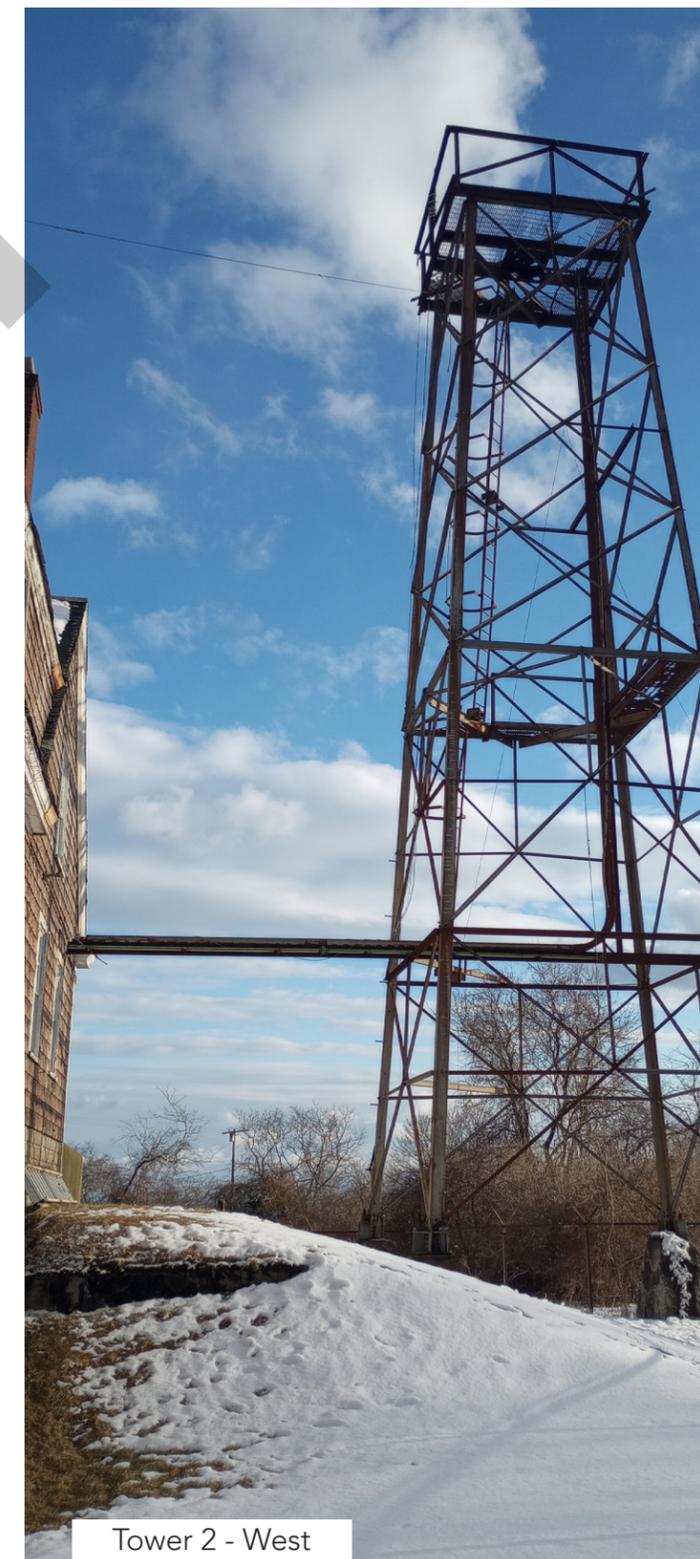
Tower 2 - West

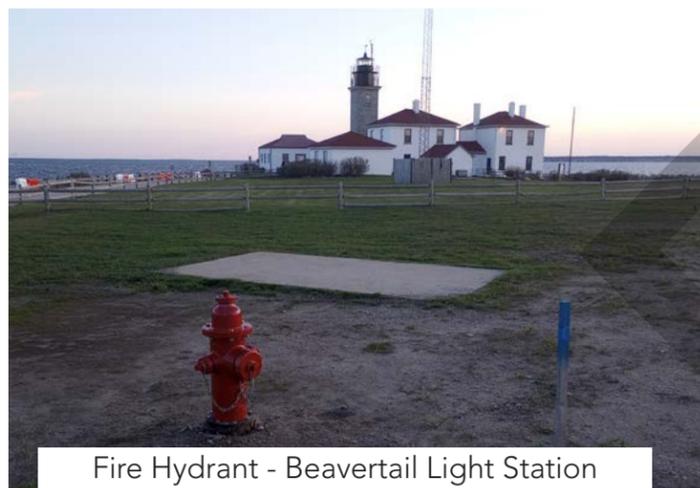
Fire Hydrant - Beavertail Light Station

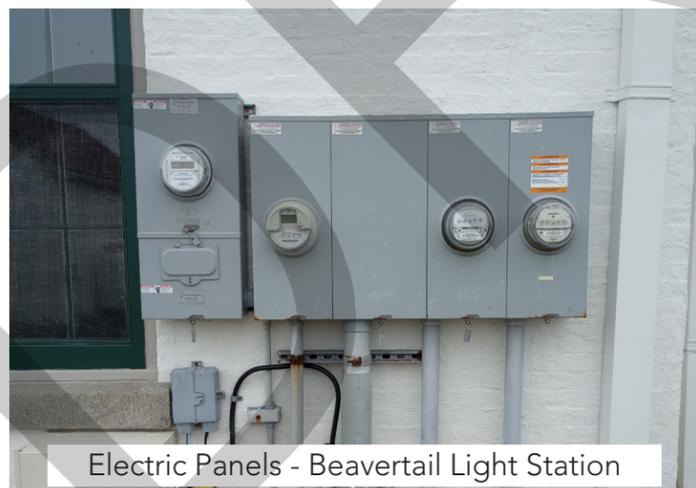
Electric Panels - Beavertail Light Station

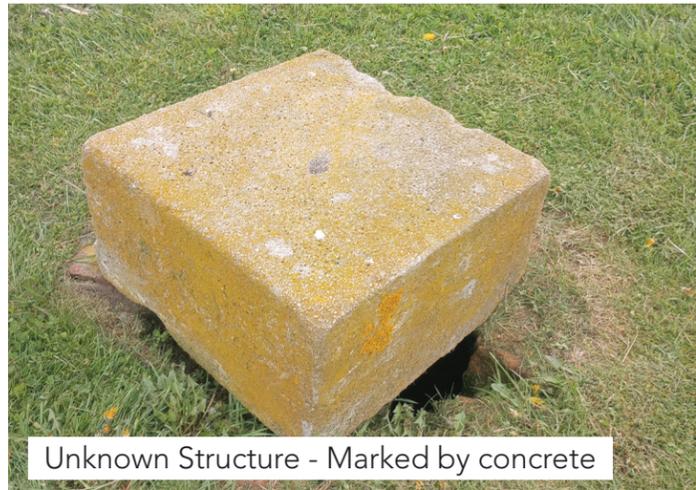
Unknown Structure - Marked by concrete

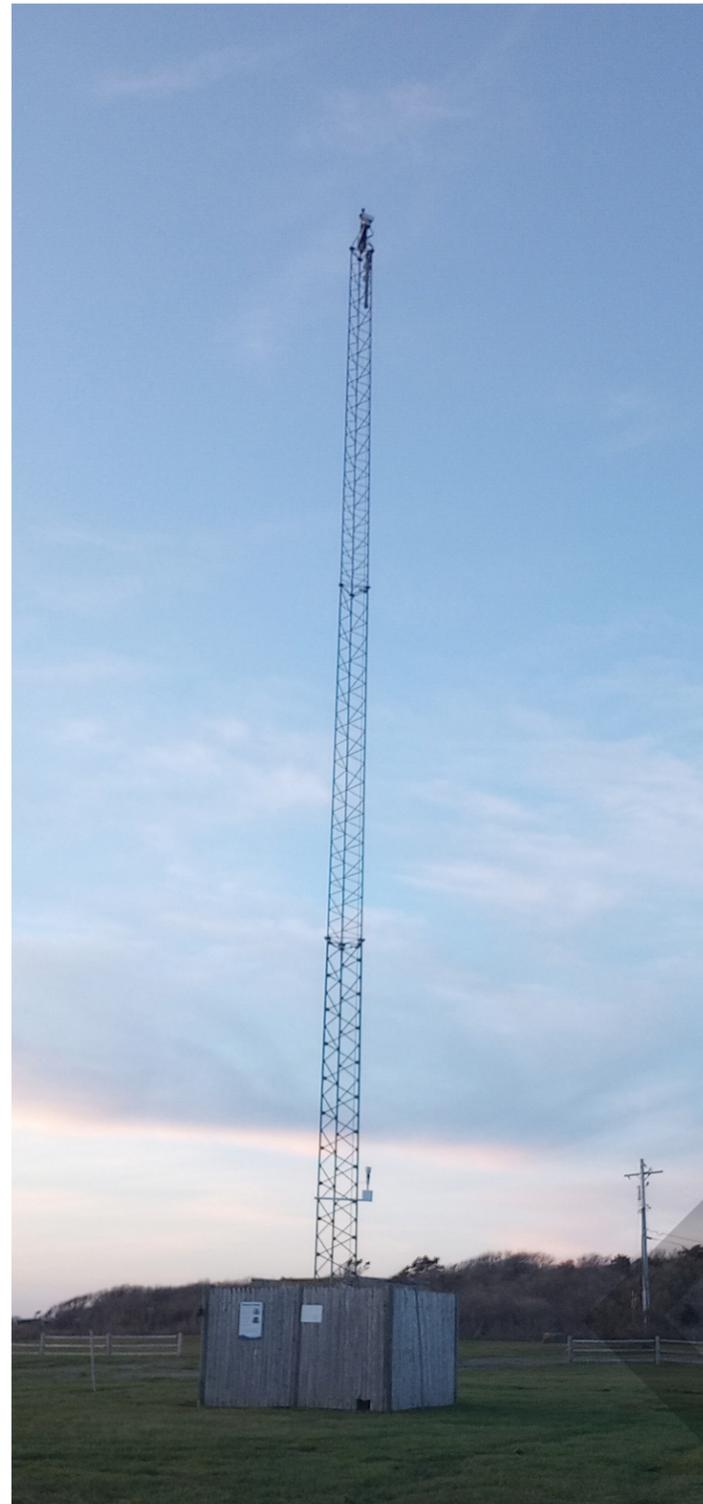
Tower 3 - Radio Antenna - Beavertail Light Station

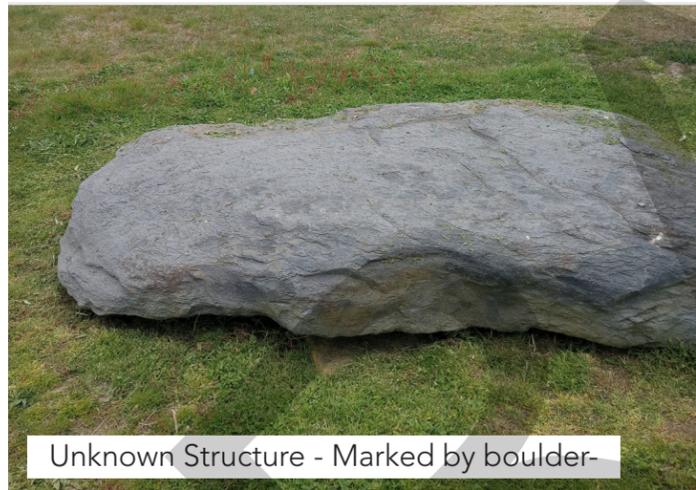
Unknown Structure - Marked by boulder-

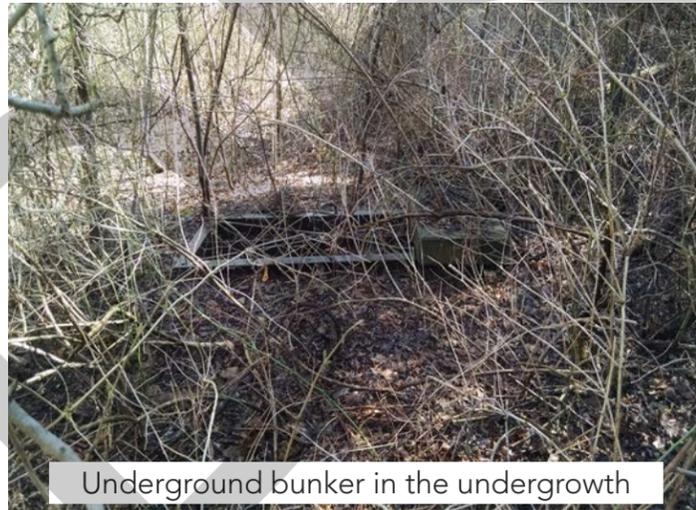
Underground bunker in the undergrowth

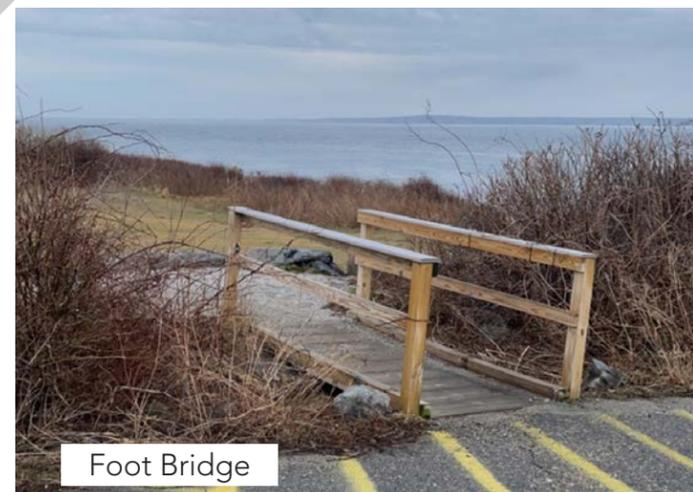
Foot Bridge

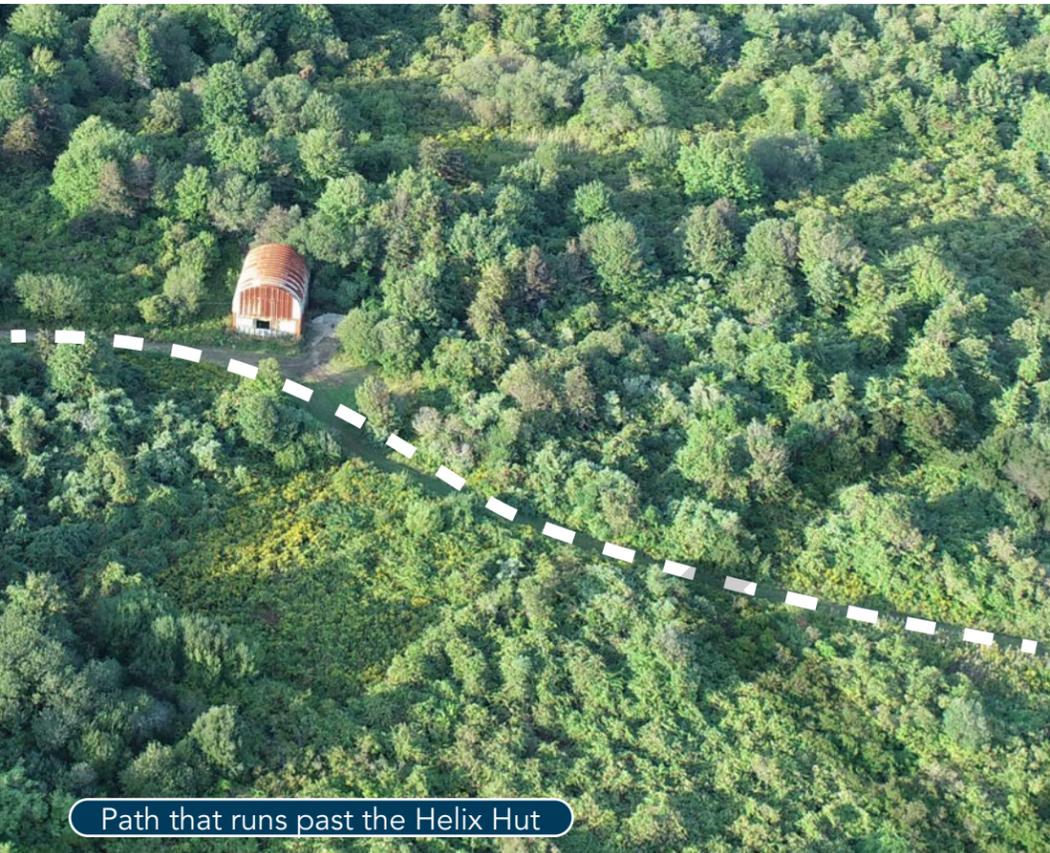
Path that runs past the Helix Hut

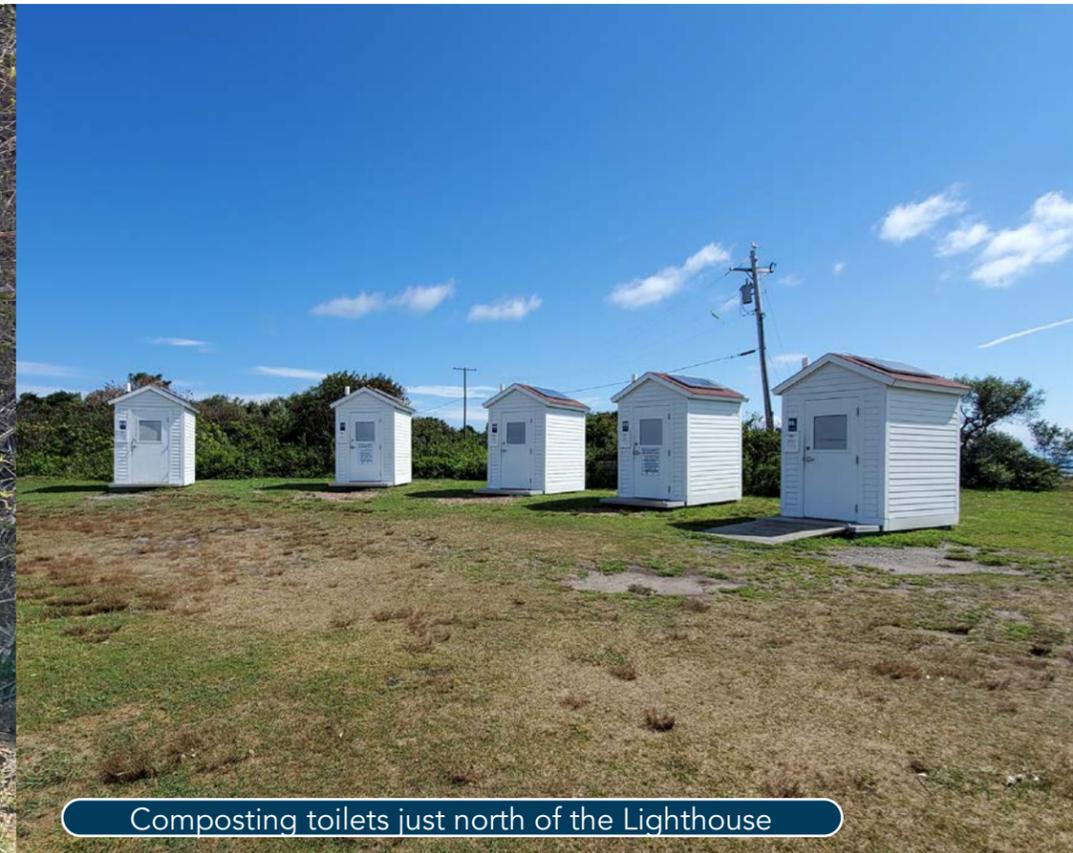
Composting toilets just north of the Lighthouse

There are five composting toilets located on the site north-west of the lighthouse. They are positioned in close proximity to each other, sited between Parking Lot 2 and the Light Station.

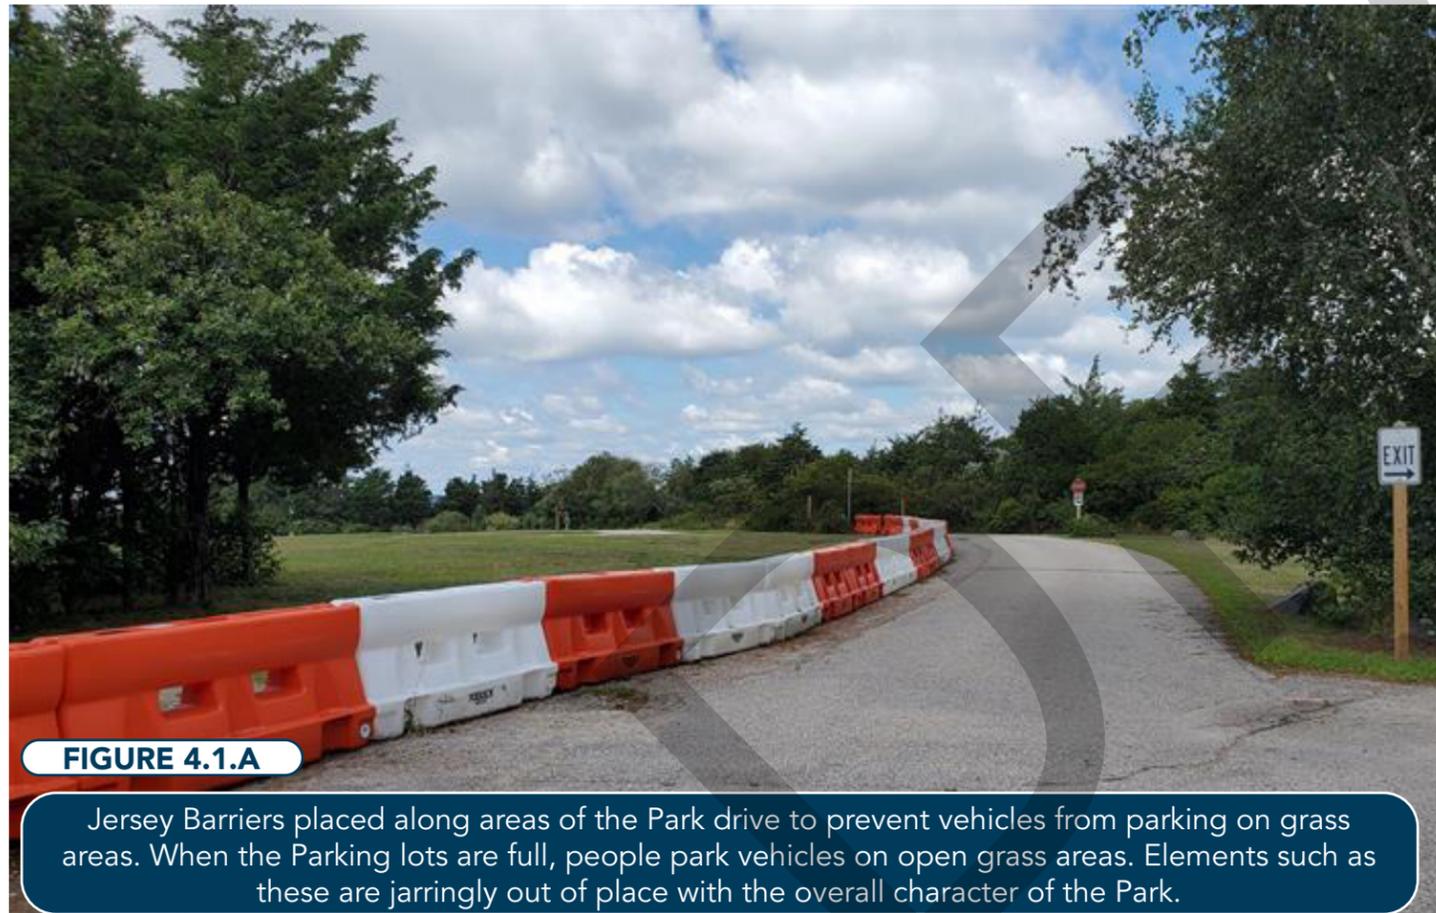
**FIGURE 4.1.A**

Jersey Barriers placed along areas of the Park drive to prevent vehicles from parking on grass areas. When the Parking lots are full, people park vehicles on open grass areas. Elements such as these are jarringly out of place with the overall character of the Park.

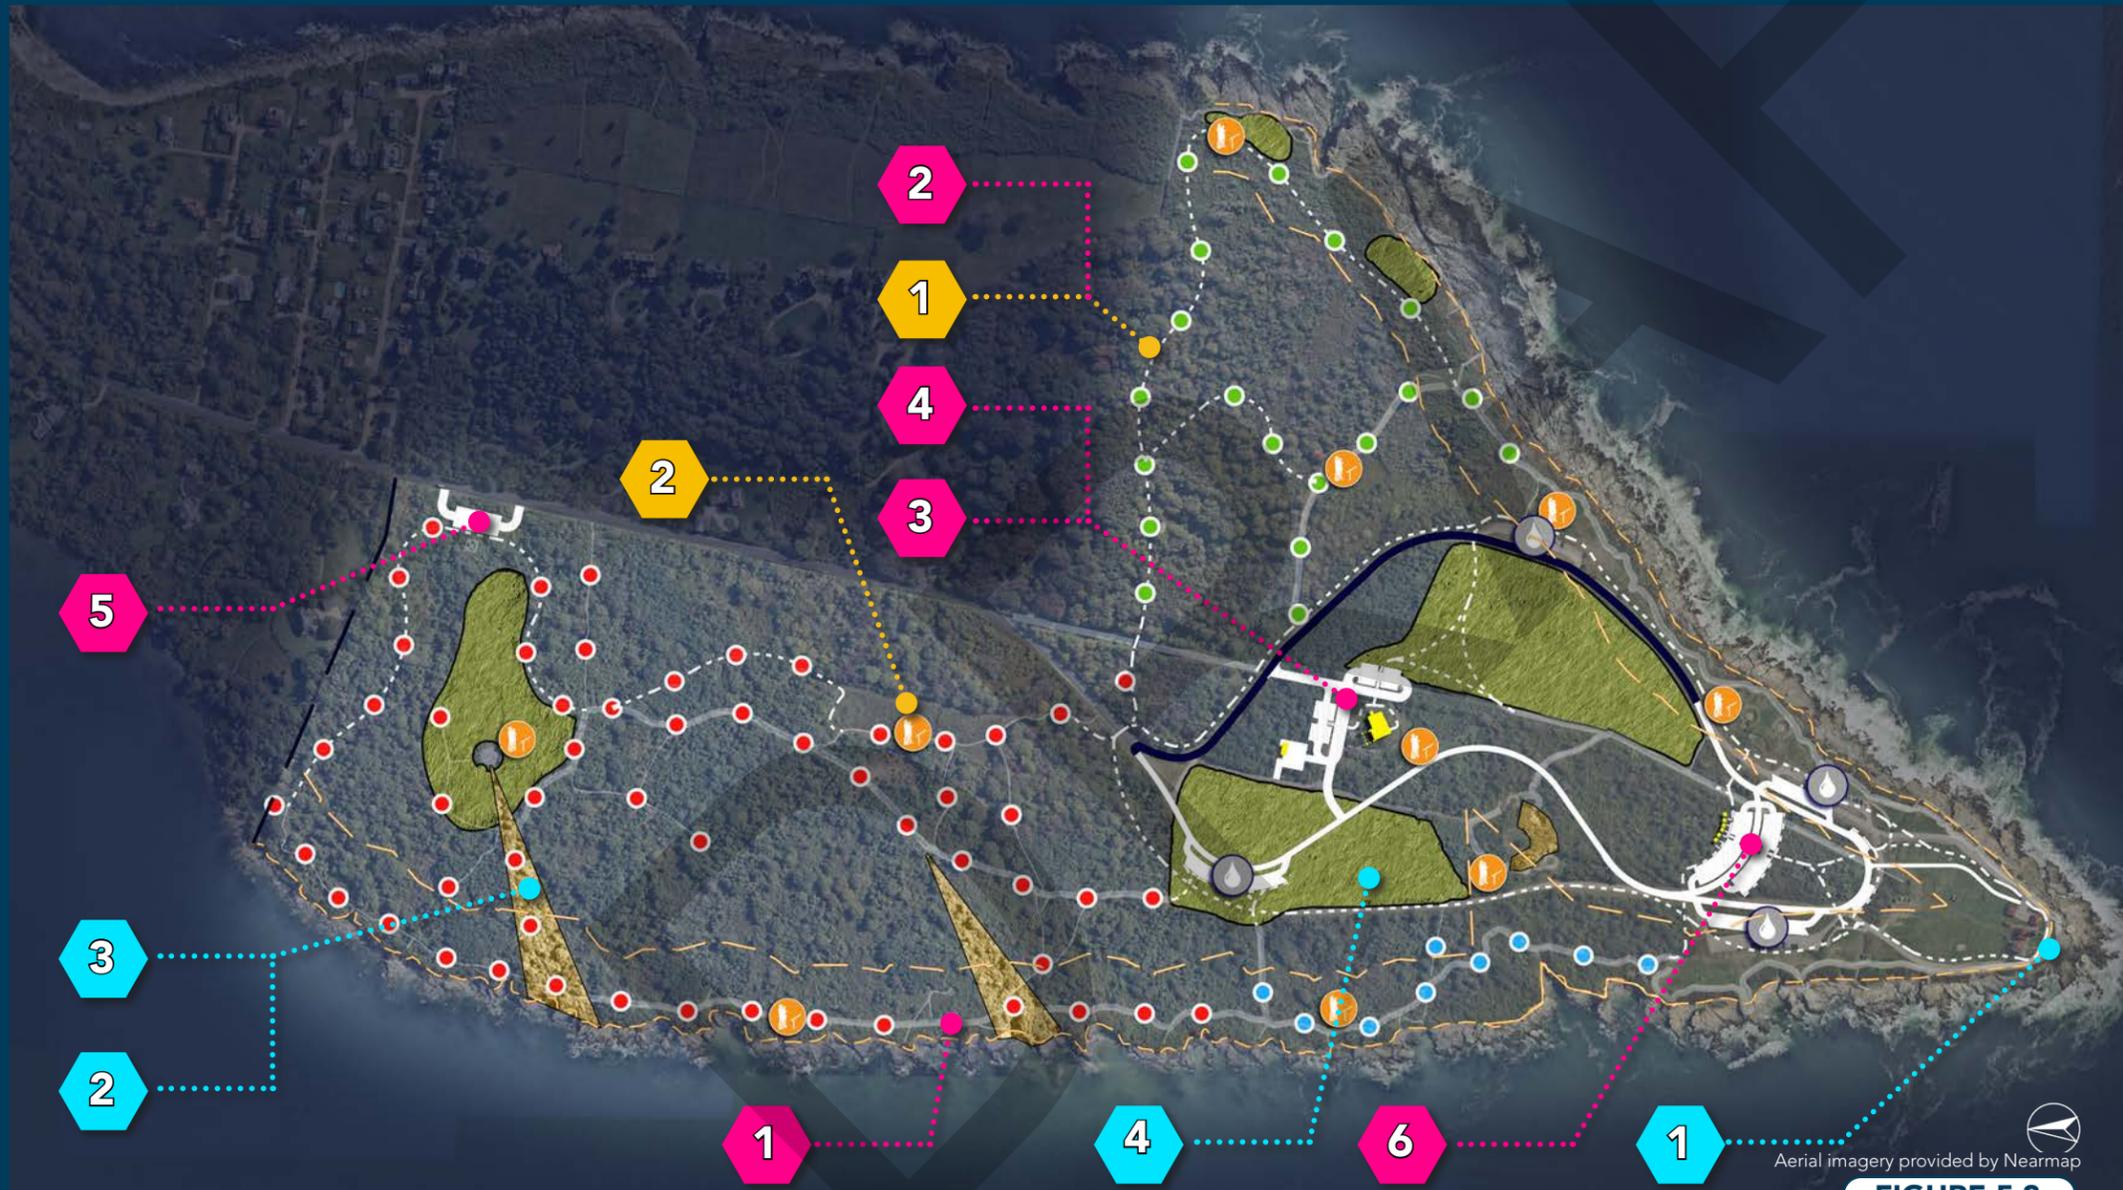
FIGURE 5.3

- 1 Formalize and improve existing trails
- 2 Additional walking trails
- 3 Mid-park parking lots
- 4 Transform HECP into visitors center
- 5 North-park parking lot (trailhead with composting toilet)
- 6 South-park parking area

- 20 Park Entrance Gate
- 21 Entrance Parking / Turn Around
- 22 Benches (project wide - as appropriate)
- 23 Parking Edge Control (project wide - as appropriate)

- 24 Interpretive Signage (project wide - as appropriate)
- 25 Wayfinding Signage Throughout Beavertail State Park

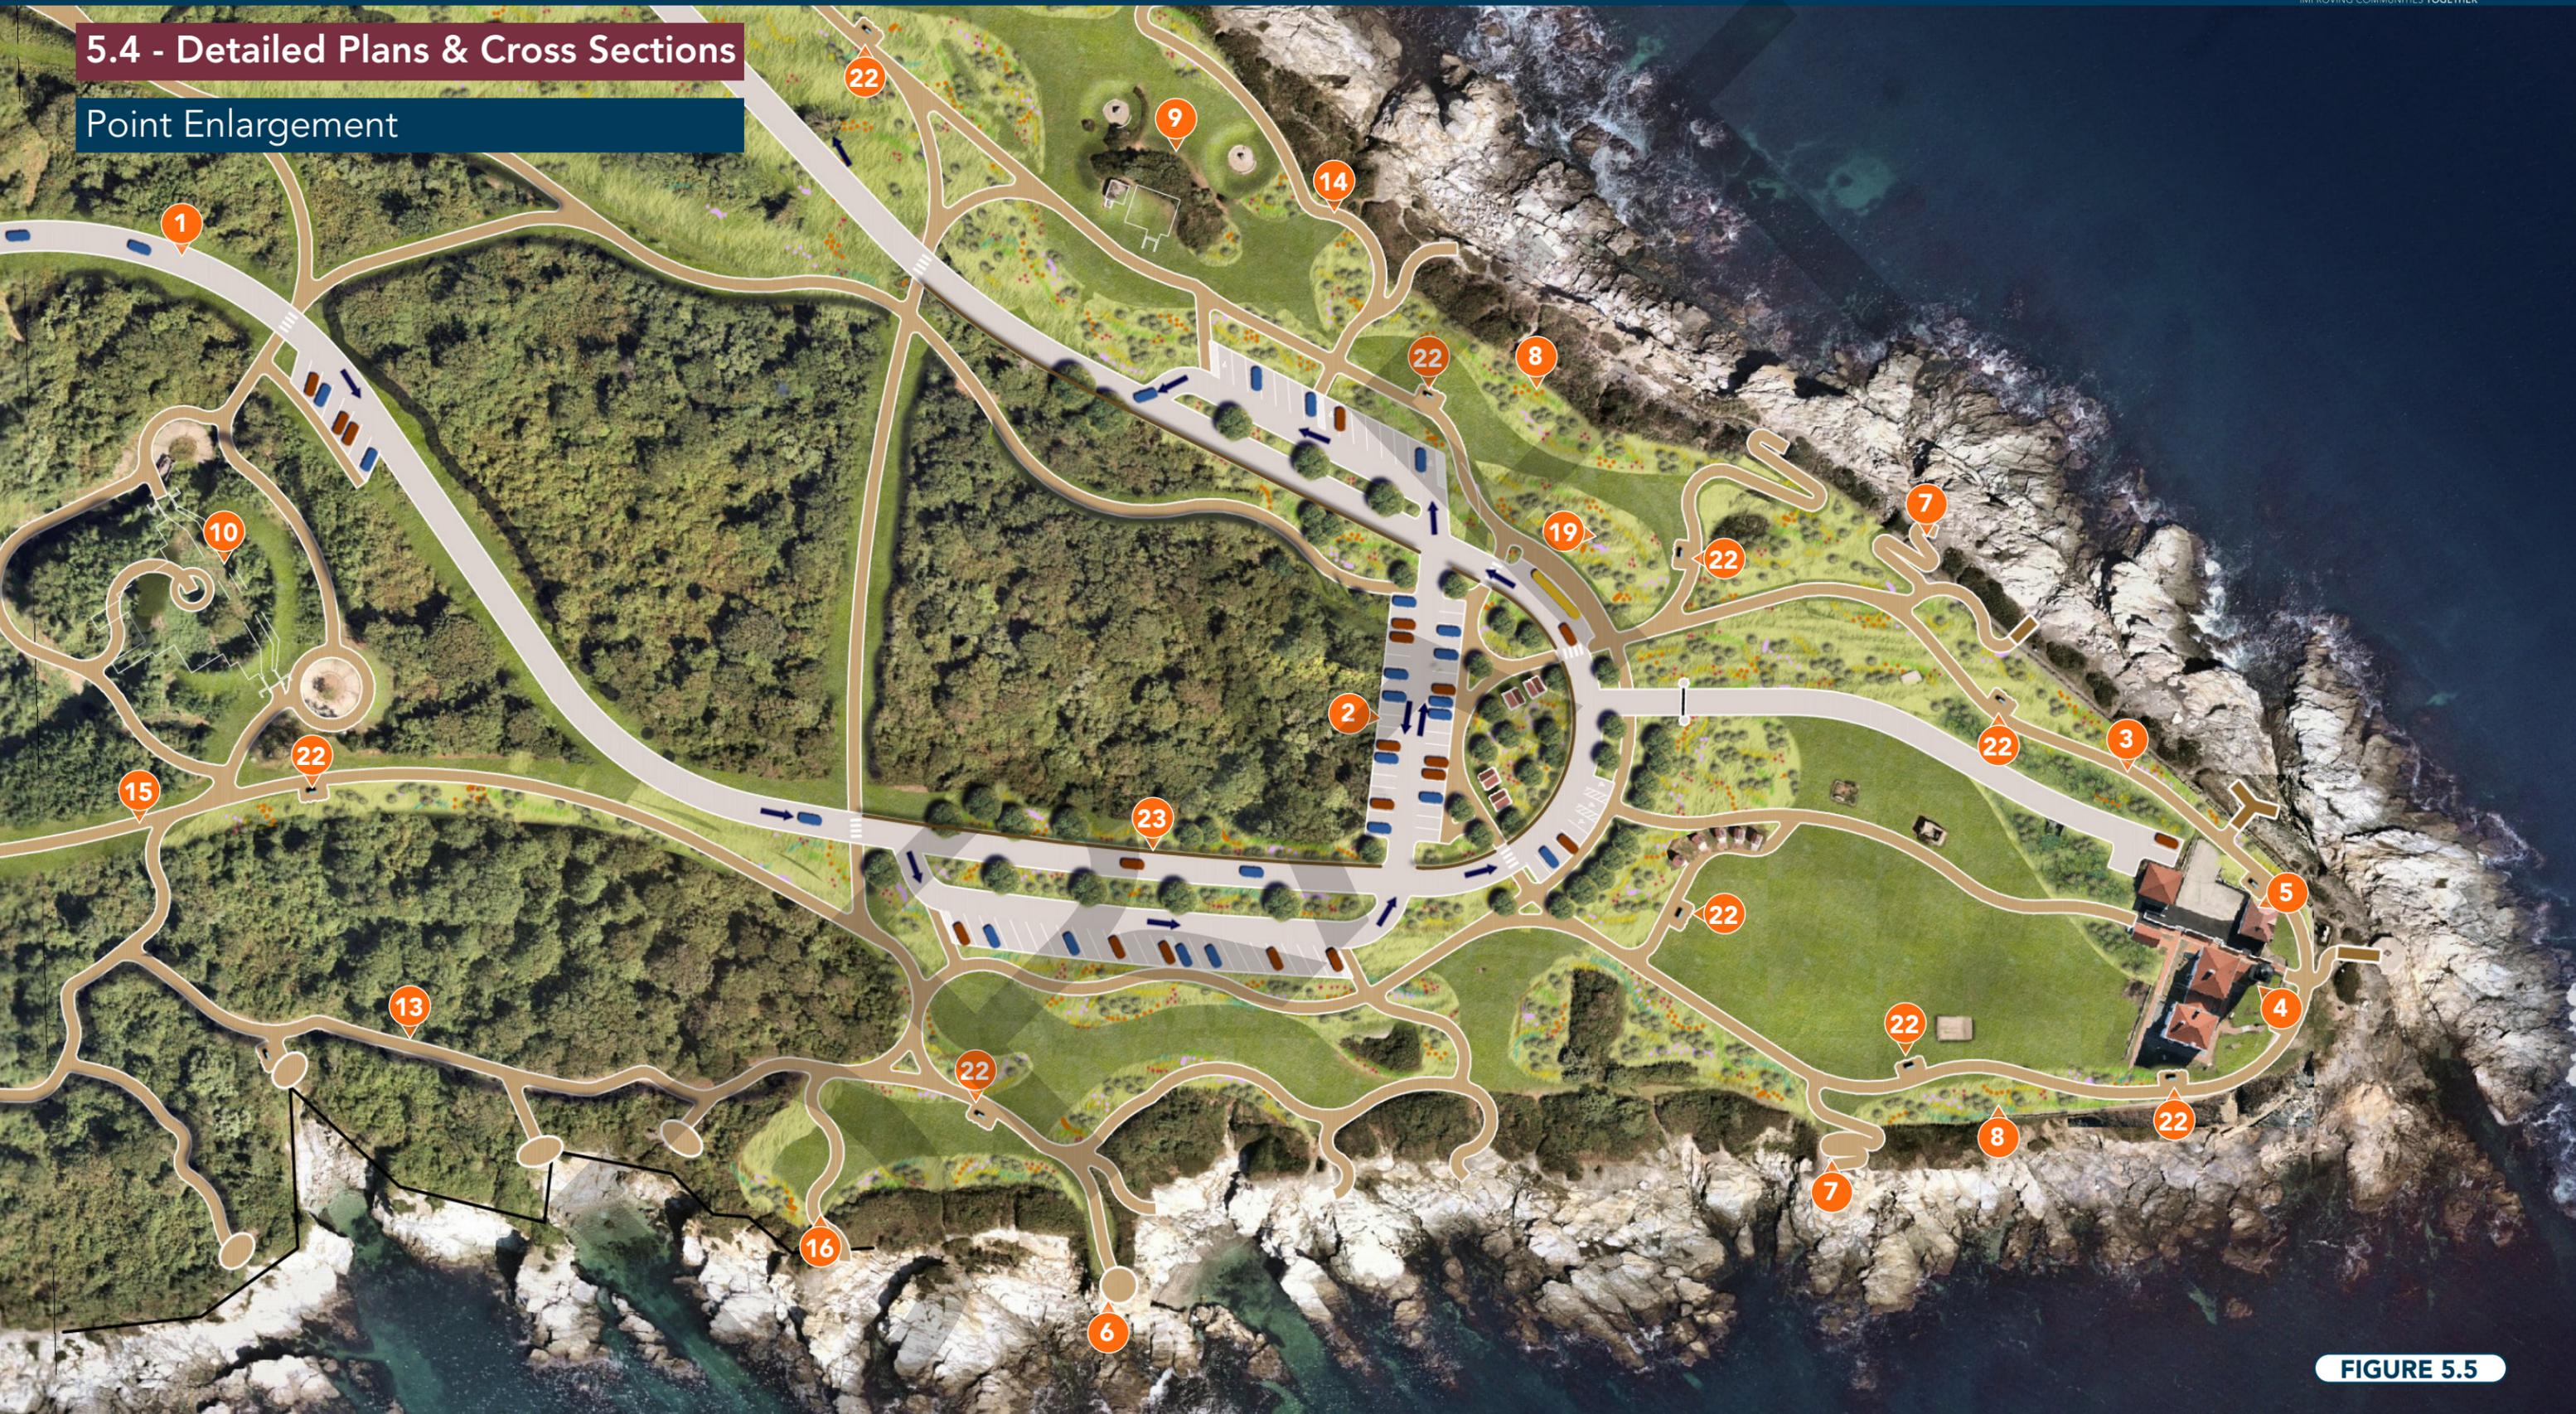
FIGURE 5.5

Point Enlargement

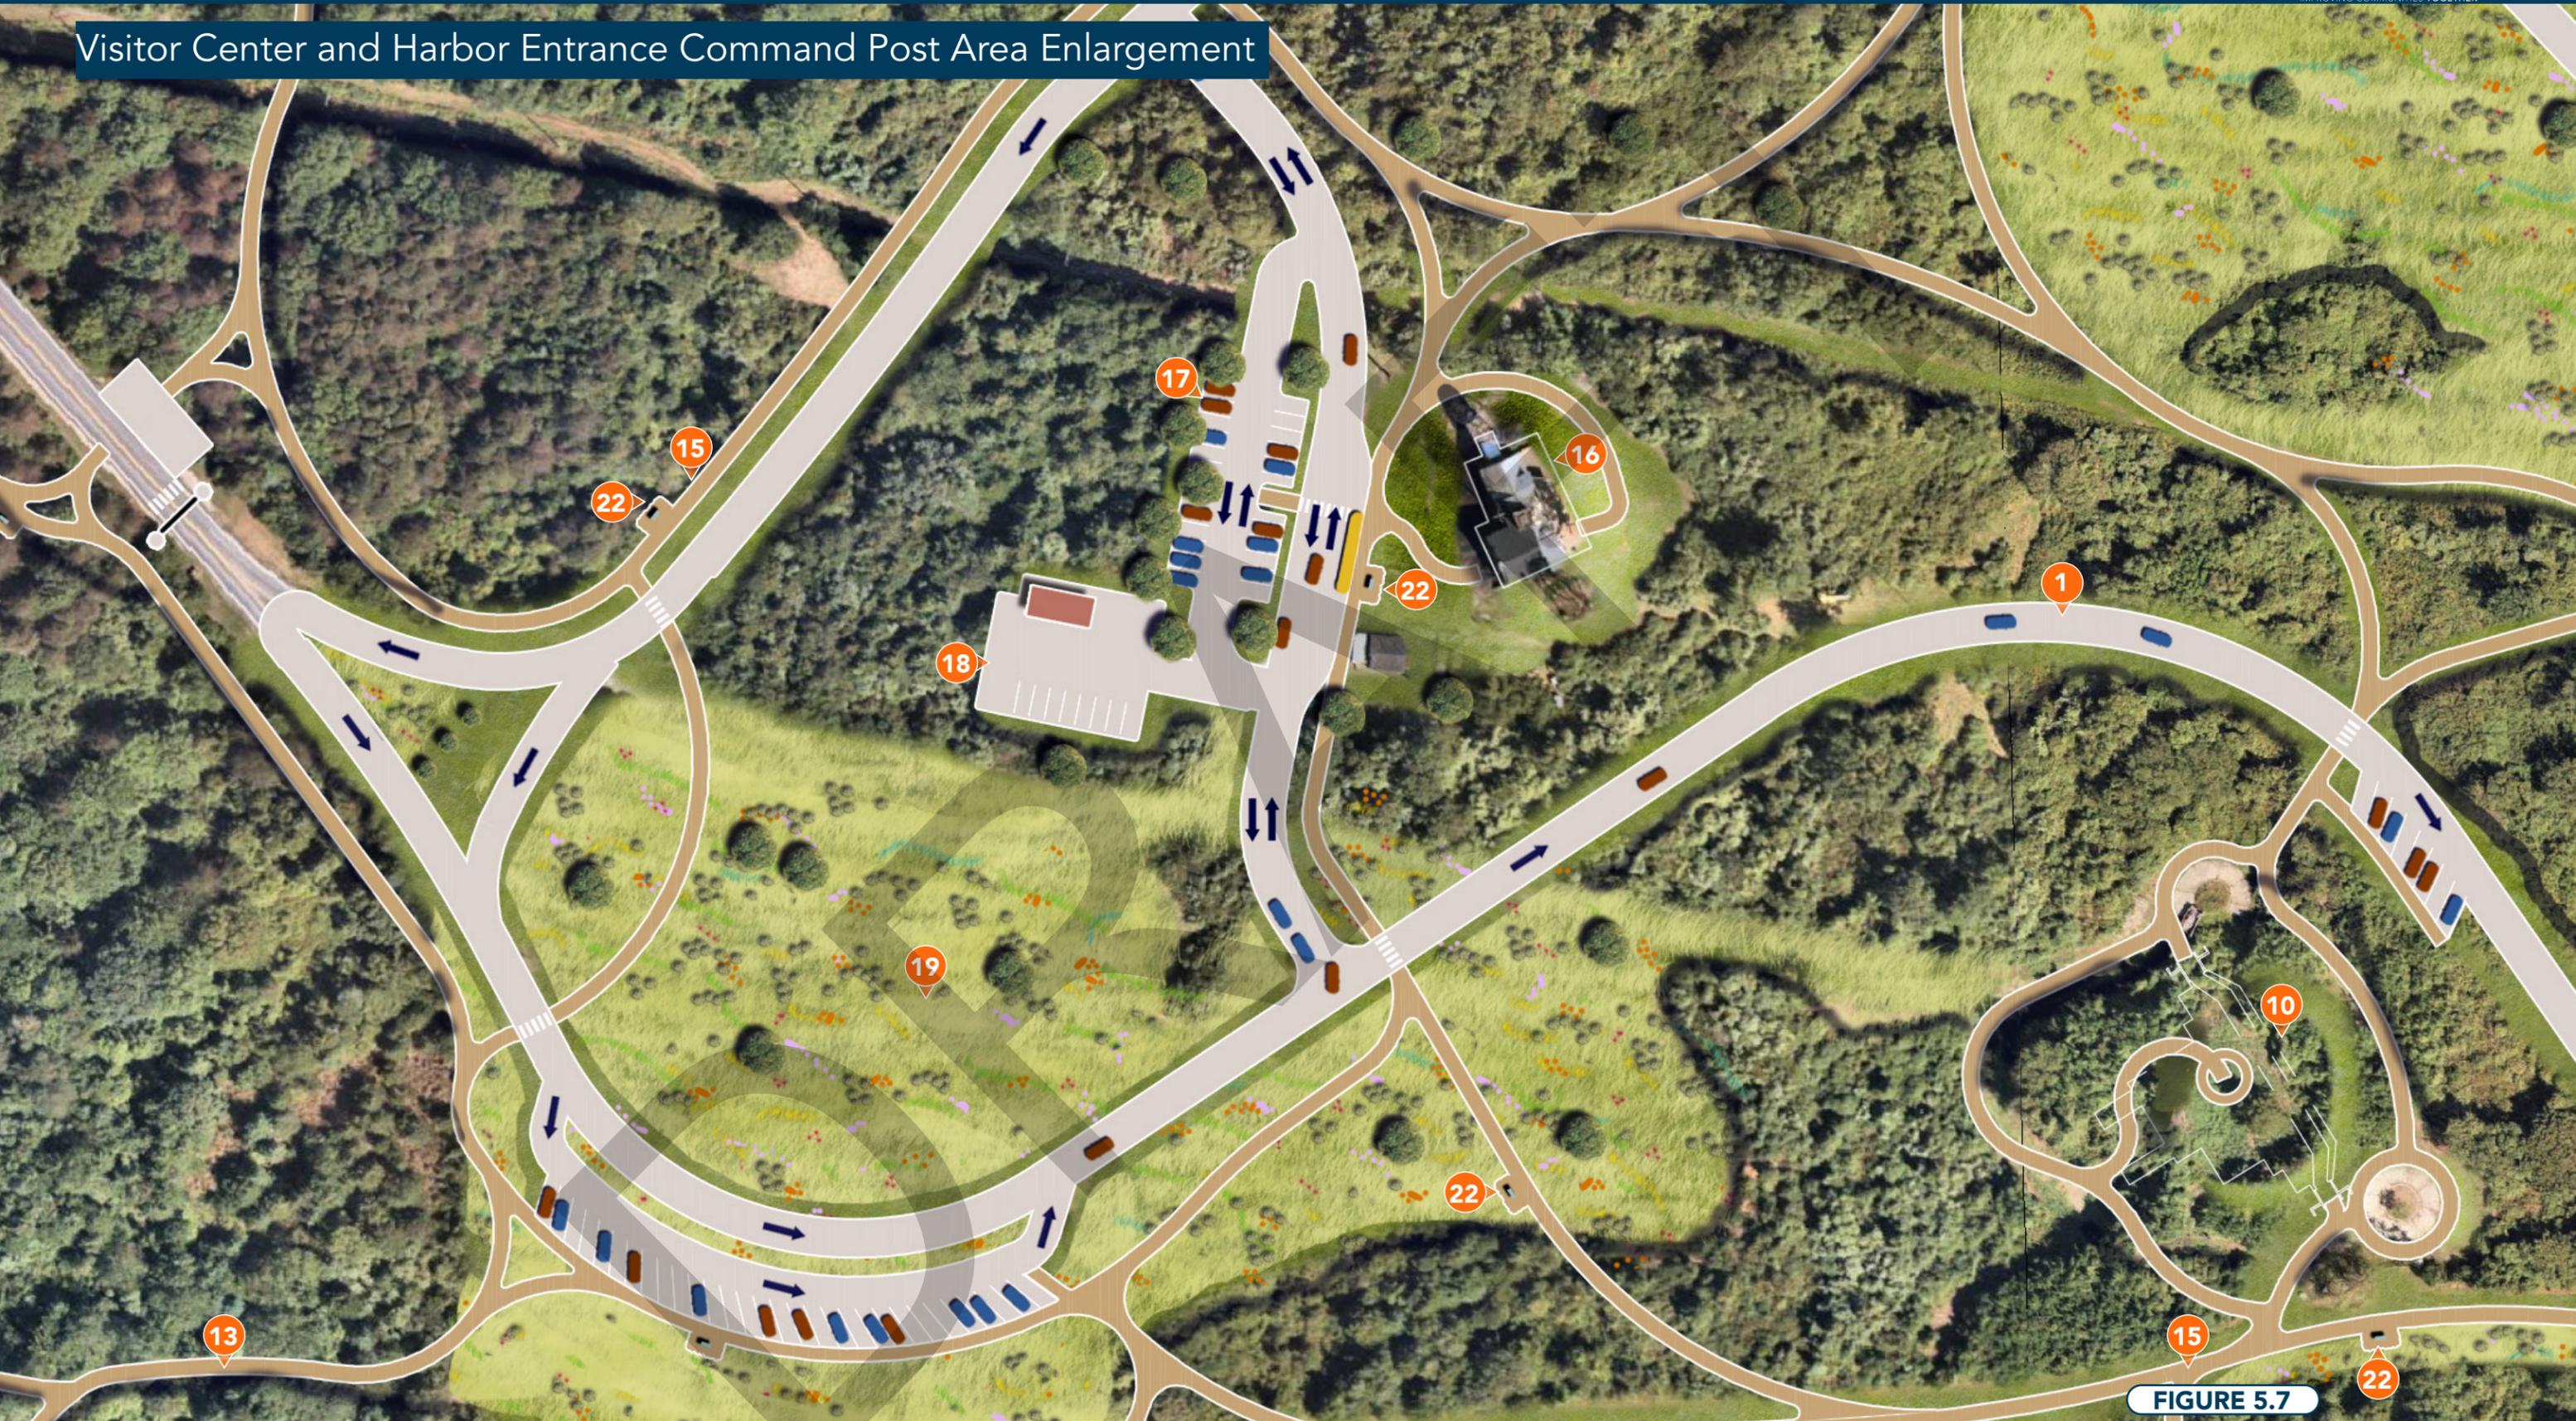
FIGURE 5.7

Visitor Center and Harbor Entrance Command Post Area Enlargement
