FINAL DRAFT

# BEAVERTAIL STATE PARK MASTER PLAN 2025

The beavertail State Park Master Plan is intended to re-imagine the future of Beavertail State Park and addresses the following:

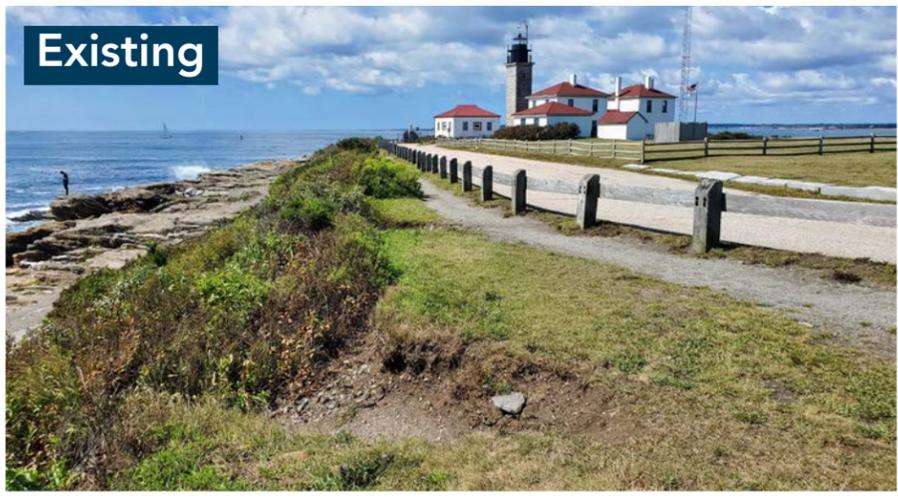
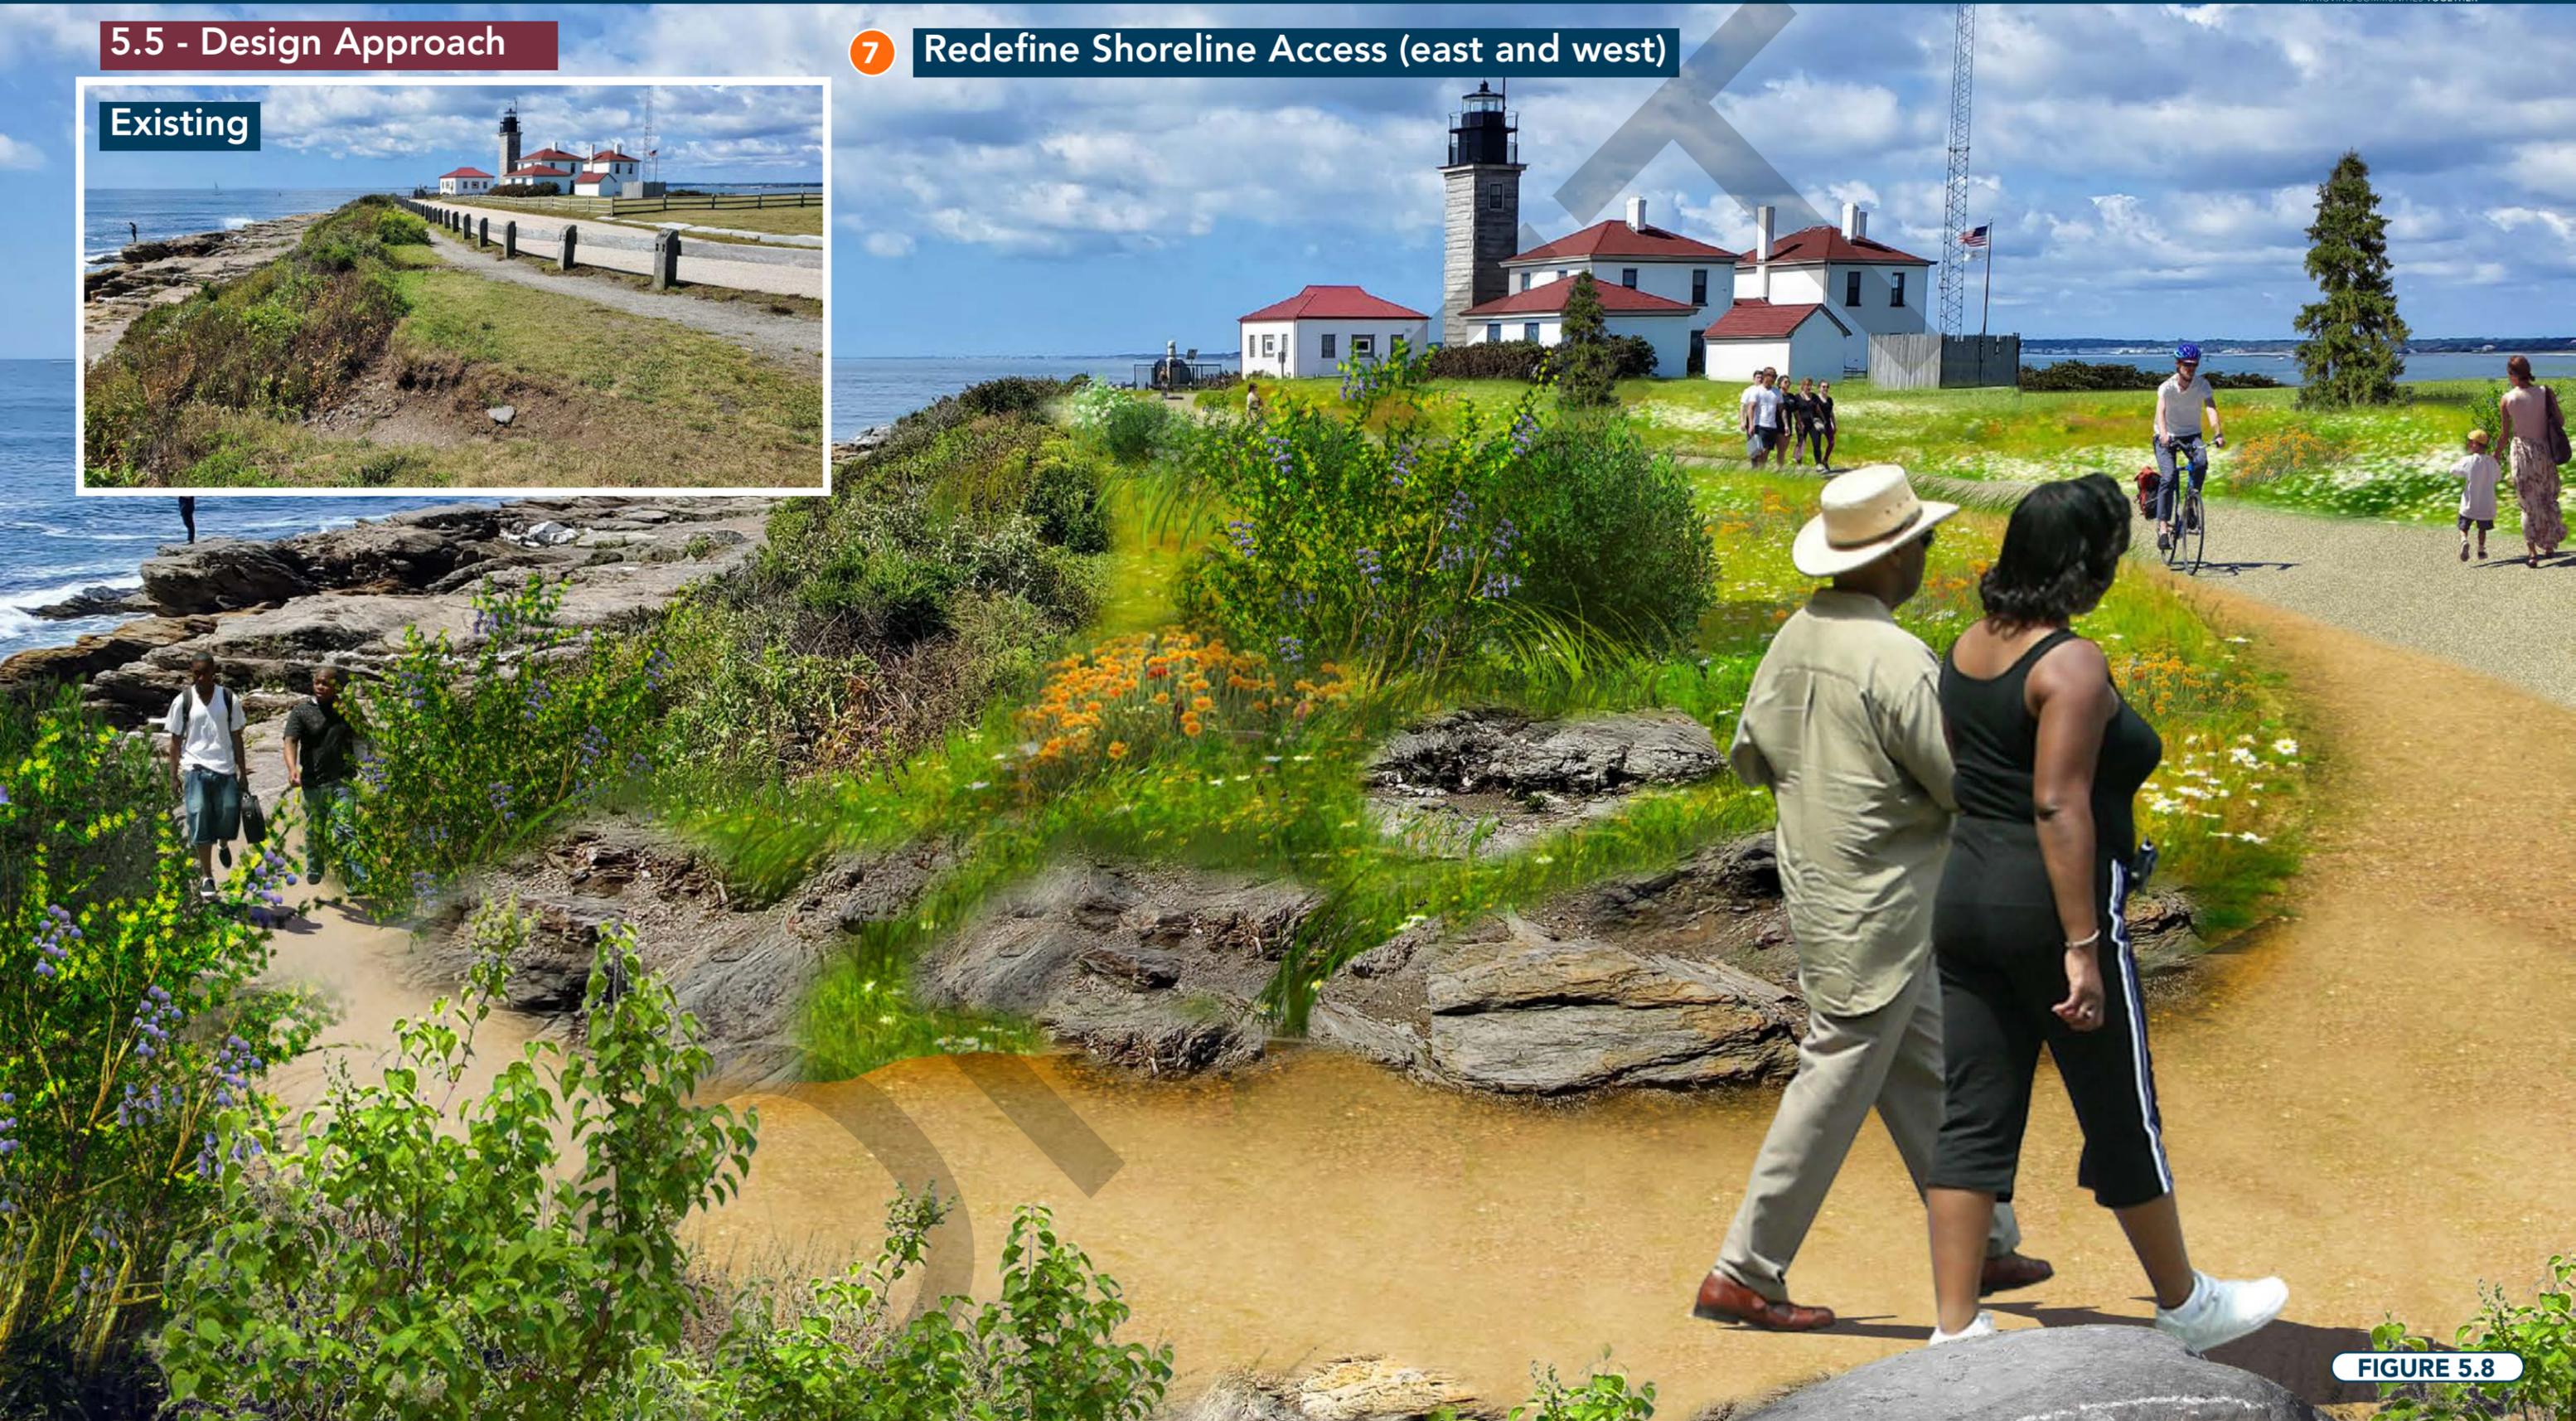
FIGURE 5.8

7 Redefine Shoreline Access (east and west)

(See figures 5.8, 5.14, and 5.17)

- Improve designated access points using a combination of approaches based on steepness of grades, vegetations, level of usage, and conditions in the intertidal zone below. Access to the intertidal zone should not be improved in locations where sensitive habitats exist, where exposed soils or friable ledge conditions predominate, or where the grades below are excessively steep. Access should transition to a stable, relatively uniform, and natural surface.

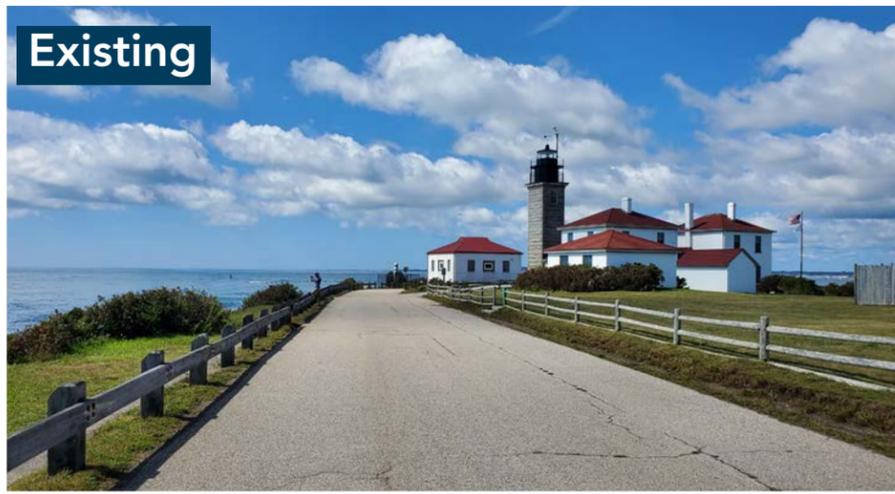
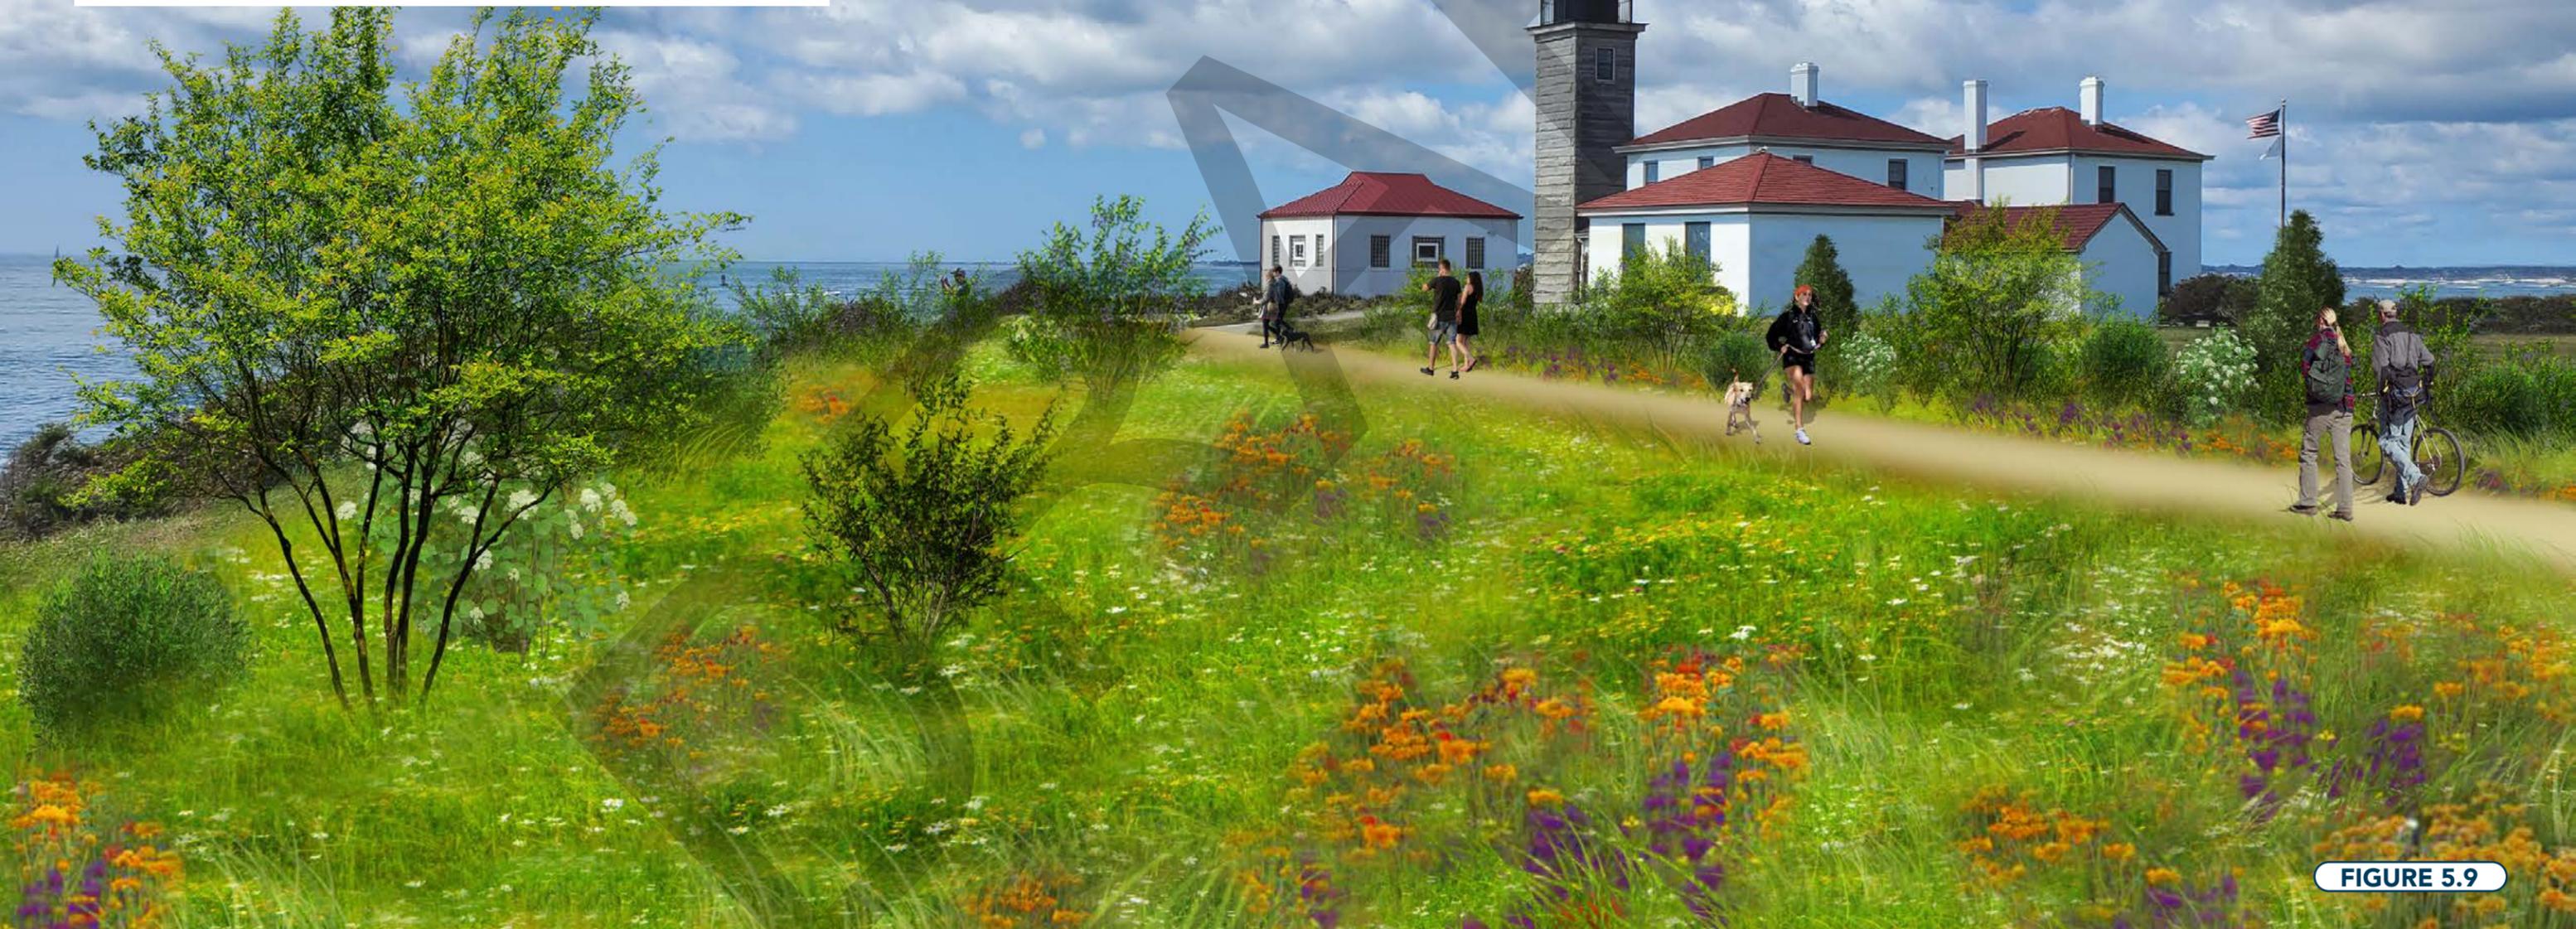
FIGURE 5.9

8 Stabilize Coastal Bank (east and west)

(See figures 5.9, 5.15, 5.16)

- Eliminate worn footpaths along the top of the coastal bluff. Revegetate these areas. Install fence in limited areas to redirect pedestrians.

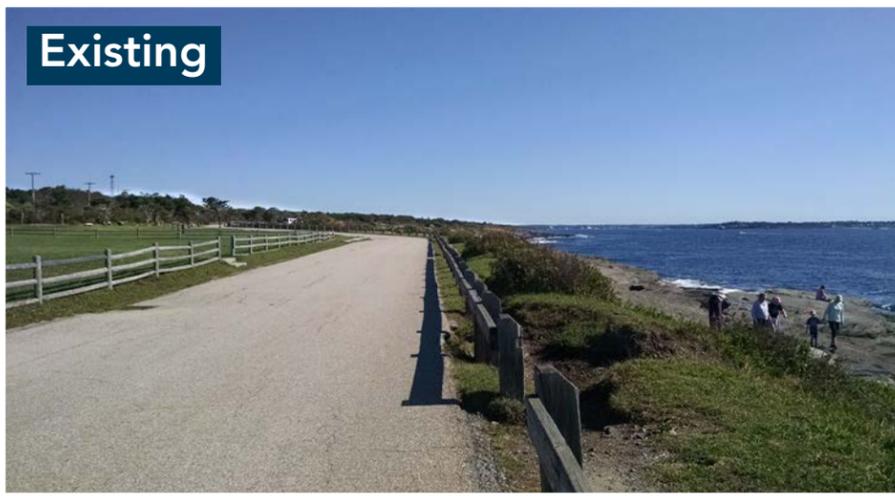
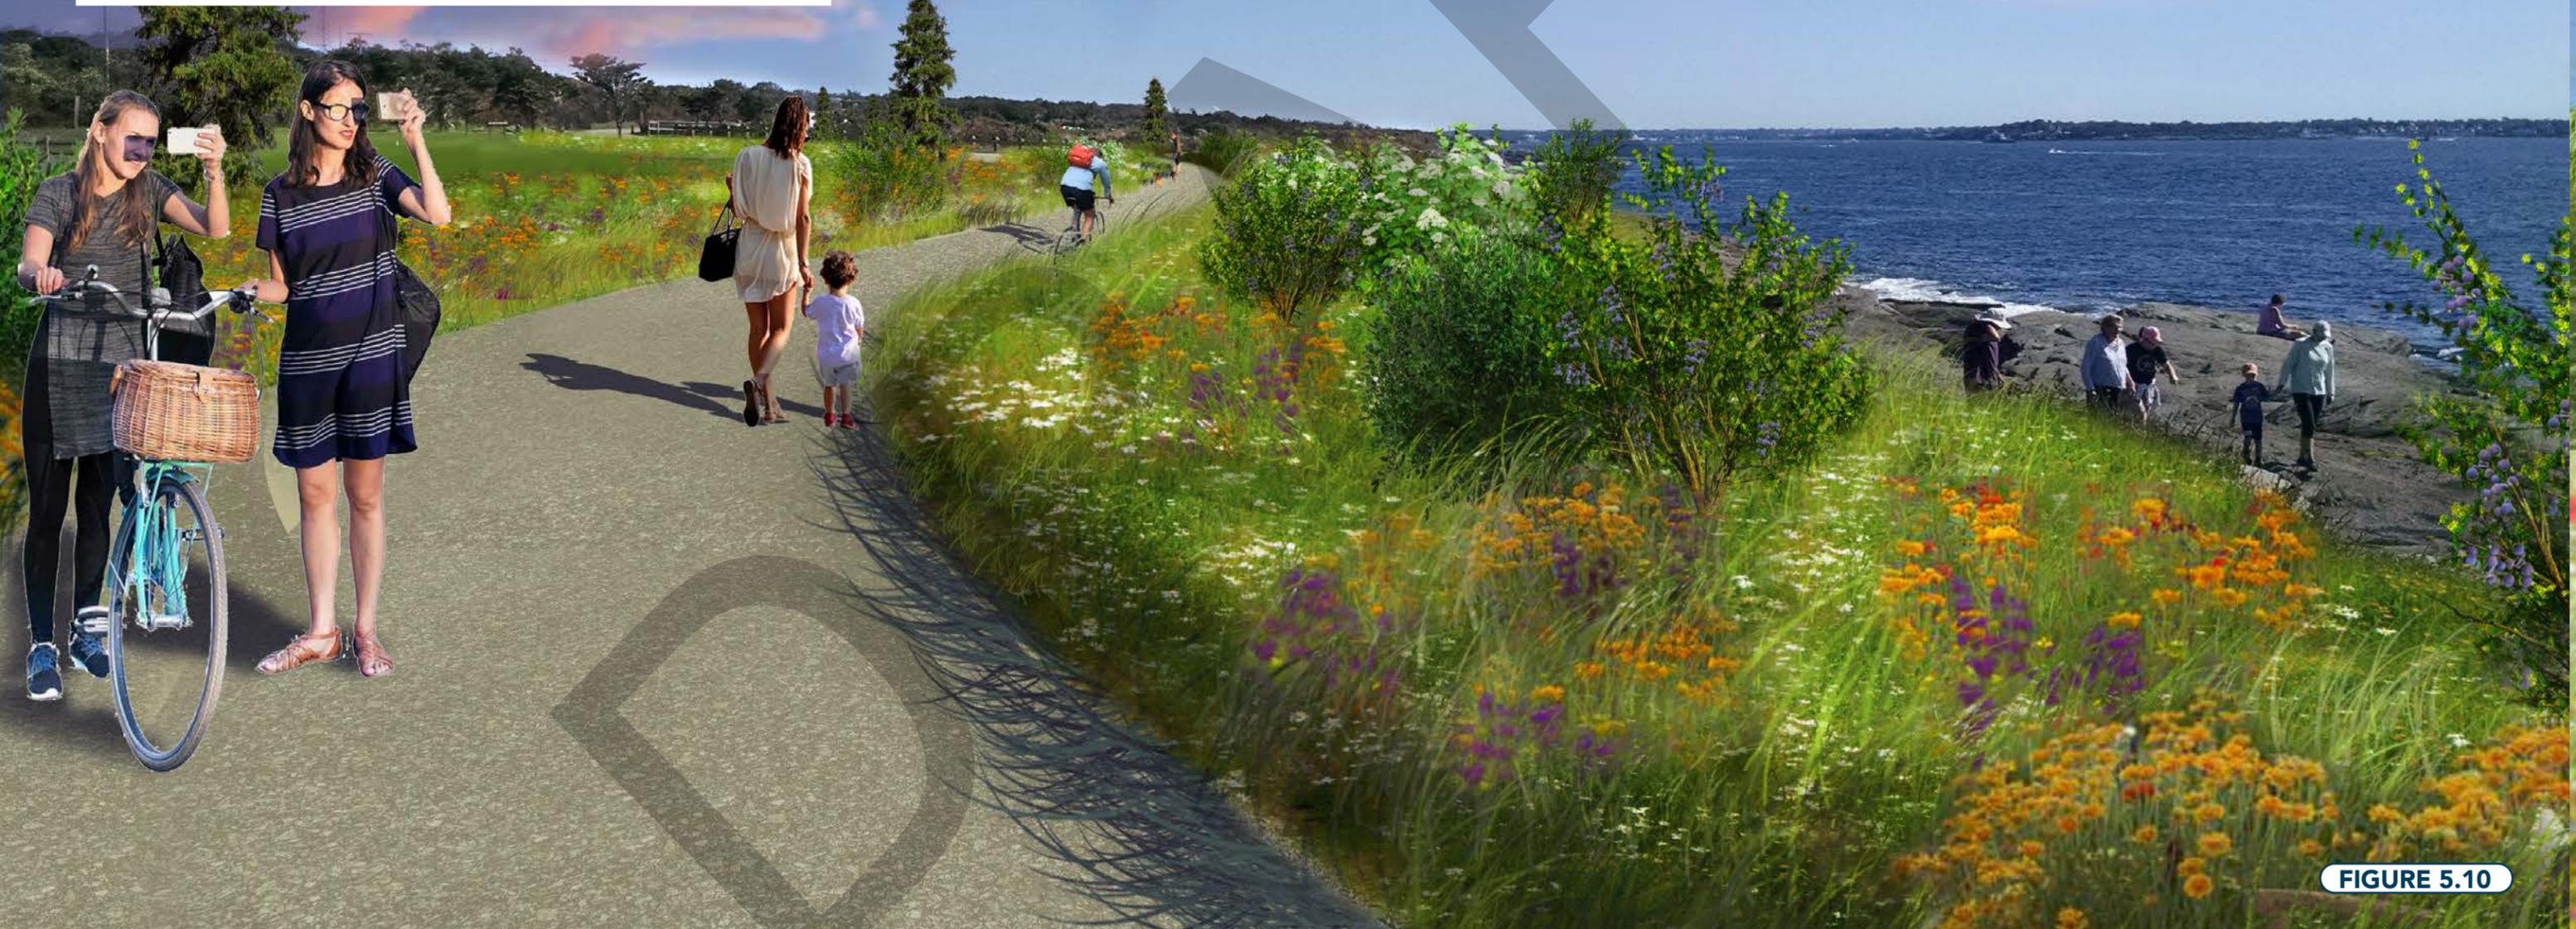
FIGURE 5.10

3 Redefine access to Beavertail Lighthouse

(See figure 5.10)

- Permanently eliminate vehicular access around the lighthouse. Remove wood guardrail. Install split rail wood fencing in targeted areas. Construct 10-foot-wide lighthouse loop path to replace former driveway loop.
- Construct a central ADA-compliant walkway directly to the lighthouse. Align with recent improvements at eastern side of the structure.
- Extend this linear pathway beyond the lighthouse to a new pedestrian ocean overlook platform constructed on the base of the original lighthouse. Access via a gangway. Create interpretive site for the public within the existing footprint of the original lighthouse.
- Construct a gated driveway to Light Station for deliveries and lighthouse keepers. Remove large sections of split rail around mown grass areas. Visually buffer driveway from view with pollinator meadows and low growing shrub plantings.

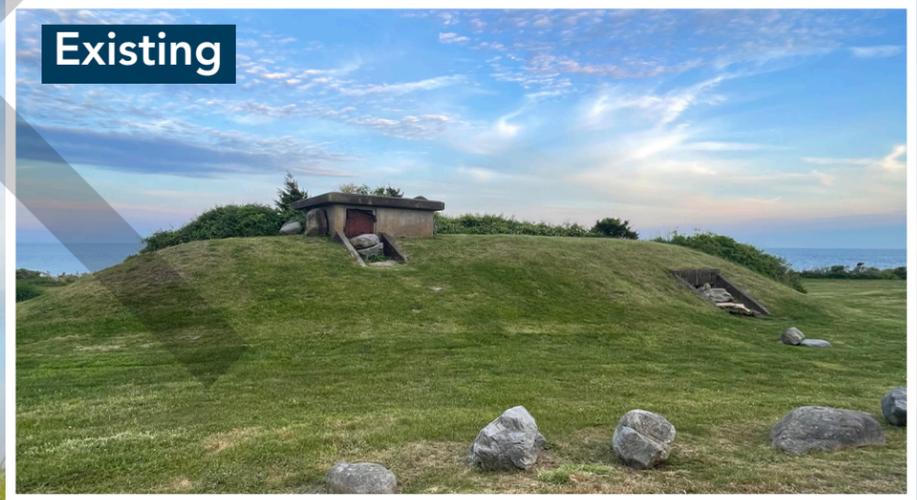
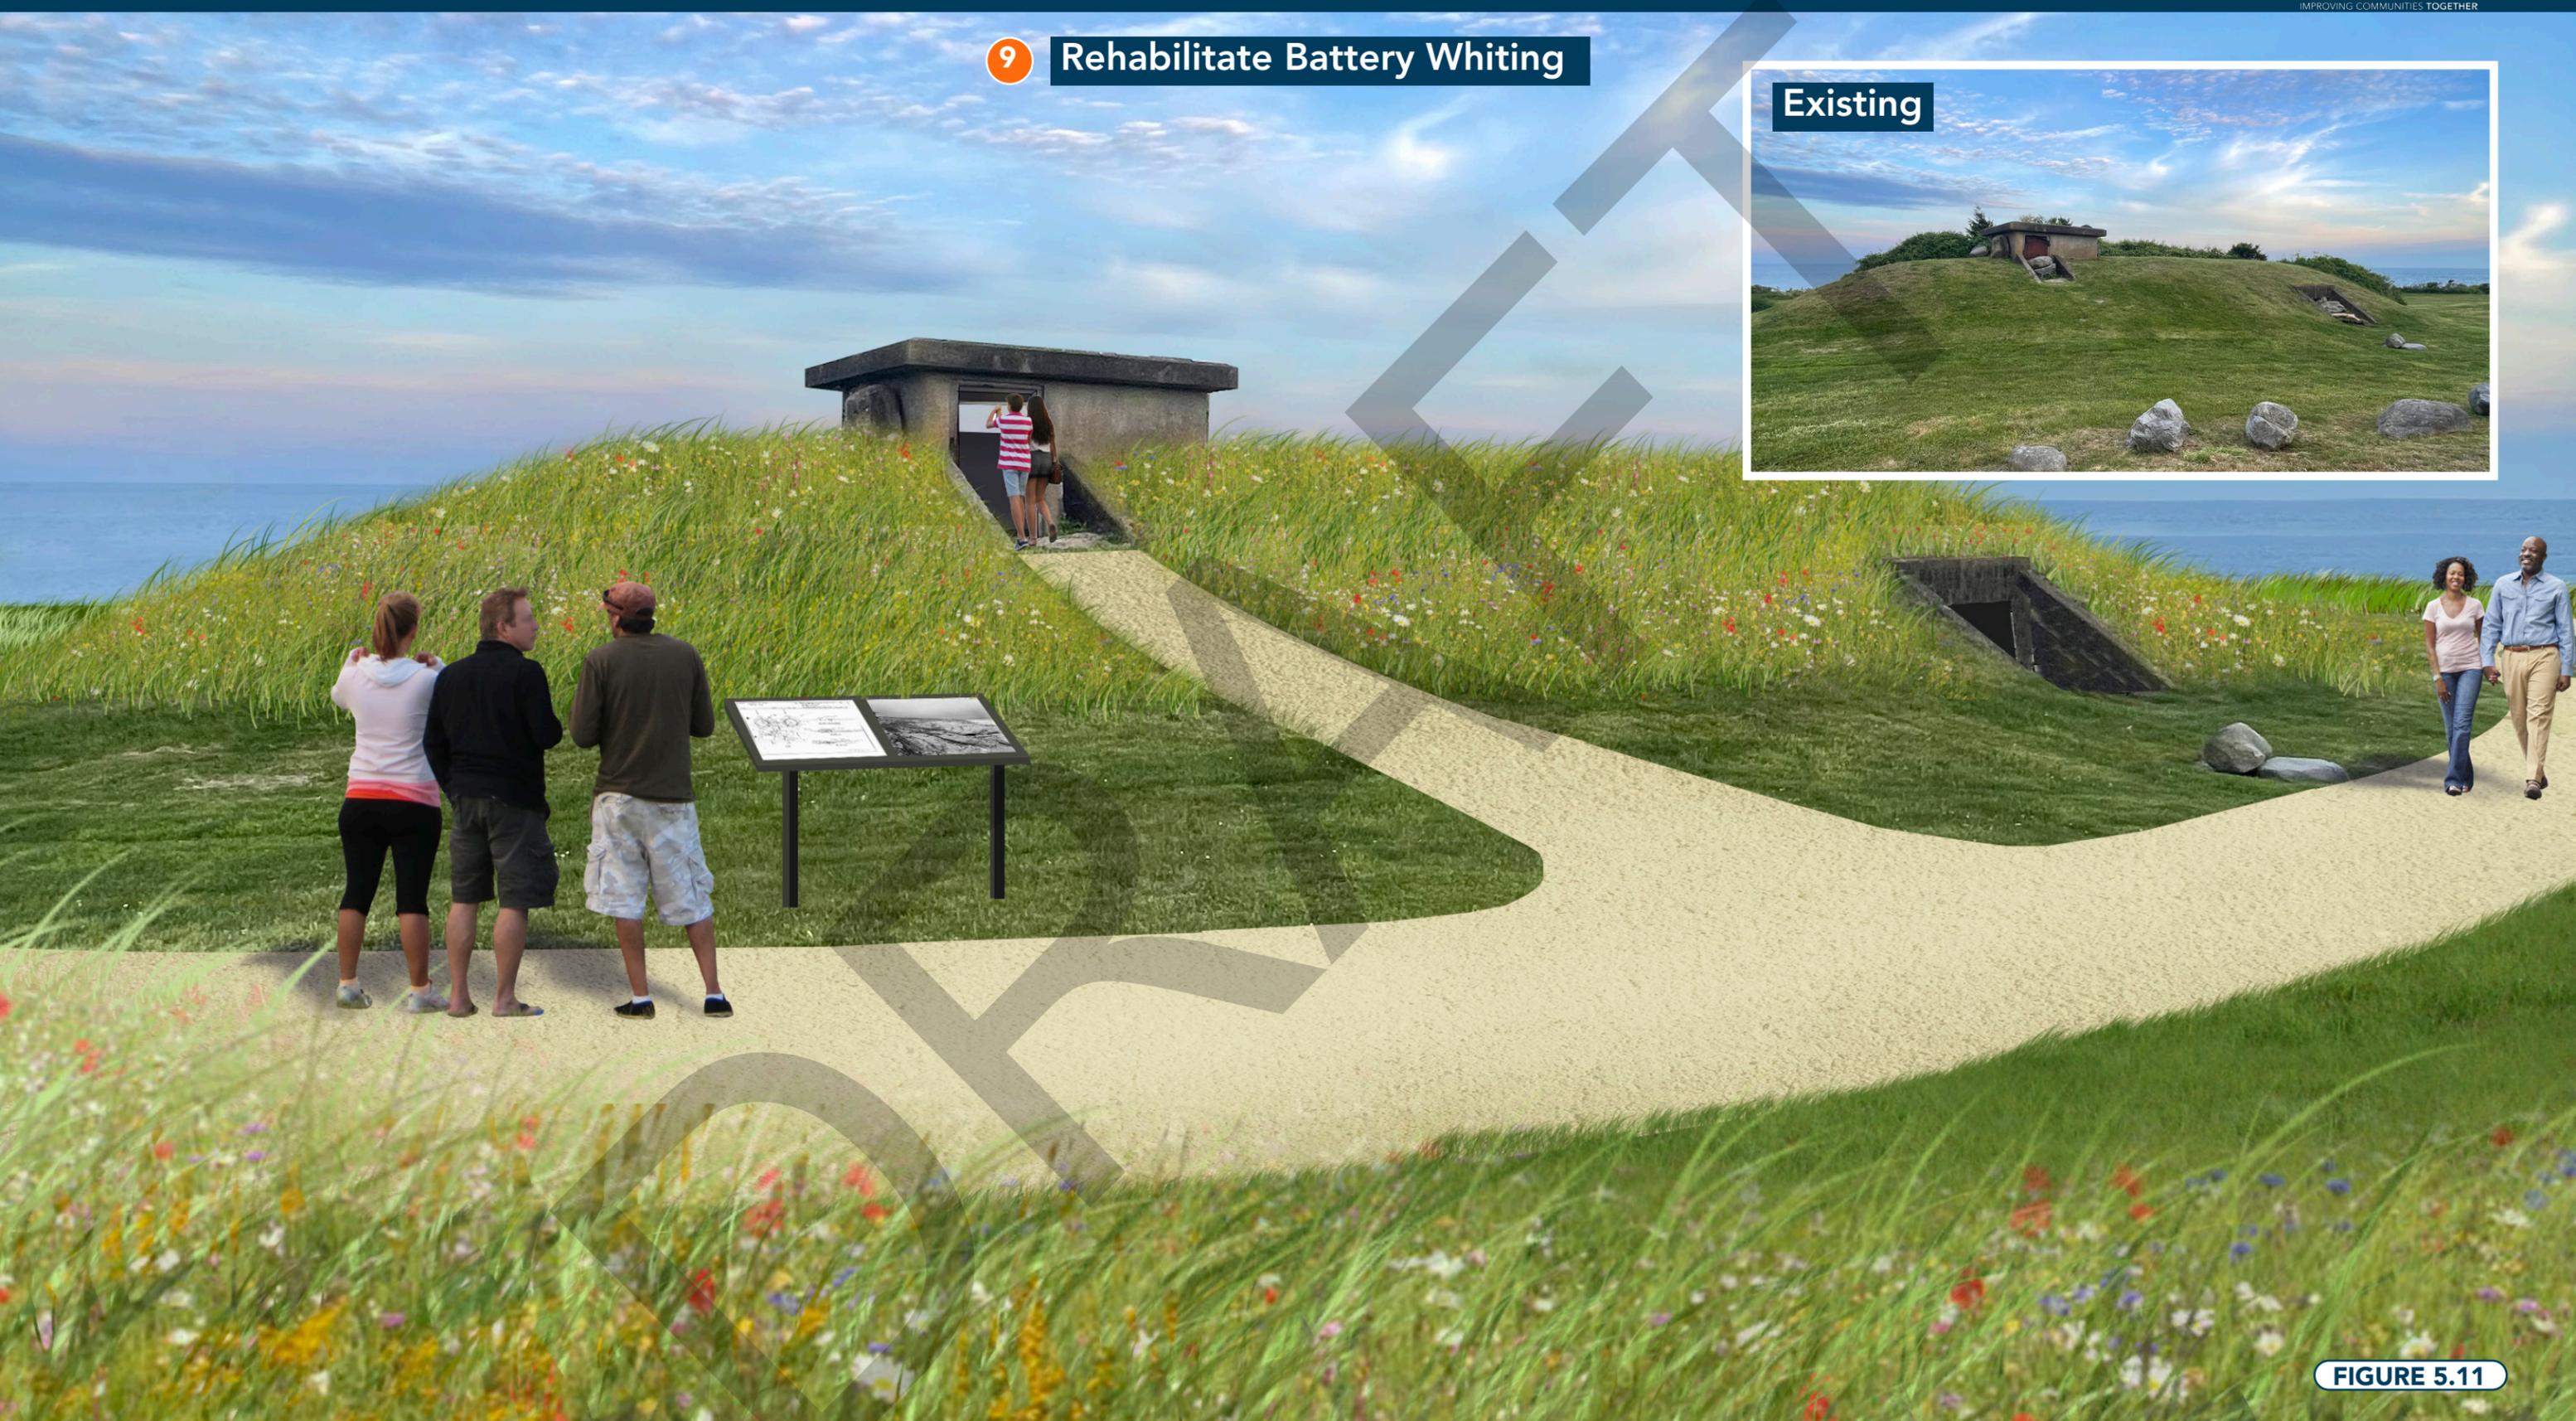
FIGURE 5.11

9 Rehabilitate Battery Whiting

(See figure 5.11)

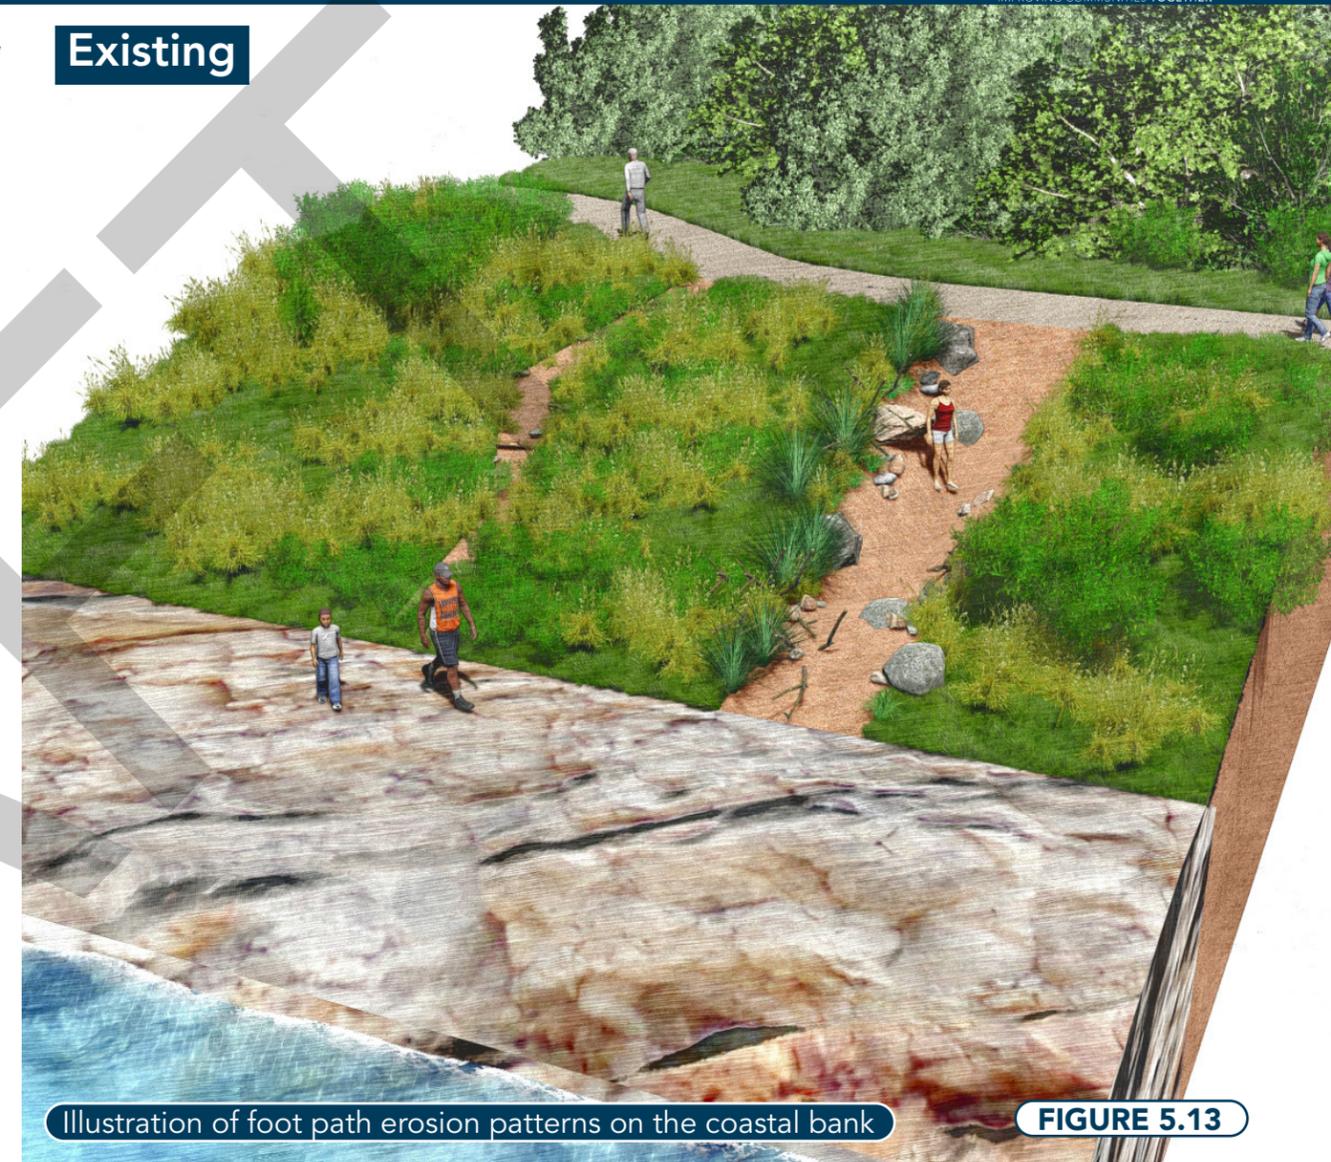
Illustration of foot path erosion patterns on the coastal bank

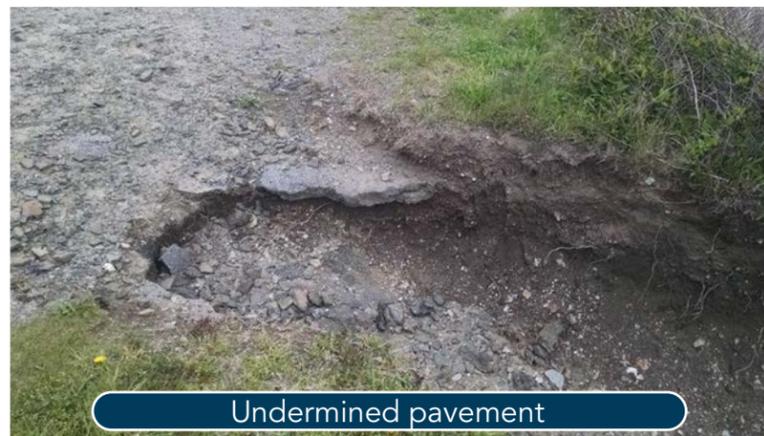
Undermined pavement

Photos and an illustration depicting the typically occurring access pathway conditions is shown in Figure 5.13. These pathways often traverse the coastal bank perpendicular to the contours, with pedestrians walking in a straight line down the slope which creates a channel for stormwater to flow down the bank, carving away vegetation and accelerating erosion. Often secondary paths are developed nearby to provide similar vantage points proximate to the primary path.

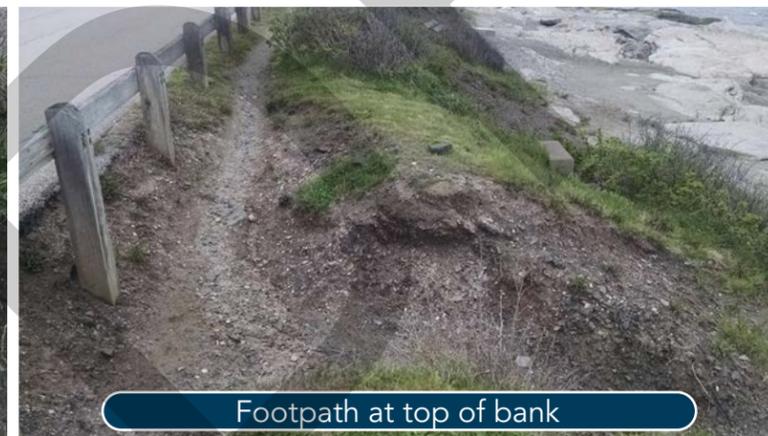
Footpath at top of bank

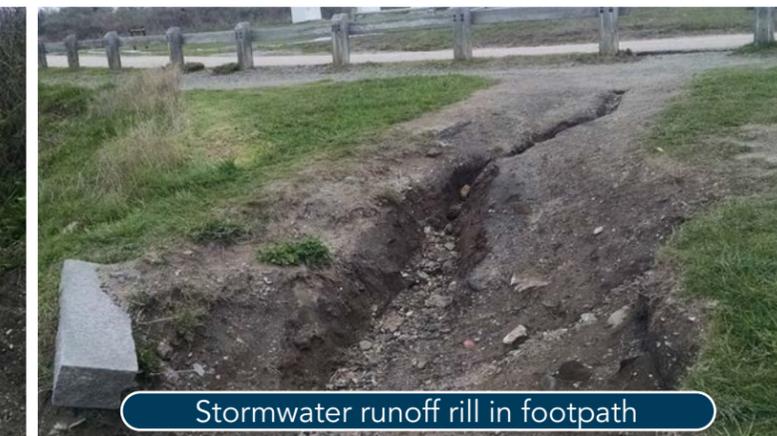
Stormwater runoff rill in footpath

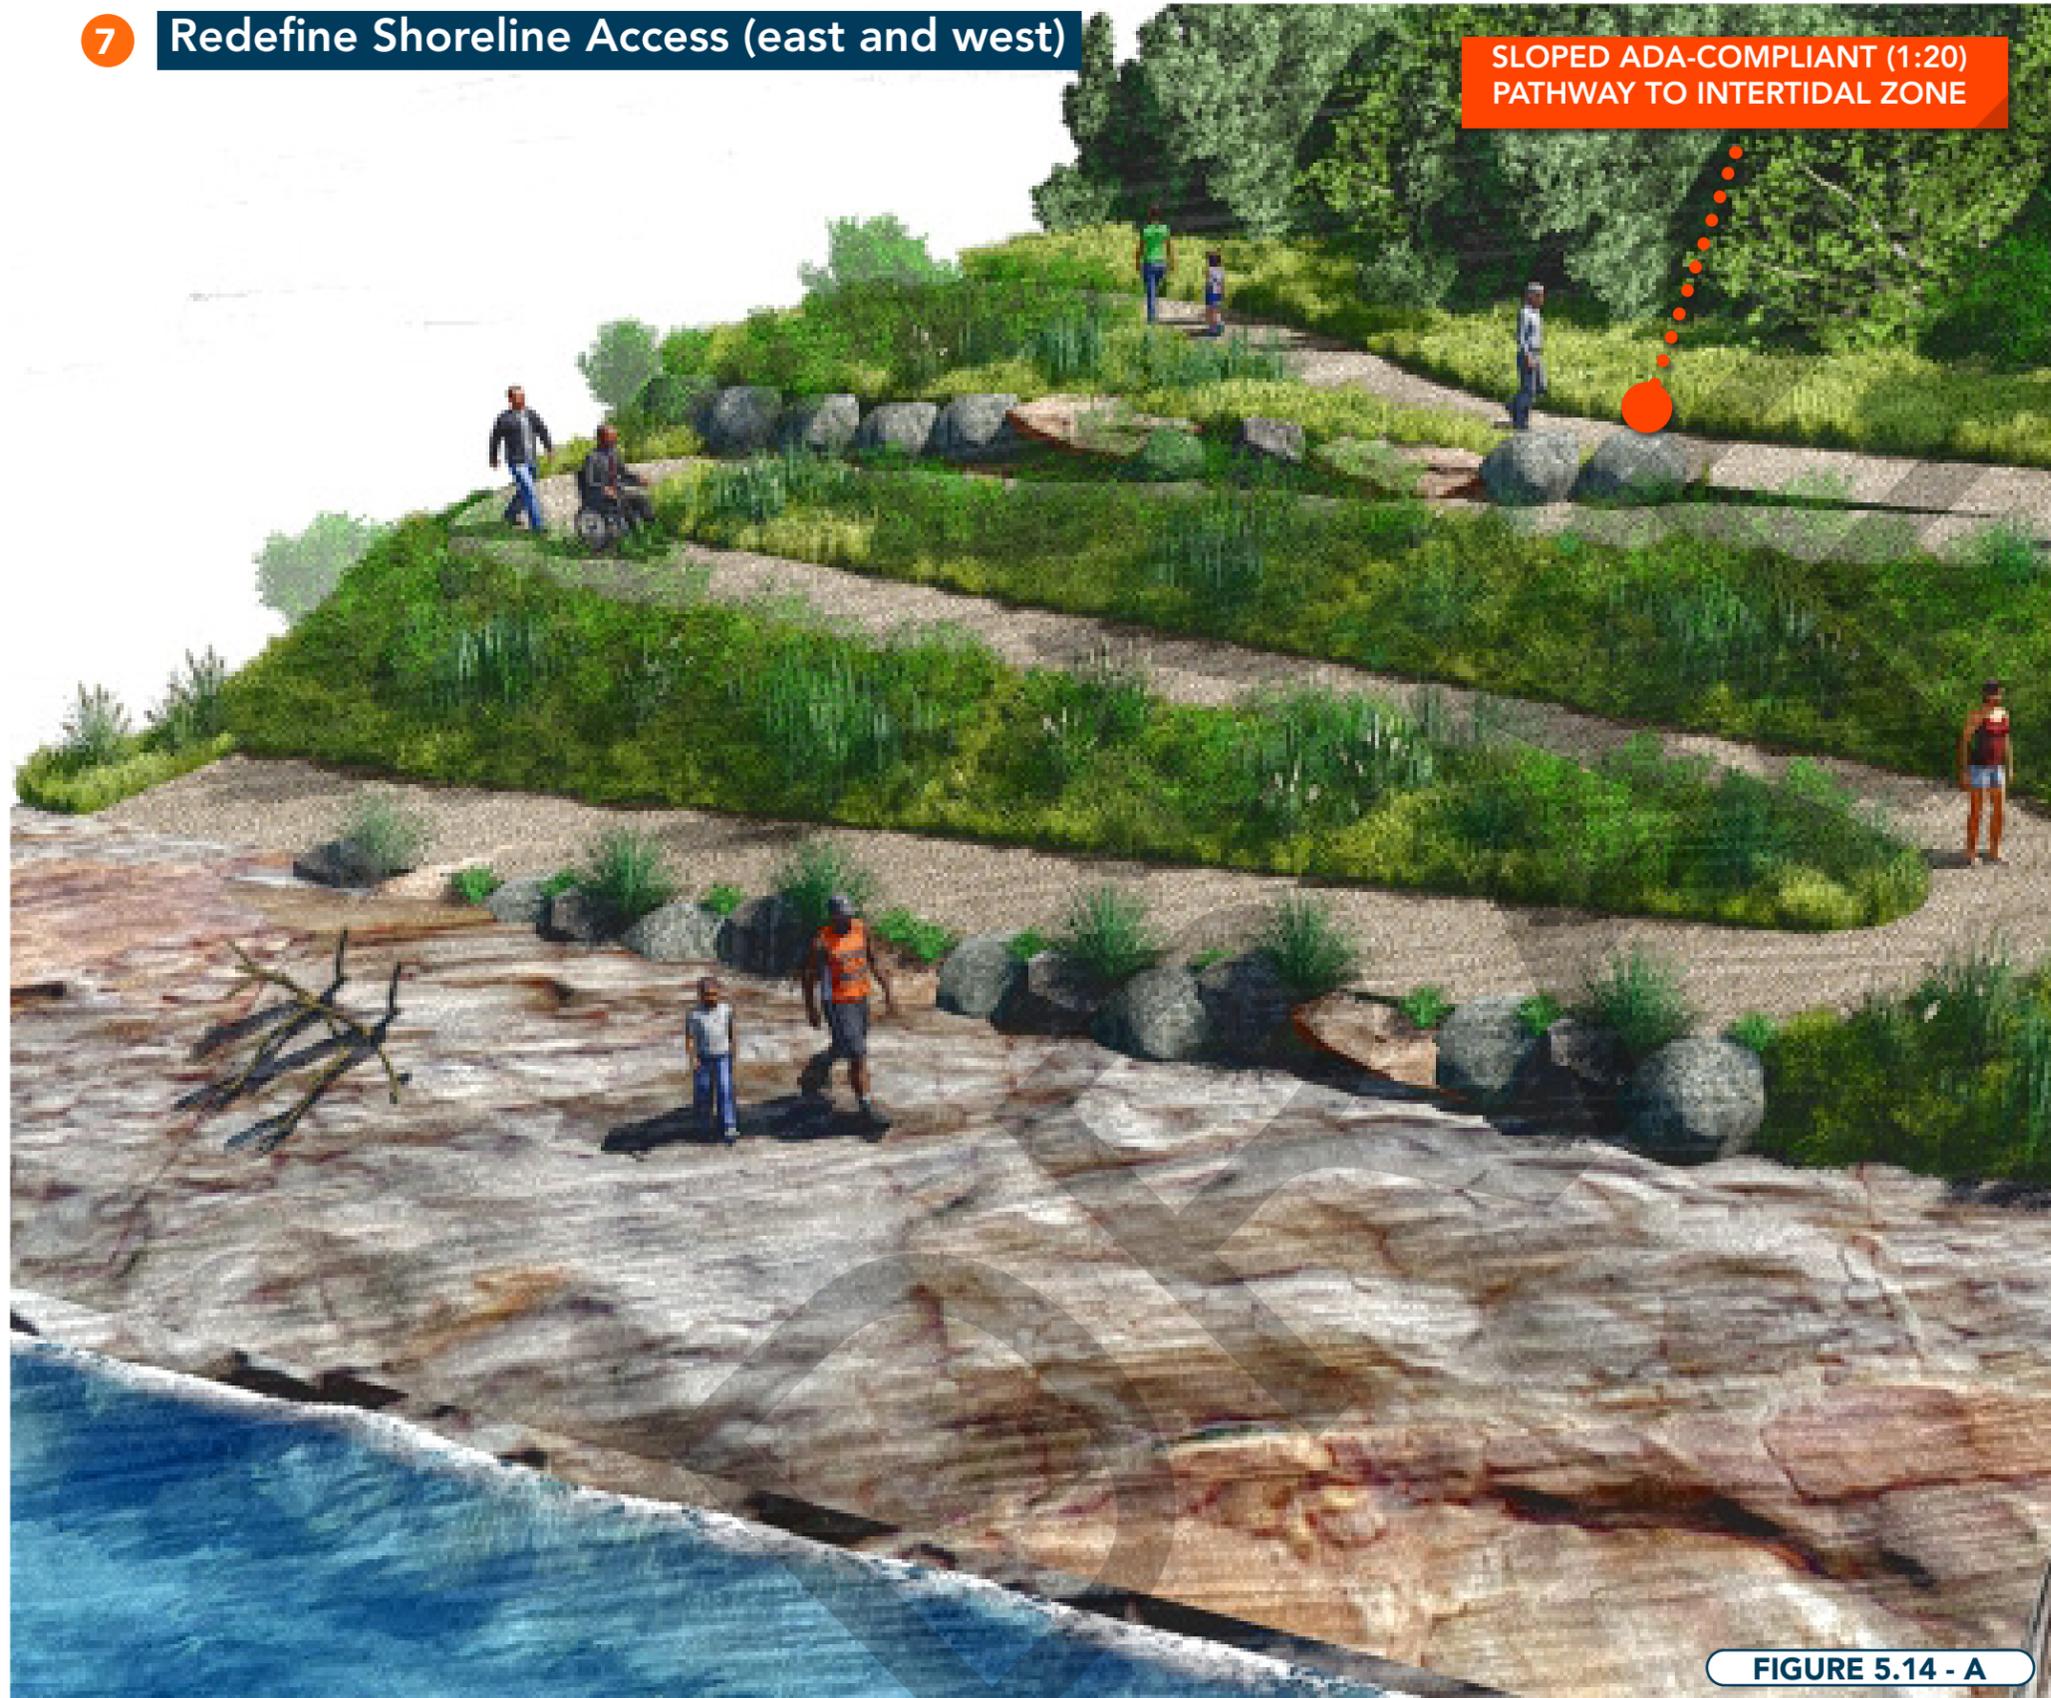
FIGURE 5.14 - A

Figure 5.14-A: In areas where access over the coastal bank is determined appropriate and feasible, it is recommended that a serpentine path system with tight switch-backs be established to traverse the bank at the least slope possible. Re-grading slopes, installing boulders or ledge outcroppings to hold the grades and extensive revegetation is required with this approach. Paths should be stabilized aggregate or similar and not less than four feet wide.

SLOPED ADA-COMPLIANT (1:20) PATHWAY TO INTERTIDAL ZONE

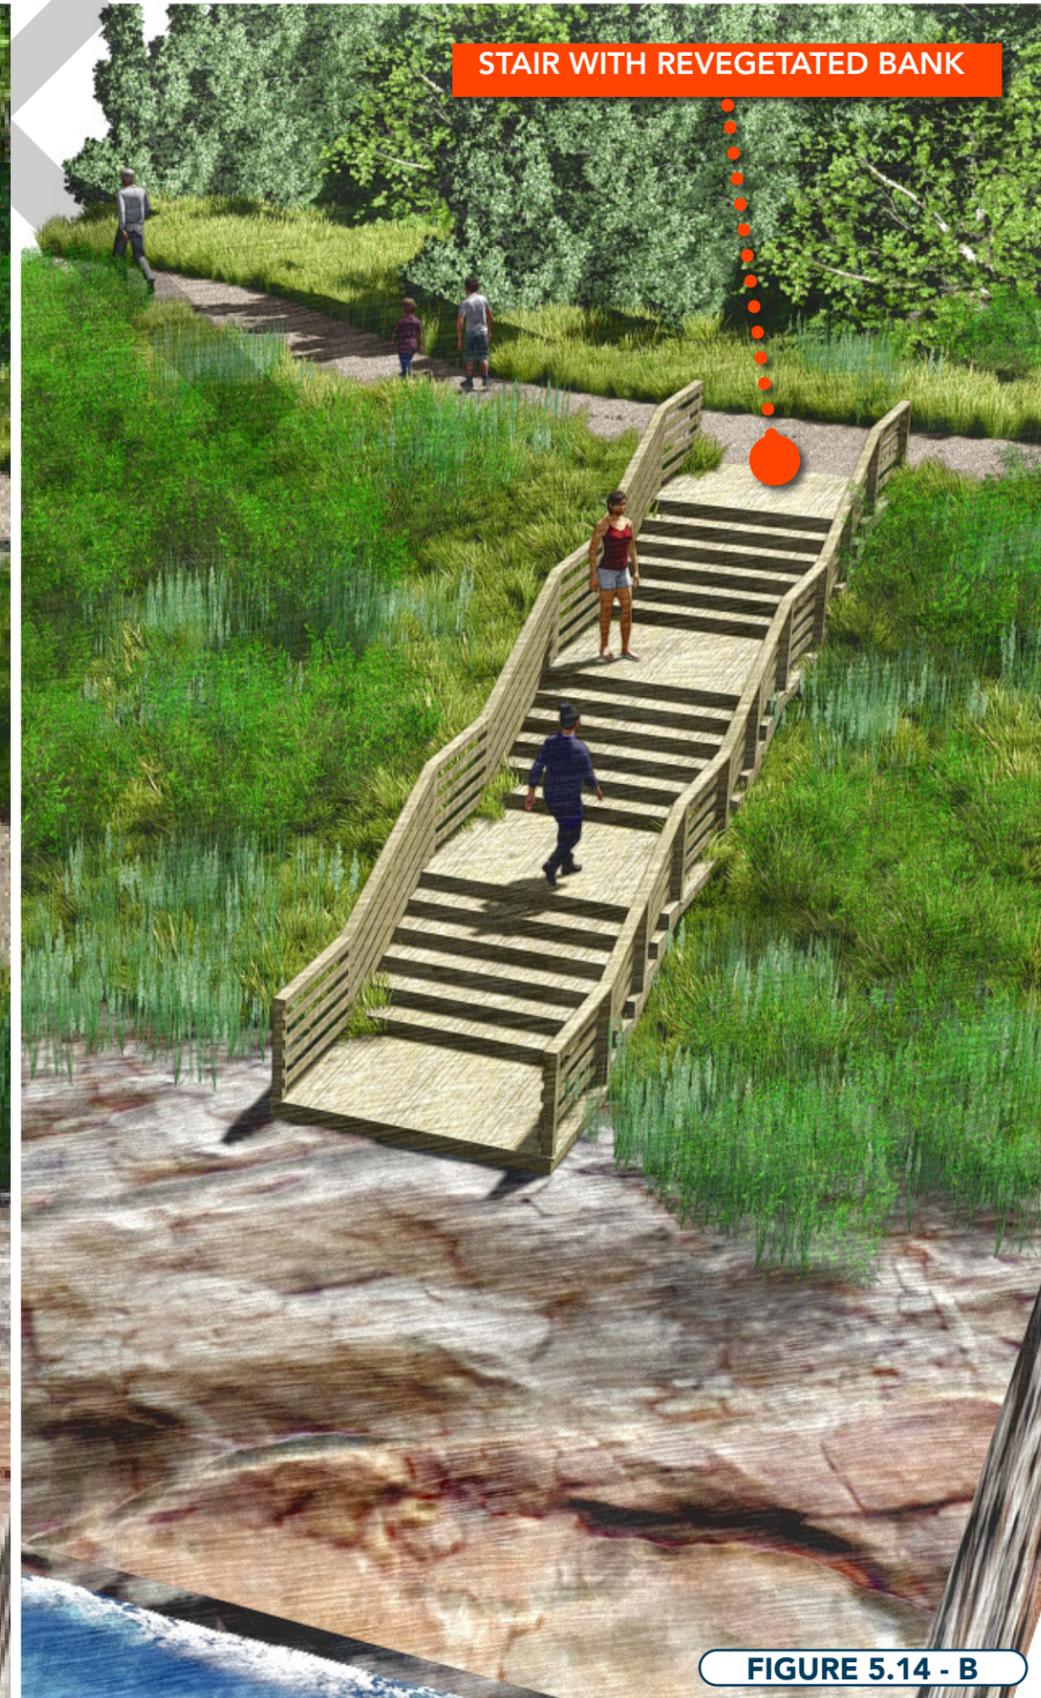
FIGURE 5.14 - B

Figure 5.14.B In locations with excessively steep slopes, stairs may be an option. Short stair runs terminating on solid ledge and configured with frequent wide landings and with benches are recommended.

STAIR WITH REVEGETATED BANK
