FINAL DRAFT

# BEAVERTAIL STATE PARK MASTER PLAN 2025

The beavertail State Park Master Plan is intended to re-imagine the future of Beavertail State Park and addresses the following:

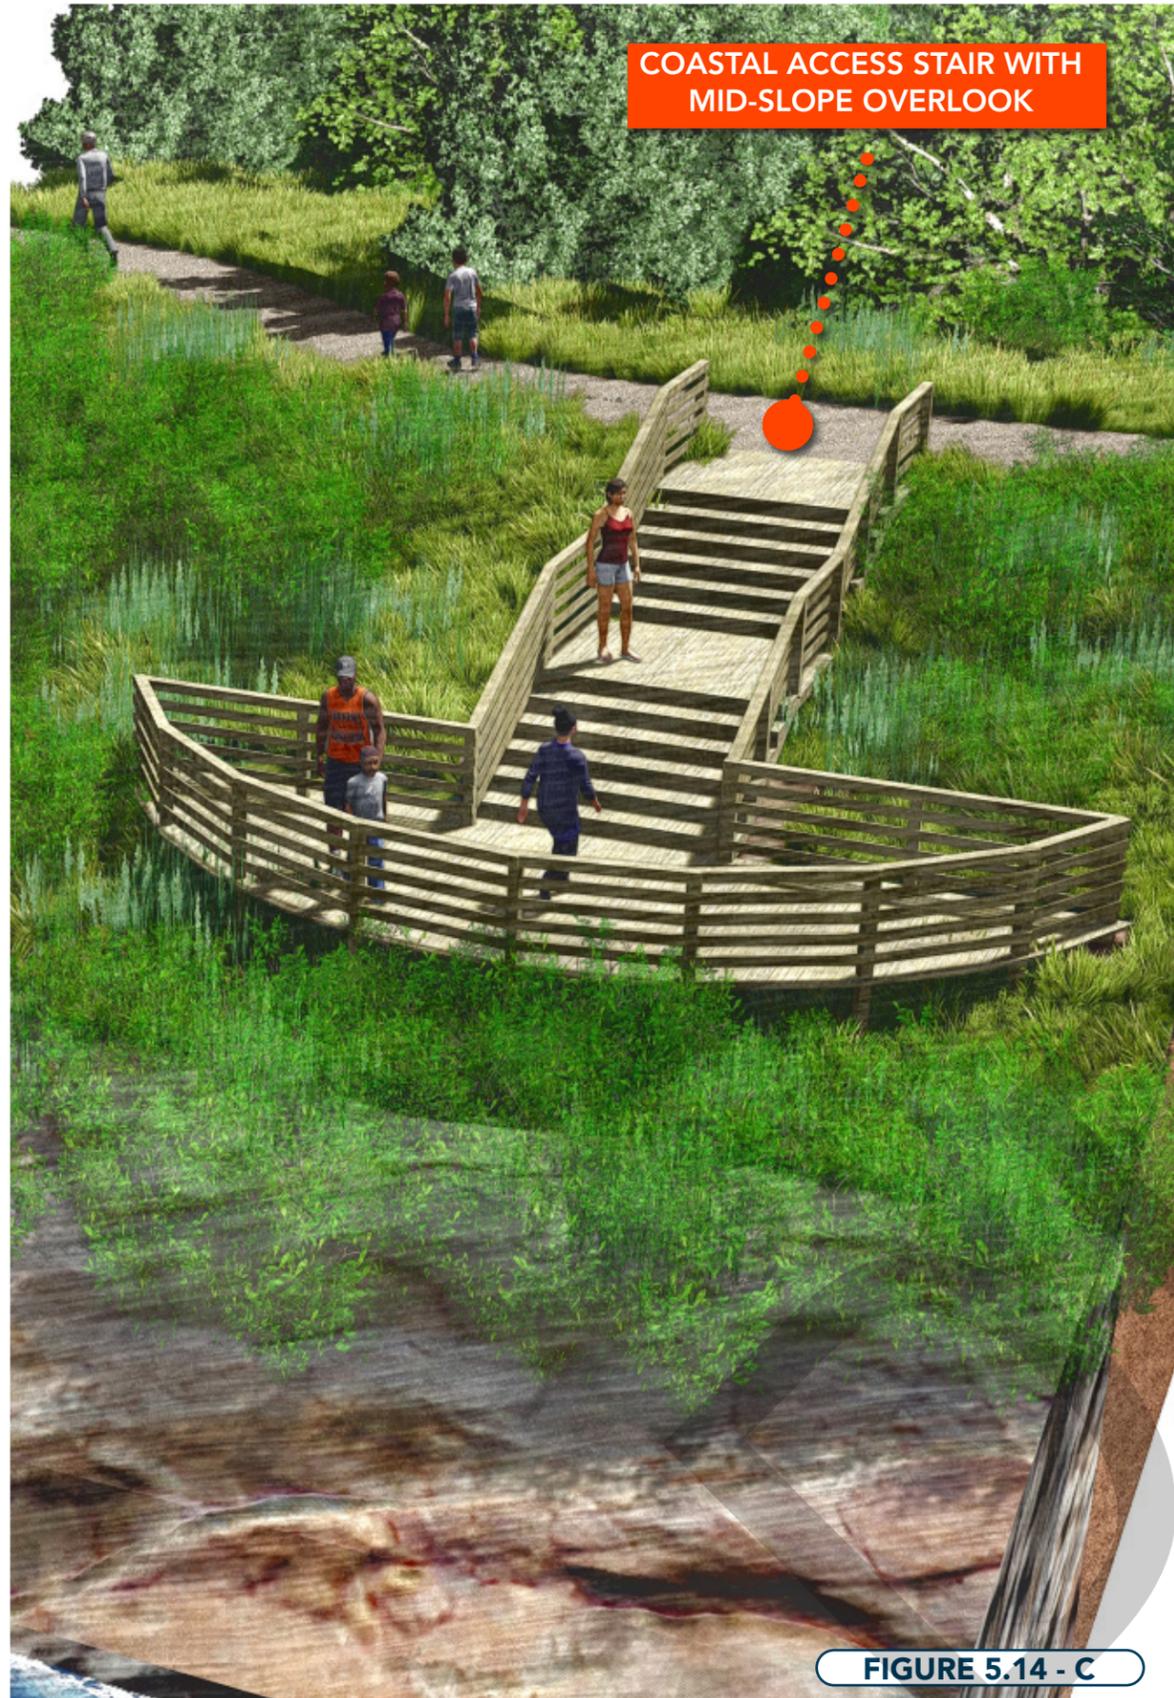
FIGURE 5.14 - C

Figure 5.14.C In locations where it is determined that physical access to the intertidal zone is not desirable, stairs and overlook platforms at strategic locations may offer interesting vantage points and waterfowl viewing areas at mid-slope without creating physical access to the intertidal zone.

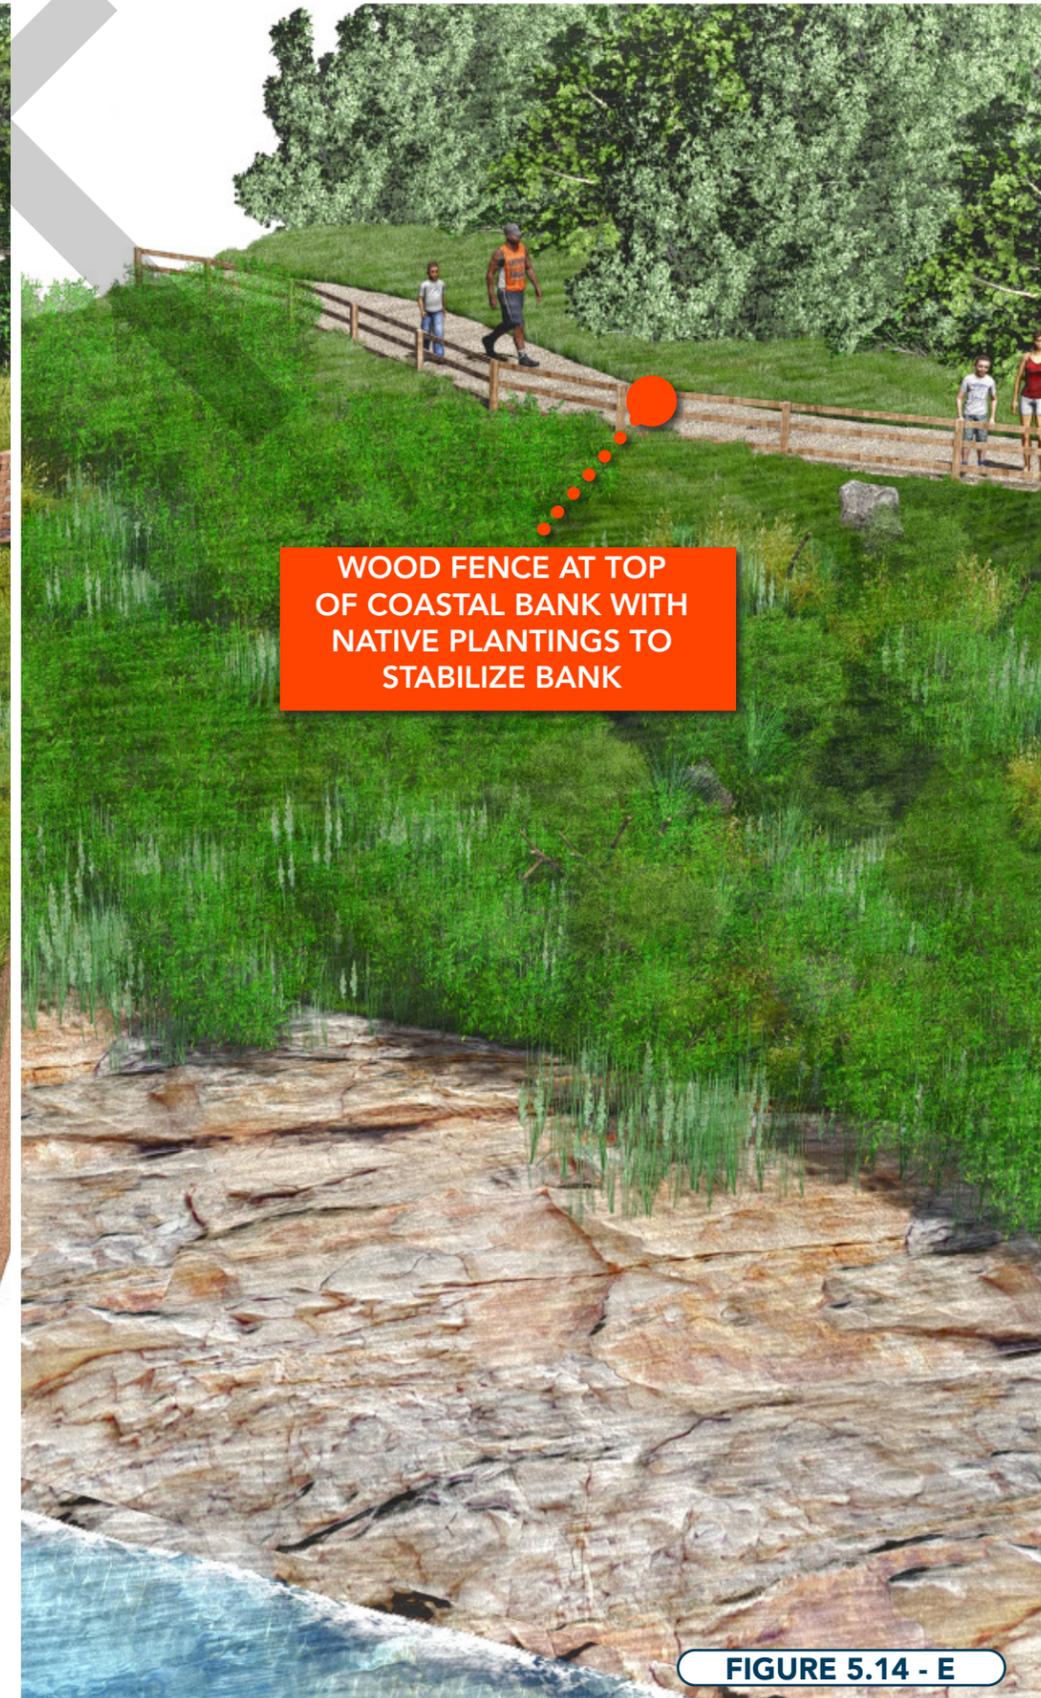
FIGURE 5.14 - E

Figure 5.14.-E Many excessively steep pathways exist, often resulting in a highly eroded and unstable coastal bank condition. Often these paths are redundant paths, or are dead ends, terminating at a steep, untraversable slope. In some locations it is recommended that pedestrian access be eliminated entirely and the slope stabilized and revegetated. Regrading and stabilizing the slope, extensive revegetation plantings and the installation of fencing at the top of the slope are key components of this approach.

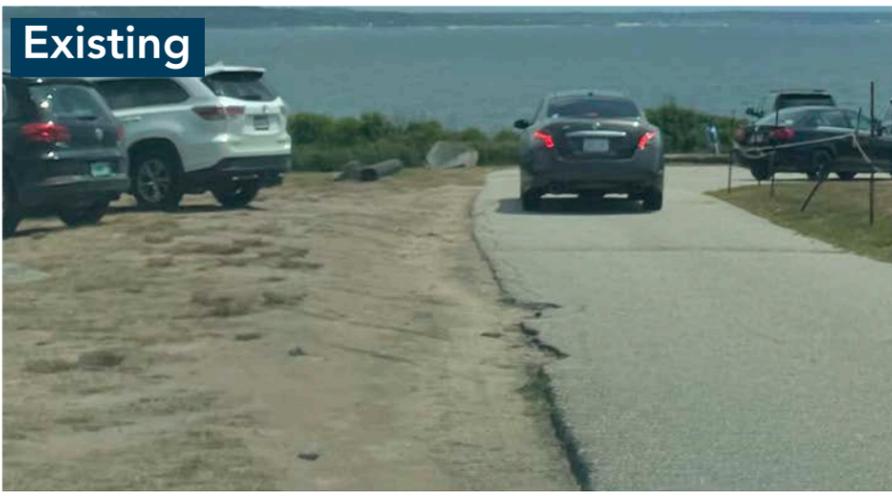
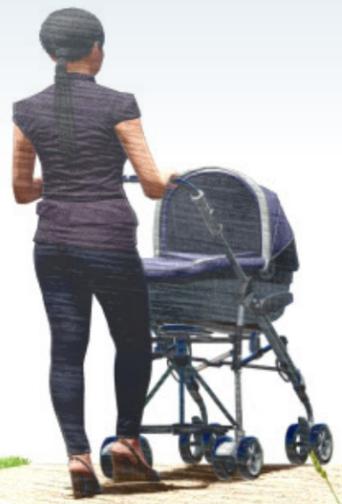
FIGURE 5.18

1 Reconfigure for Retreat, Realign Park Roadways & Parking Lots. Address Uncontrolled Storm Water Runoff.

(See figure 5.18)

- Retain the one-way park loop road circulation flow.
- ‘Retreat’ through re-alignment of portions of the Park loop road and parking areas. Pull the road and parking back into the interior of the Park. Create integral stormwater management and water quality features to slow stormwater runoff and promote infiltration. Configure the road to visually engage the HECF and Battery 213, while purposefully retaining iconic view to Narragansett Bay and Beavertail Light Station.

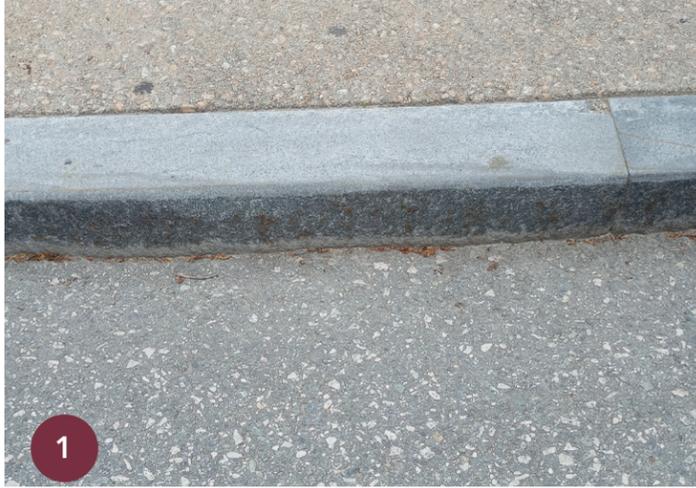
**HMA Asphalt & Granite Curb**  
Hot mix asphalt (HMA) provides a cost-effective durable surface. Installed in lifts of different gradations, HMA is a recommended treatment as the surfacing material for the primary park roadway. The existing park roadways are made of this material.

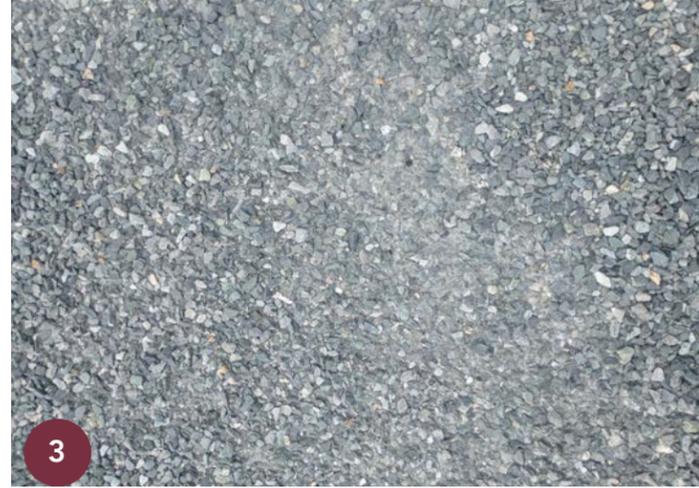
**Chip-Seal Asphalt Pavement**  
Chip-seal asphalt is a surface treatment applied over a Hot Mix Asphalt Base. This surface is comprised of an oil tack coat overlaid with small diameter crushed stone aggregate. Aggregate size and distribution is critical to provide an ADA-compliant surface. This material was installed at the Light Station in 2022.

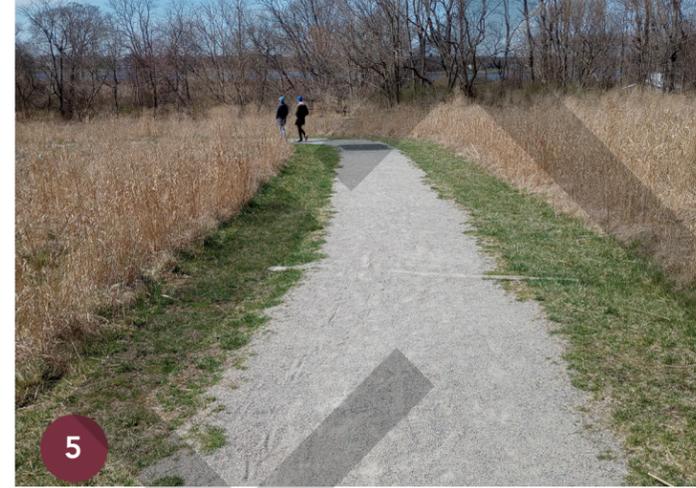
**Stabilized Aggregate Pathways**  
Stabilized aggregate pathways are created utilizing a blend of 5/16" minus aggregate stone mixed with a binding agent and overlaid on a crushed stone base. The system porous under favorable sub surface conditions. The surface is ADA accessible.

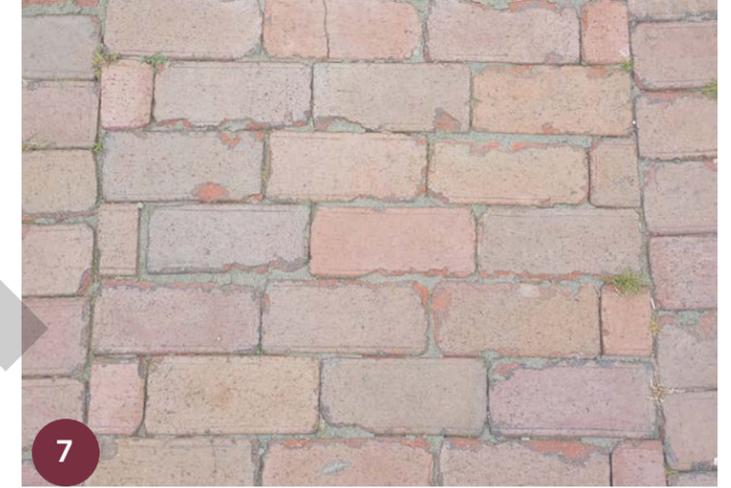
**Brick Walkway**  
Clay brick is utilized in the existing walkways adjacent to the lighthouse. Work that reconfigures the walkways should utilize the same material to match texture and appearance. Brick walkways should be geometric and uniform in width.

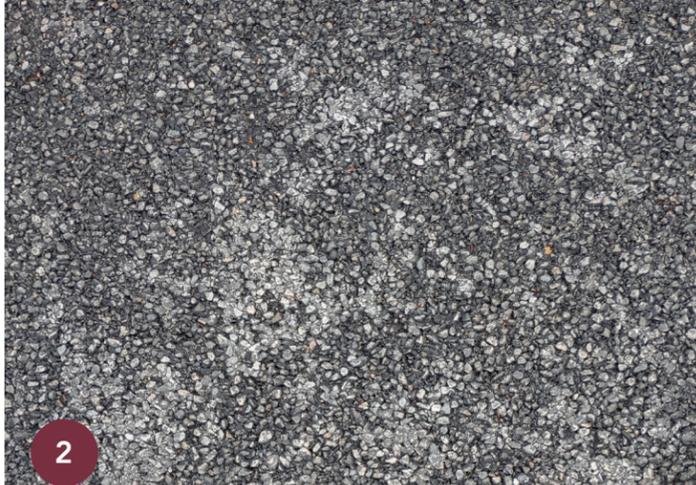
**Porous Asphalt Pavement**  
Porous asphalt is an open graded HMA mix of asphalt batched and installed in a manner that retains open pore space within the mix, allowing stormwater to pass through rather than run off. A deep bed of crushed stone as a 'reservoir course' is required below to store and infiltrate the water.

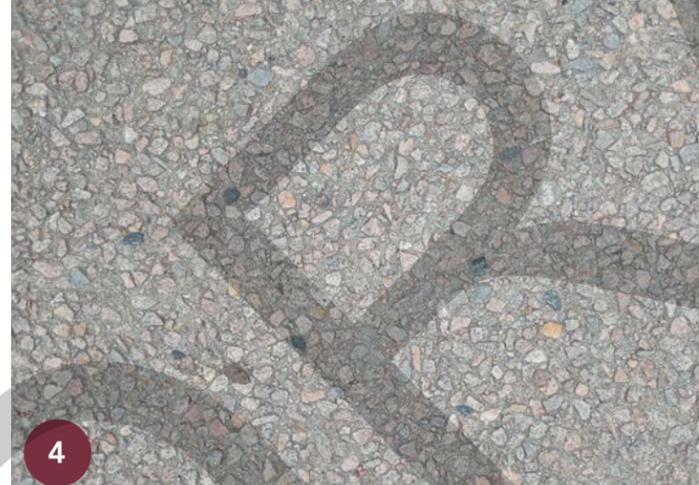
**Exposed Aggregate Concrete**  
Exposed aggregate concrete is a finish treatment that exposes the crushed stone in un-cured concrete and results in a more formal textured surface appearance. It is an appropriate treatment for areas where pathways transition to buildings or other surfaces and precise grading is required: wheelchair ramps, etc.

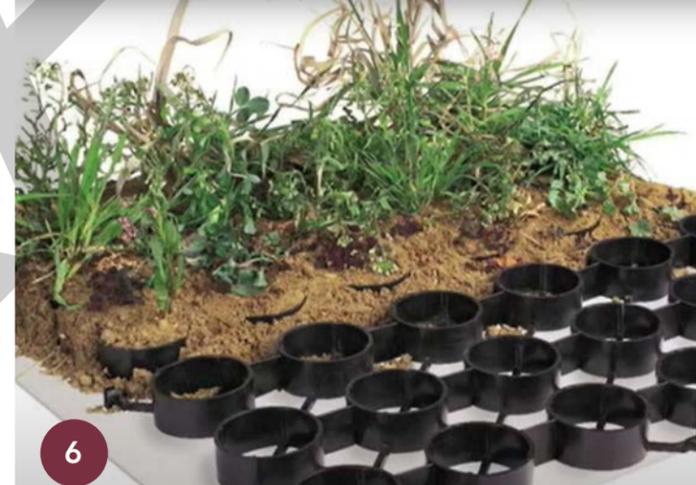
**Geo-Reinforced Paving System**  
Geo-technical support systems are suitable for seasonal parking areas. A system of composite materials or precast modular units installed over engineered base material provides integrity to support vehicles. Open 'cells' within the system may be filled with stone or for a green appearance, loam onto which grass is planted.

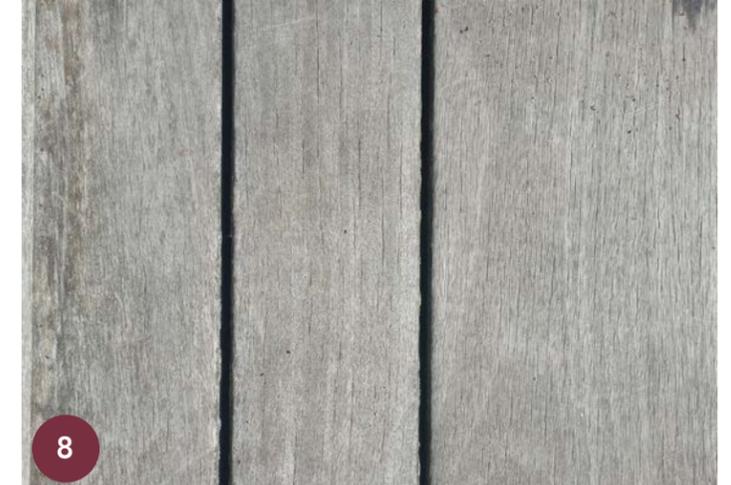
**Wood Decking**  
Forestry Certified Council (FSC) certified natural wood timber, framing and decking lumber materials should be utilized for boardwalks, overlooks, as well as ramps, stairs and decks necessary to access such structures. Wood should be durable, rot resistant and sustainably managed and sourced.

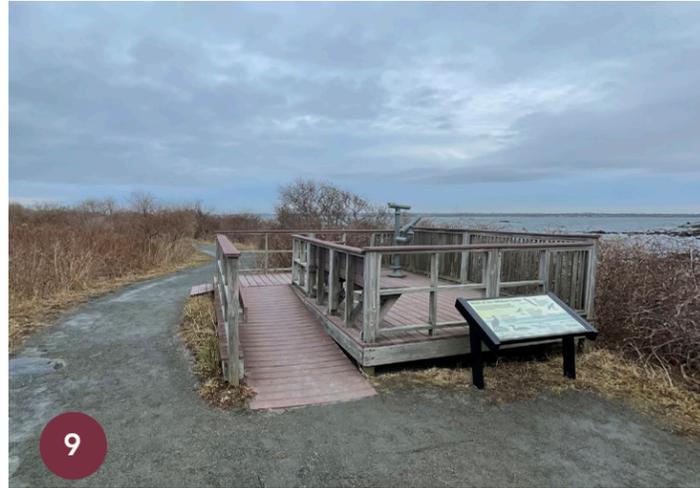
**9**

**Overlooks**  
 Overlook platforms will afford visitors opportunity to view wildlife and Narragansett Bay while limiting foot traffic over the coastal bank. Platforms must be configured to be ADA-compliant with appropriate handrails. Open railings maximize views.

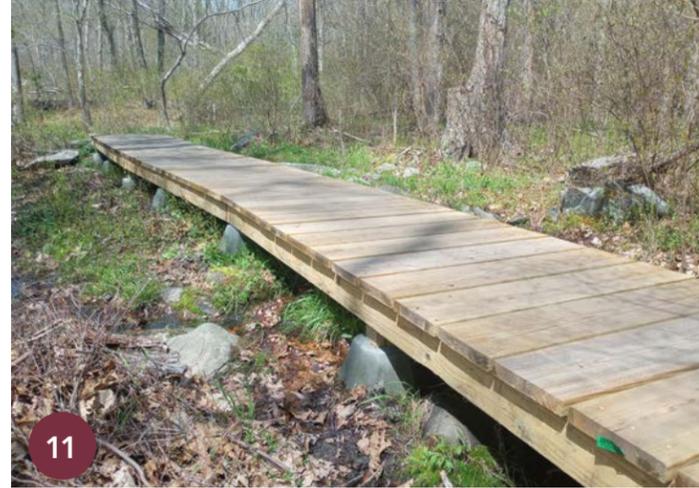
**11**

**Low-Profile Boardwalks**  
 Low-profile boardwalk systems located where foot paths cross wet areas will protect vegetation and wildlife and reduce erosion. Boardwalks may be installed close to the ground on pedestals. Complete systems should have curb rails and handrails, although guardrails may be avoided.

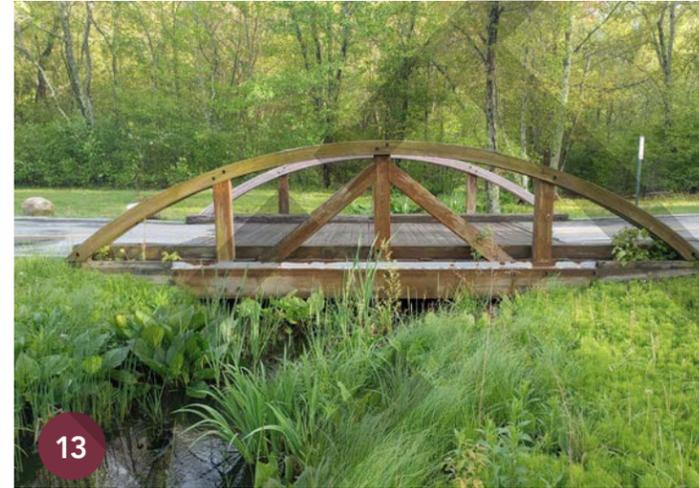
**13**

**Short-Span Bridges**  
 Bridges are warranted in several locations where trails intersect intermittent streams. The spans required are typically less than 30 feet. In open-highly visible areas architecturally designed bridge structures may be preferred. The bridges should be at least ten feet wide and rated for maintenance and rescue equipment loading.

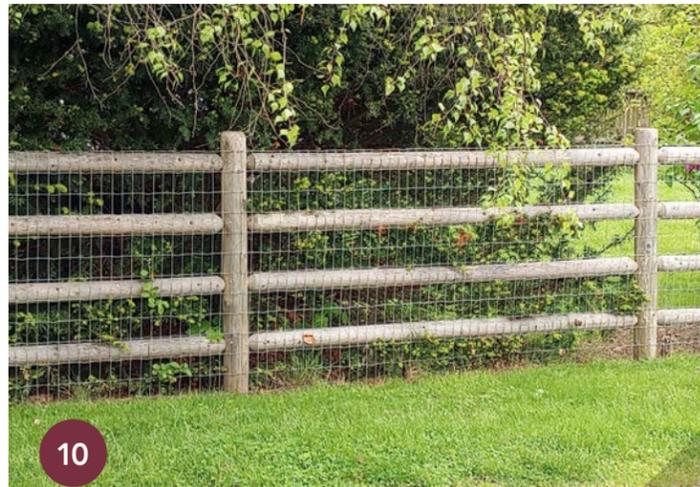
**Split Rail Fence**  
 Rustic split rail wood fences exist presently on the site. Fence systems help define spaces and protect areas from visitor intrusion. Strategically placed fencing will keep visitors from parking outside of designated areas. Cedar or Locust wood rail fencing could be considered.

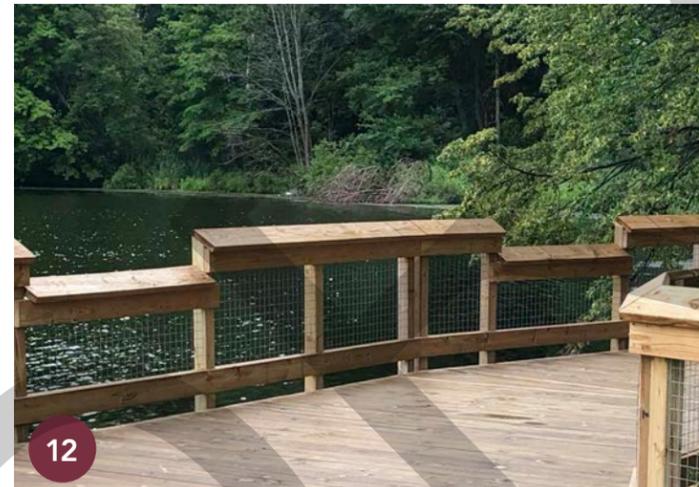
**12**

**Wire Mesh Railing on Boardwalks**  
 Utilizing black or galvanized wire mesh in the design of the railing systems developed for overlooks and boardwalk systems will maximize visibility for users of all sizes and ages.

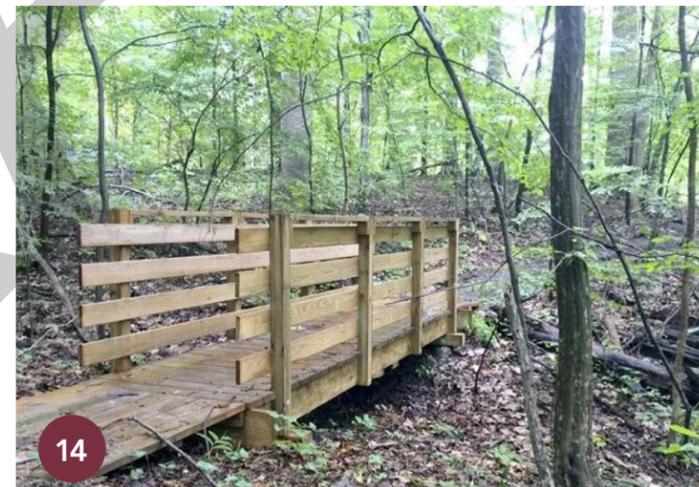
**14**

**Pedestrian Bridges**  
 Any bridge should have smooth-no-step transitions from trail surface grade to the bridge. Wood boardwalk approaches to the bridges are an effective way to achieve this. Bridges should not be less than forty-eight inches wide. Railings are necessary where grades exceeds thirty inches.

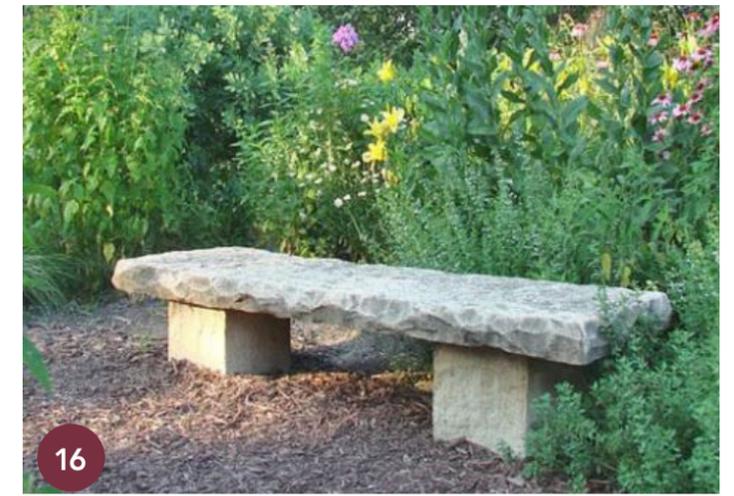
**16**

**Benches with Companion Seating**  
 Benches dispersed throughout the Park can be placed along the trails and at destination points. The areas that the benches are in allow space for companion seating for those who utilize wheelchairs. Granite bench shown above.

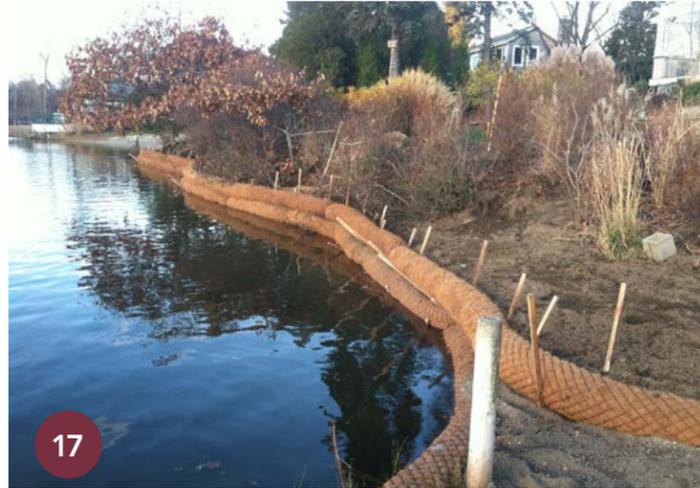
**17**  
**Coir Log**  
 Coir fiber logs comprised of natural fibers are key component of stabilizing and replanting eroded areas. Staked and layered with live 'whips' of native plants, the coir fiber logs help hold the soil as they slowly decompose.

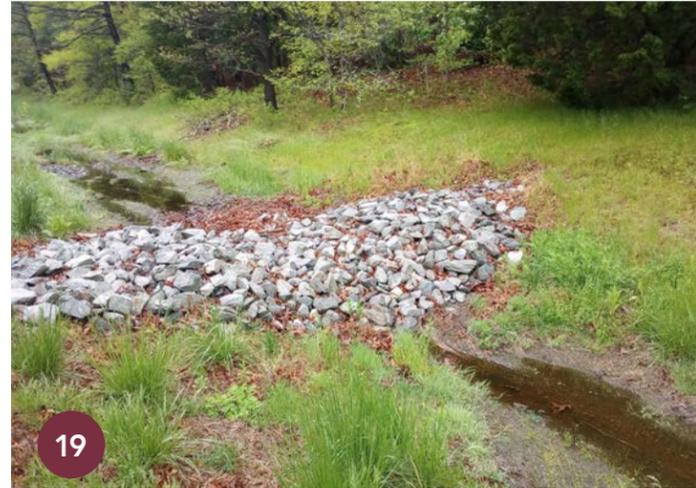
**19**  
**Check Dam**  
 Stone check dams incorporated into high volume swale systems will slow and attenuate stormwater flow. Use of stone slabs or naturally occurring, weathered stone bedded and flanked with smaller round stone is visually preferred to the use of crushed rip-rap in this park setting.

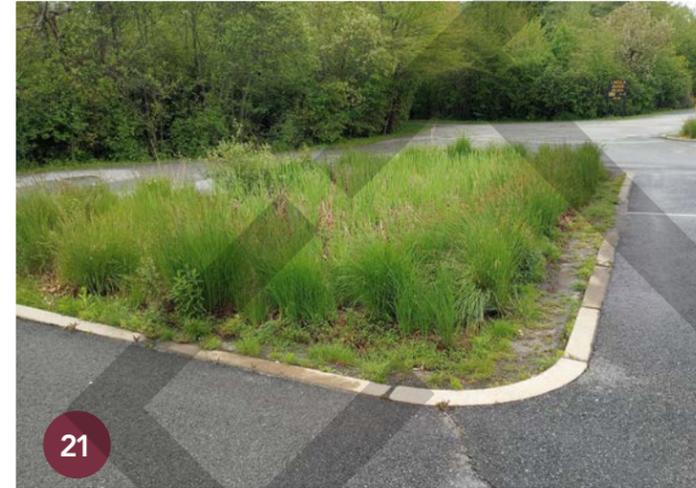
**21**  
**Planted Swale**  
 Shallow rain gardens are appropriate in areas adjacent to walkways, parking areas or the Park roadway. Plant selection enables these water quality treatment areas to also provide valuable habitat.

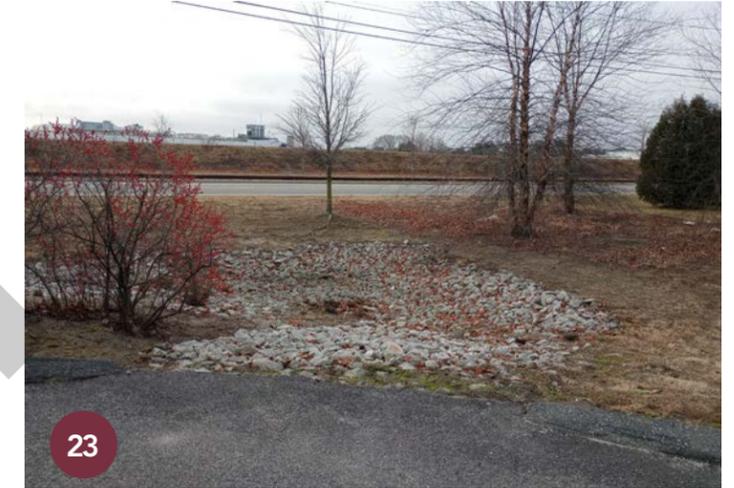
**23**  
**Rip Rap-Lined Swale**  
 Stone lined swales may be utilized in areas with higher volumes of water. Irregular edges plated with native plants is desirable. Voids in the rip rap may be planted to further visually soften the appearance and attenuate flow.

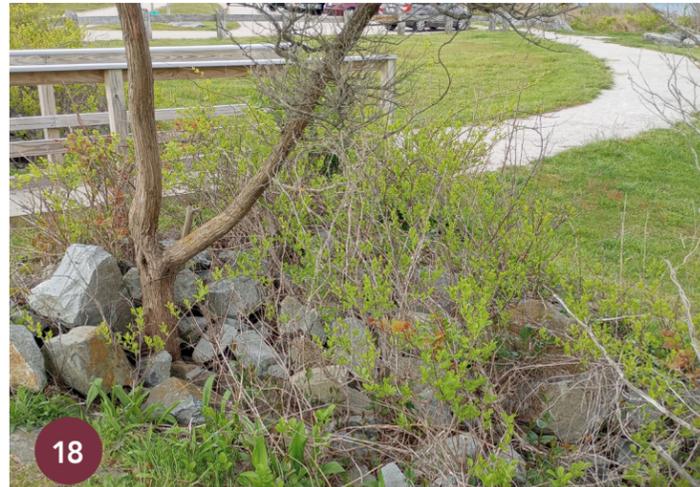
**18**  
**Vegetated Rip rap**  
 Vegetated stone rip rap is a necessary treatment to address eroded slopes. Voids in the rip rap filled with soil and planted with native grasses and shrubs will allow the formation of a reinforced root mat. The initial courses of the rip rap should be 'pinned' to ledge. Covering the rip rap entirely with soil is often preferred.

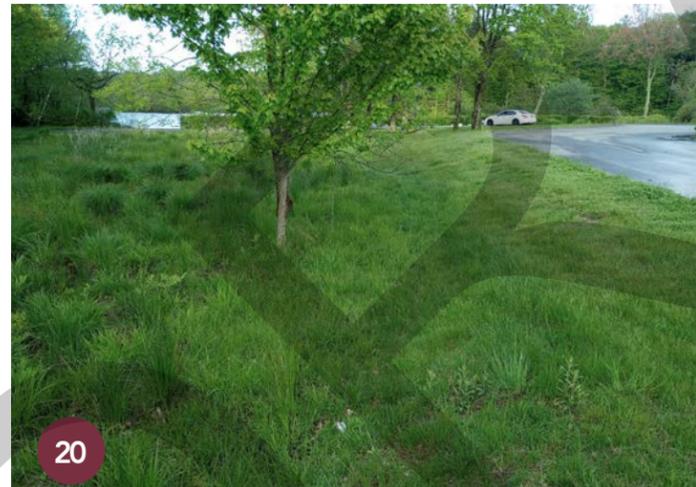
**20**  
**Grass Swale**  
 Wide, shallow grass swales slow and attenuate stormwater runoff. Swales should be planted with native grasses and graded to accommodate annual mowing operations as necessary to maintain water flow. A mown shoulder transition from pavement areas helps ensure conveyance.

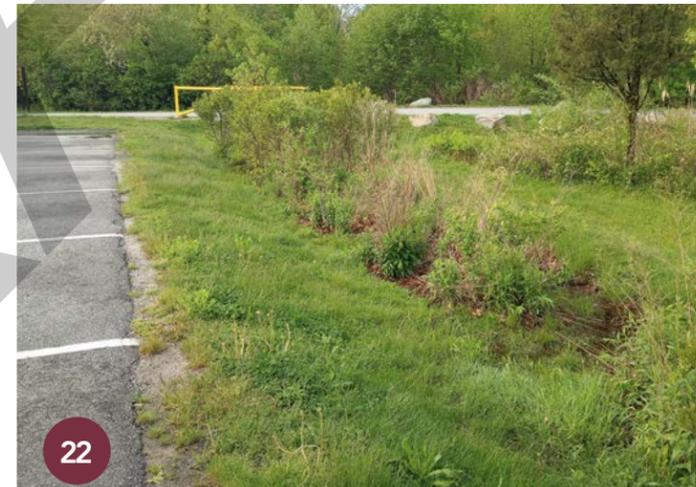
**22**  
**Planted Swale**  
 Vegetated swales slow and attenuate stormwater runoff and improve water quality. Shrub plantings create habitat and regulate pedestrian movement.

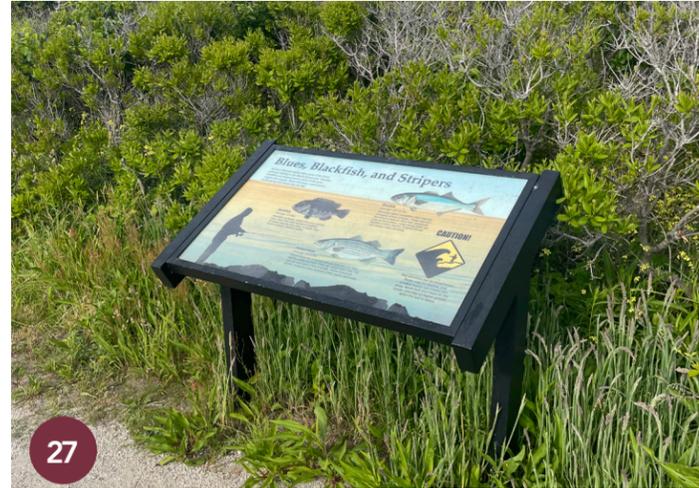
**27 Interpretive Panels**  
Interpretive panels expand the visitor experience by enhancing understanding of the natural and man-made surrounds. ADA configured panels consist of high-density graffiti resistant laminate materials with steel or wood frames. Braille and textured elements accommodate vision impaired users.

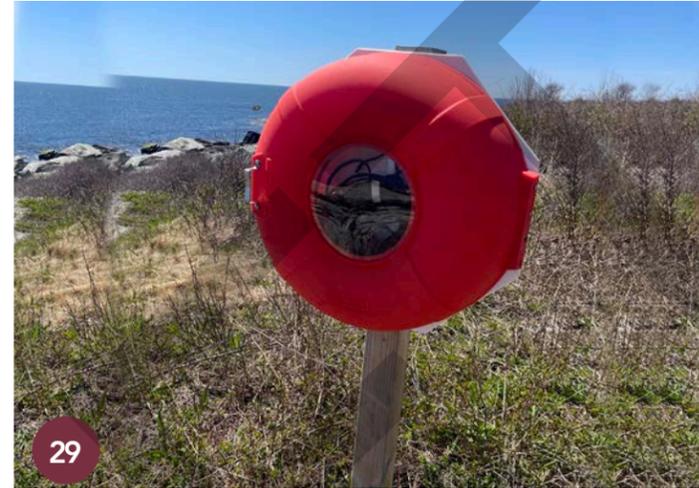
**29 Safety Resources**  
Visitor safety may be enhanced through the installation of safety equipment in the Park in areas of high risk. Coiled rope lines and life rings in weatherproof enclosures will afford park goers a means of offering assistance as a 'first-line' of response to help people encountered that are in danger.

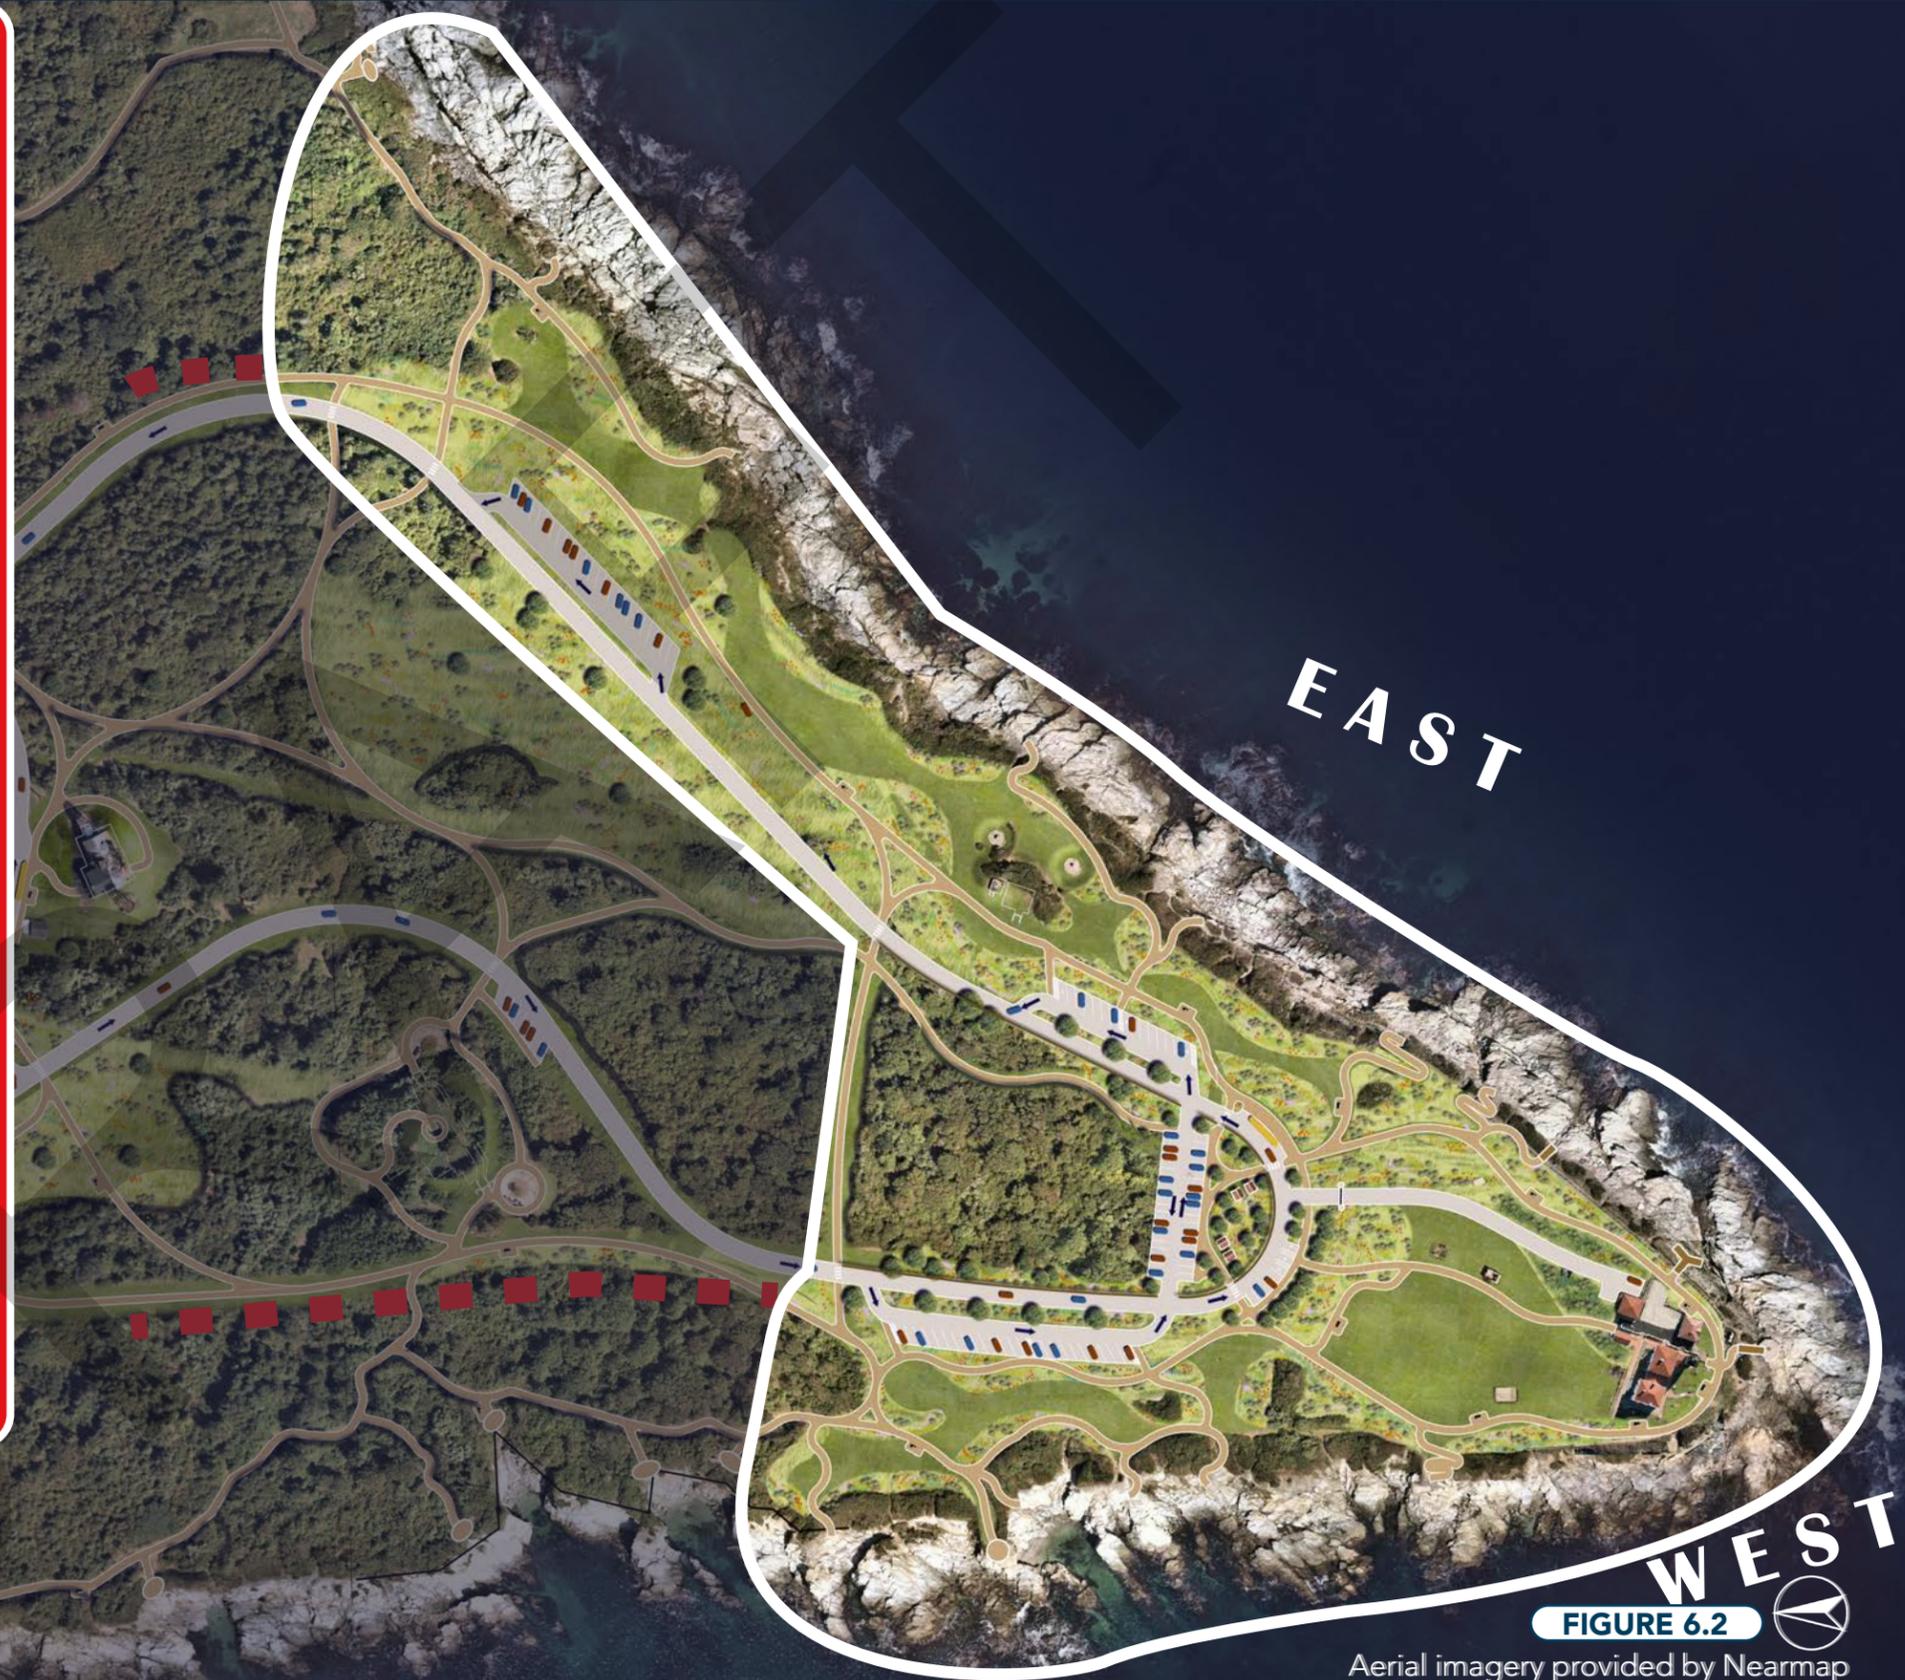
FIGURE 6.2

- Re-align southern loop of Park Drive.
- Visitor/bus drop off area and new ADA-compliant parking spaces.
- 40 car Visitor parking lot
- New visitor restrooms at visitor parking lot

- Habitat creation for Upland Meadows
- Relocate above-ground utilities to be underground

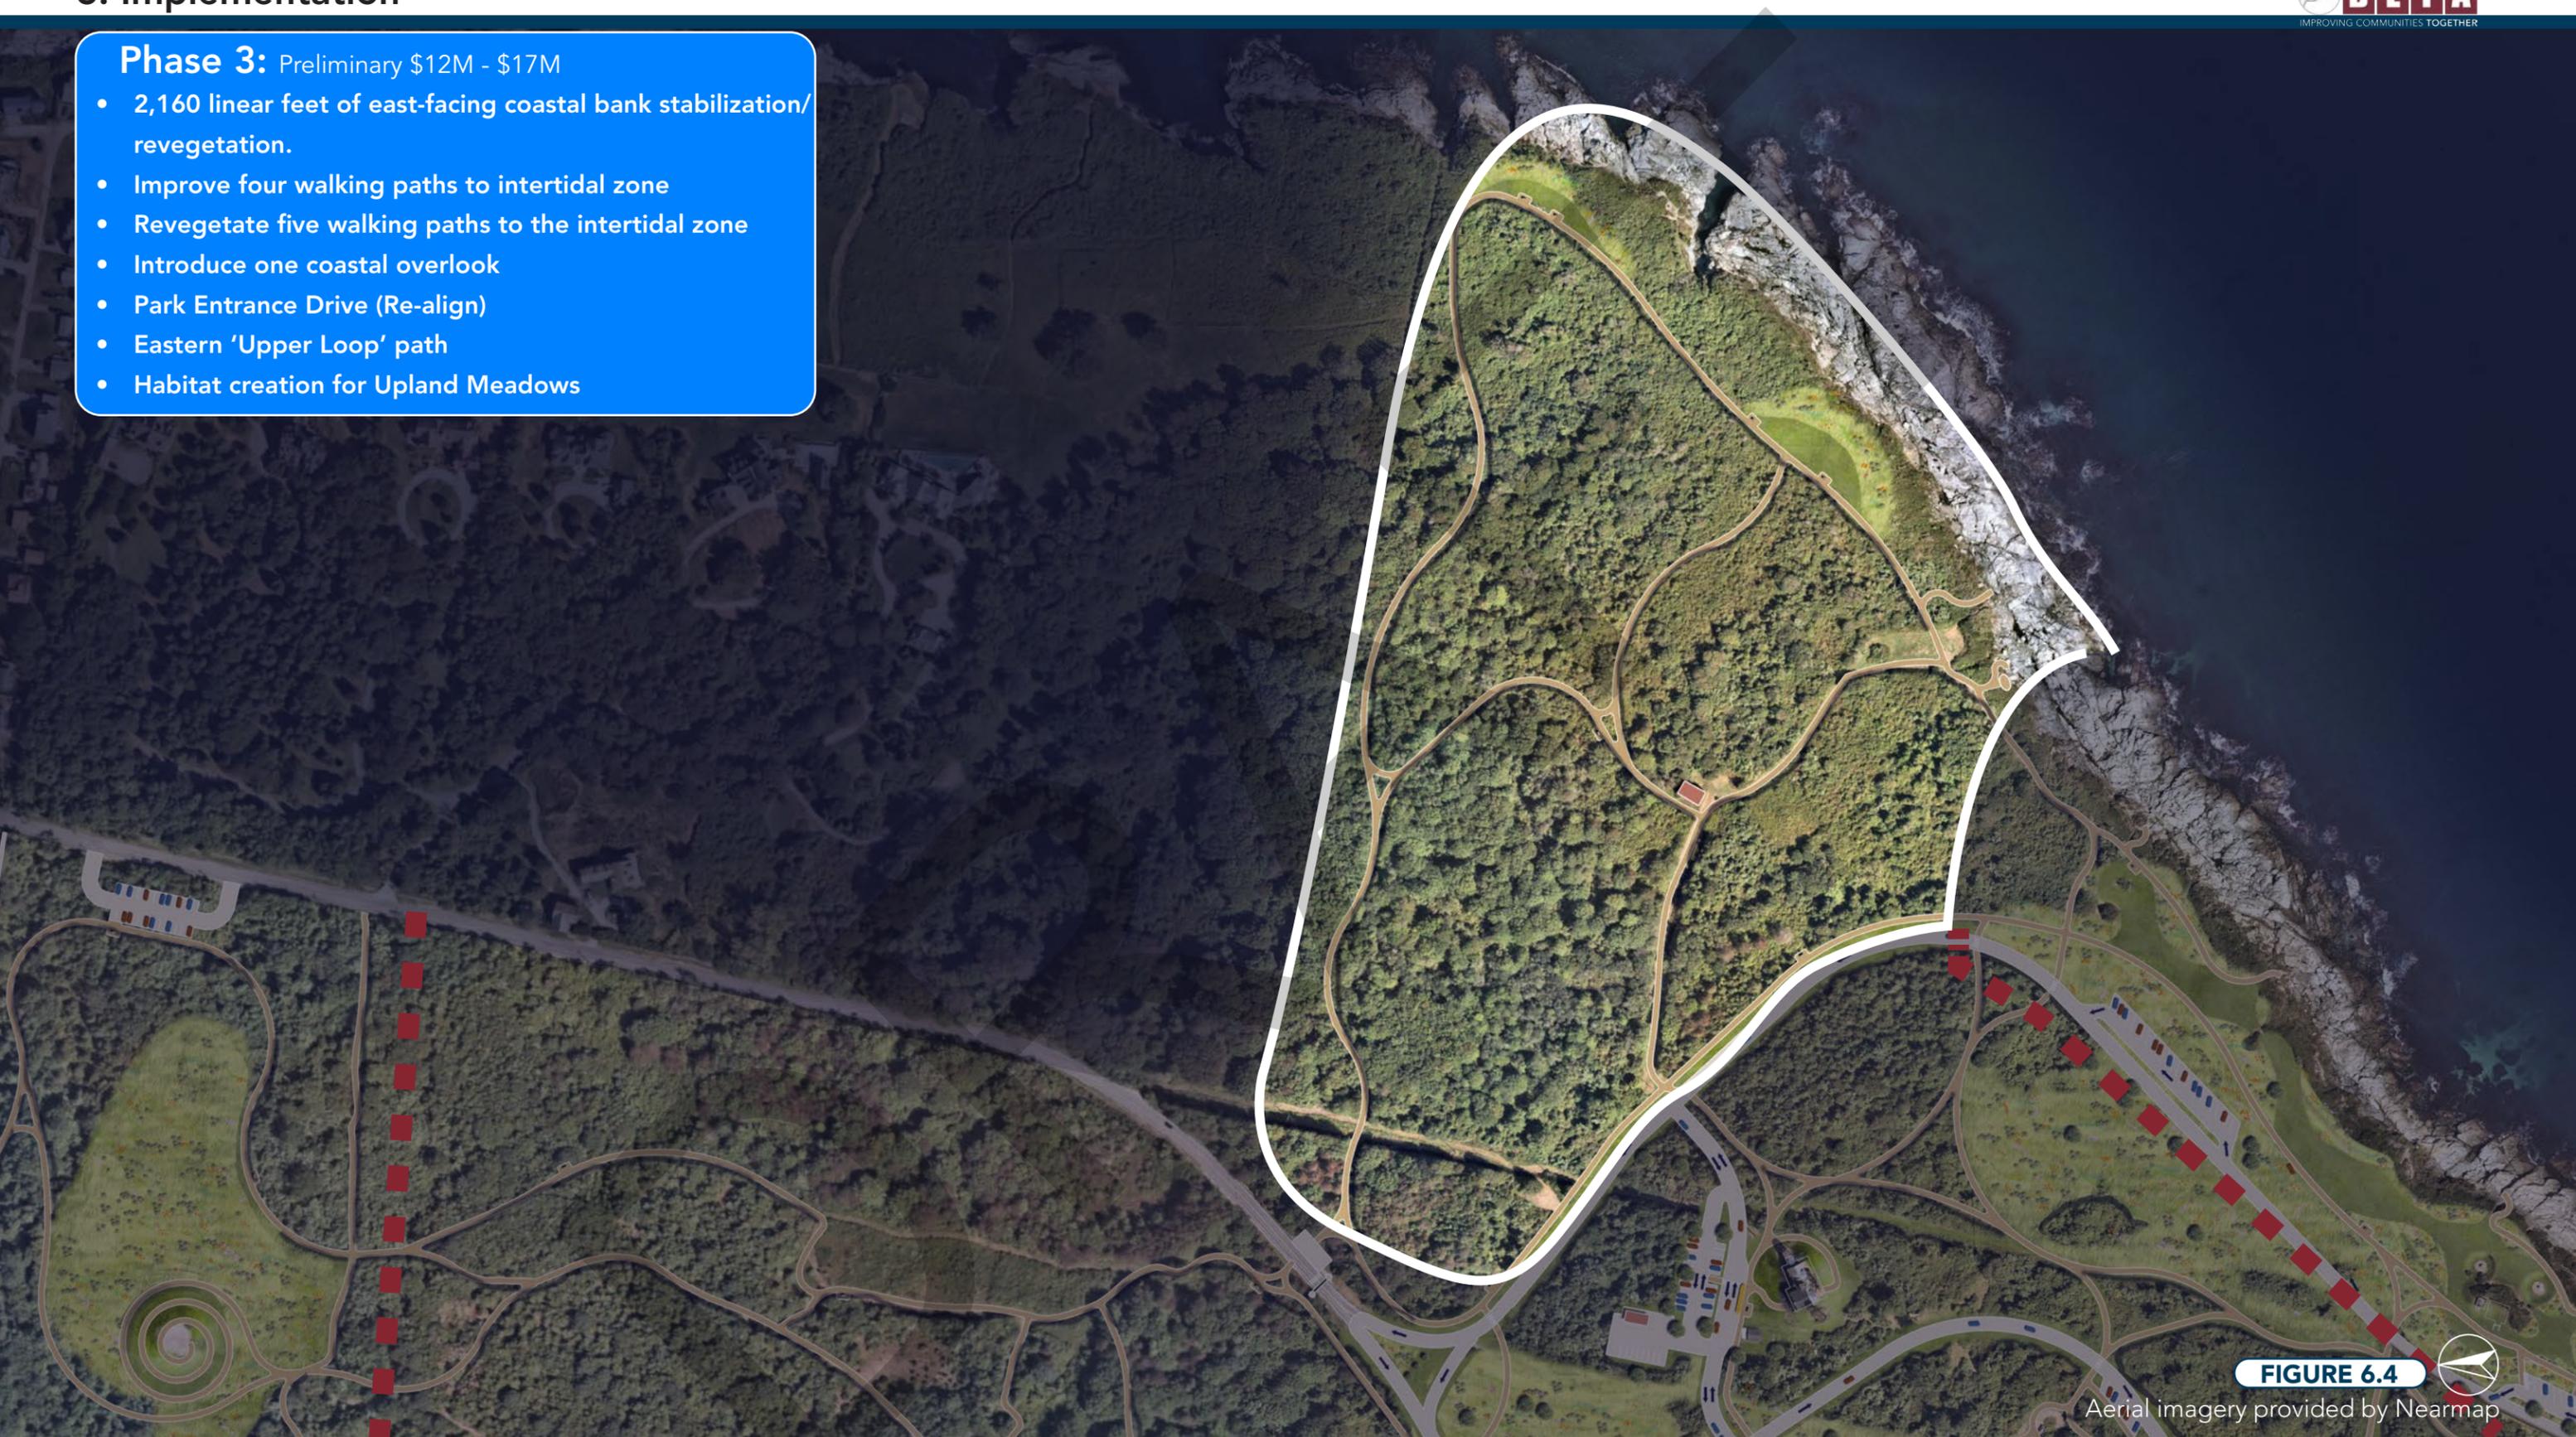
**FIGURE 6.4**

- 2,160 linear feet of east-facing coastal bank stabilization/revegetation.
- Improve four walking paths to intertidal zone
- Revegetate five walking paths to the intertidal zone
- Introduce one coastal overlook
- Park Entrance Drive (Re-align)
- Eastern 'Upper Loop' path
- Habitat creation for Upland Meadows
