FINAL DRAFT

# BEAVERTAIL STATE PARK MASTER PLAN 2025

The beavertail State Park Master Plan is intended to re-imagine the future of Beavertail State Park and addresses the following:

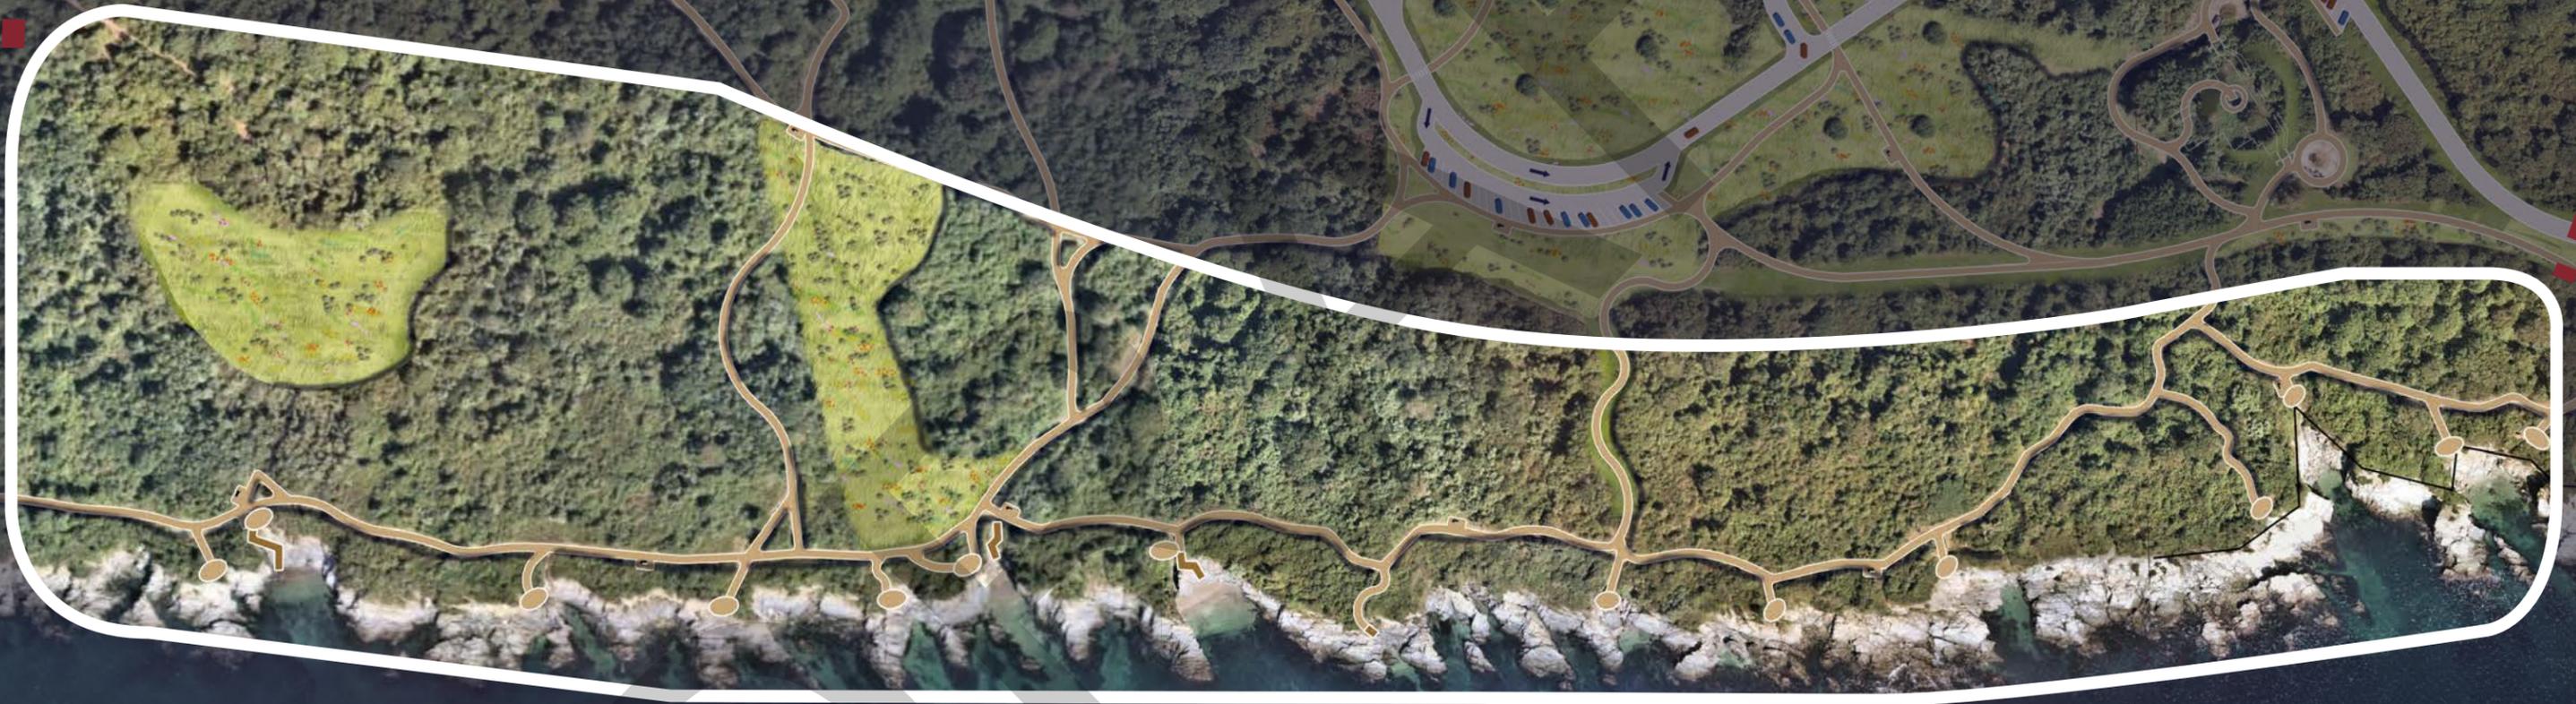
FIGURE 6.5

- 3,050 linear feet of west-facing coastal bank stabilization/revegetation.
- Improve one walking paths to intertidal zone
- Introduce four stairways to the intertidal zone
- Introduce 14 coastal overlooks
- Revegetate 12 walking paths to the intertidal zone
- New & improved trails
- Boardwalk
- Habitat creation for Upland Meadows

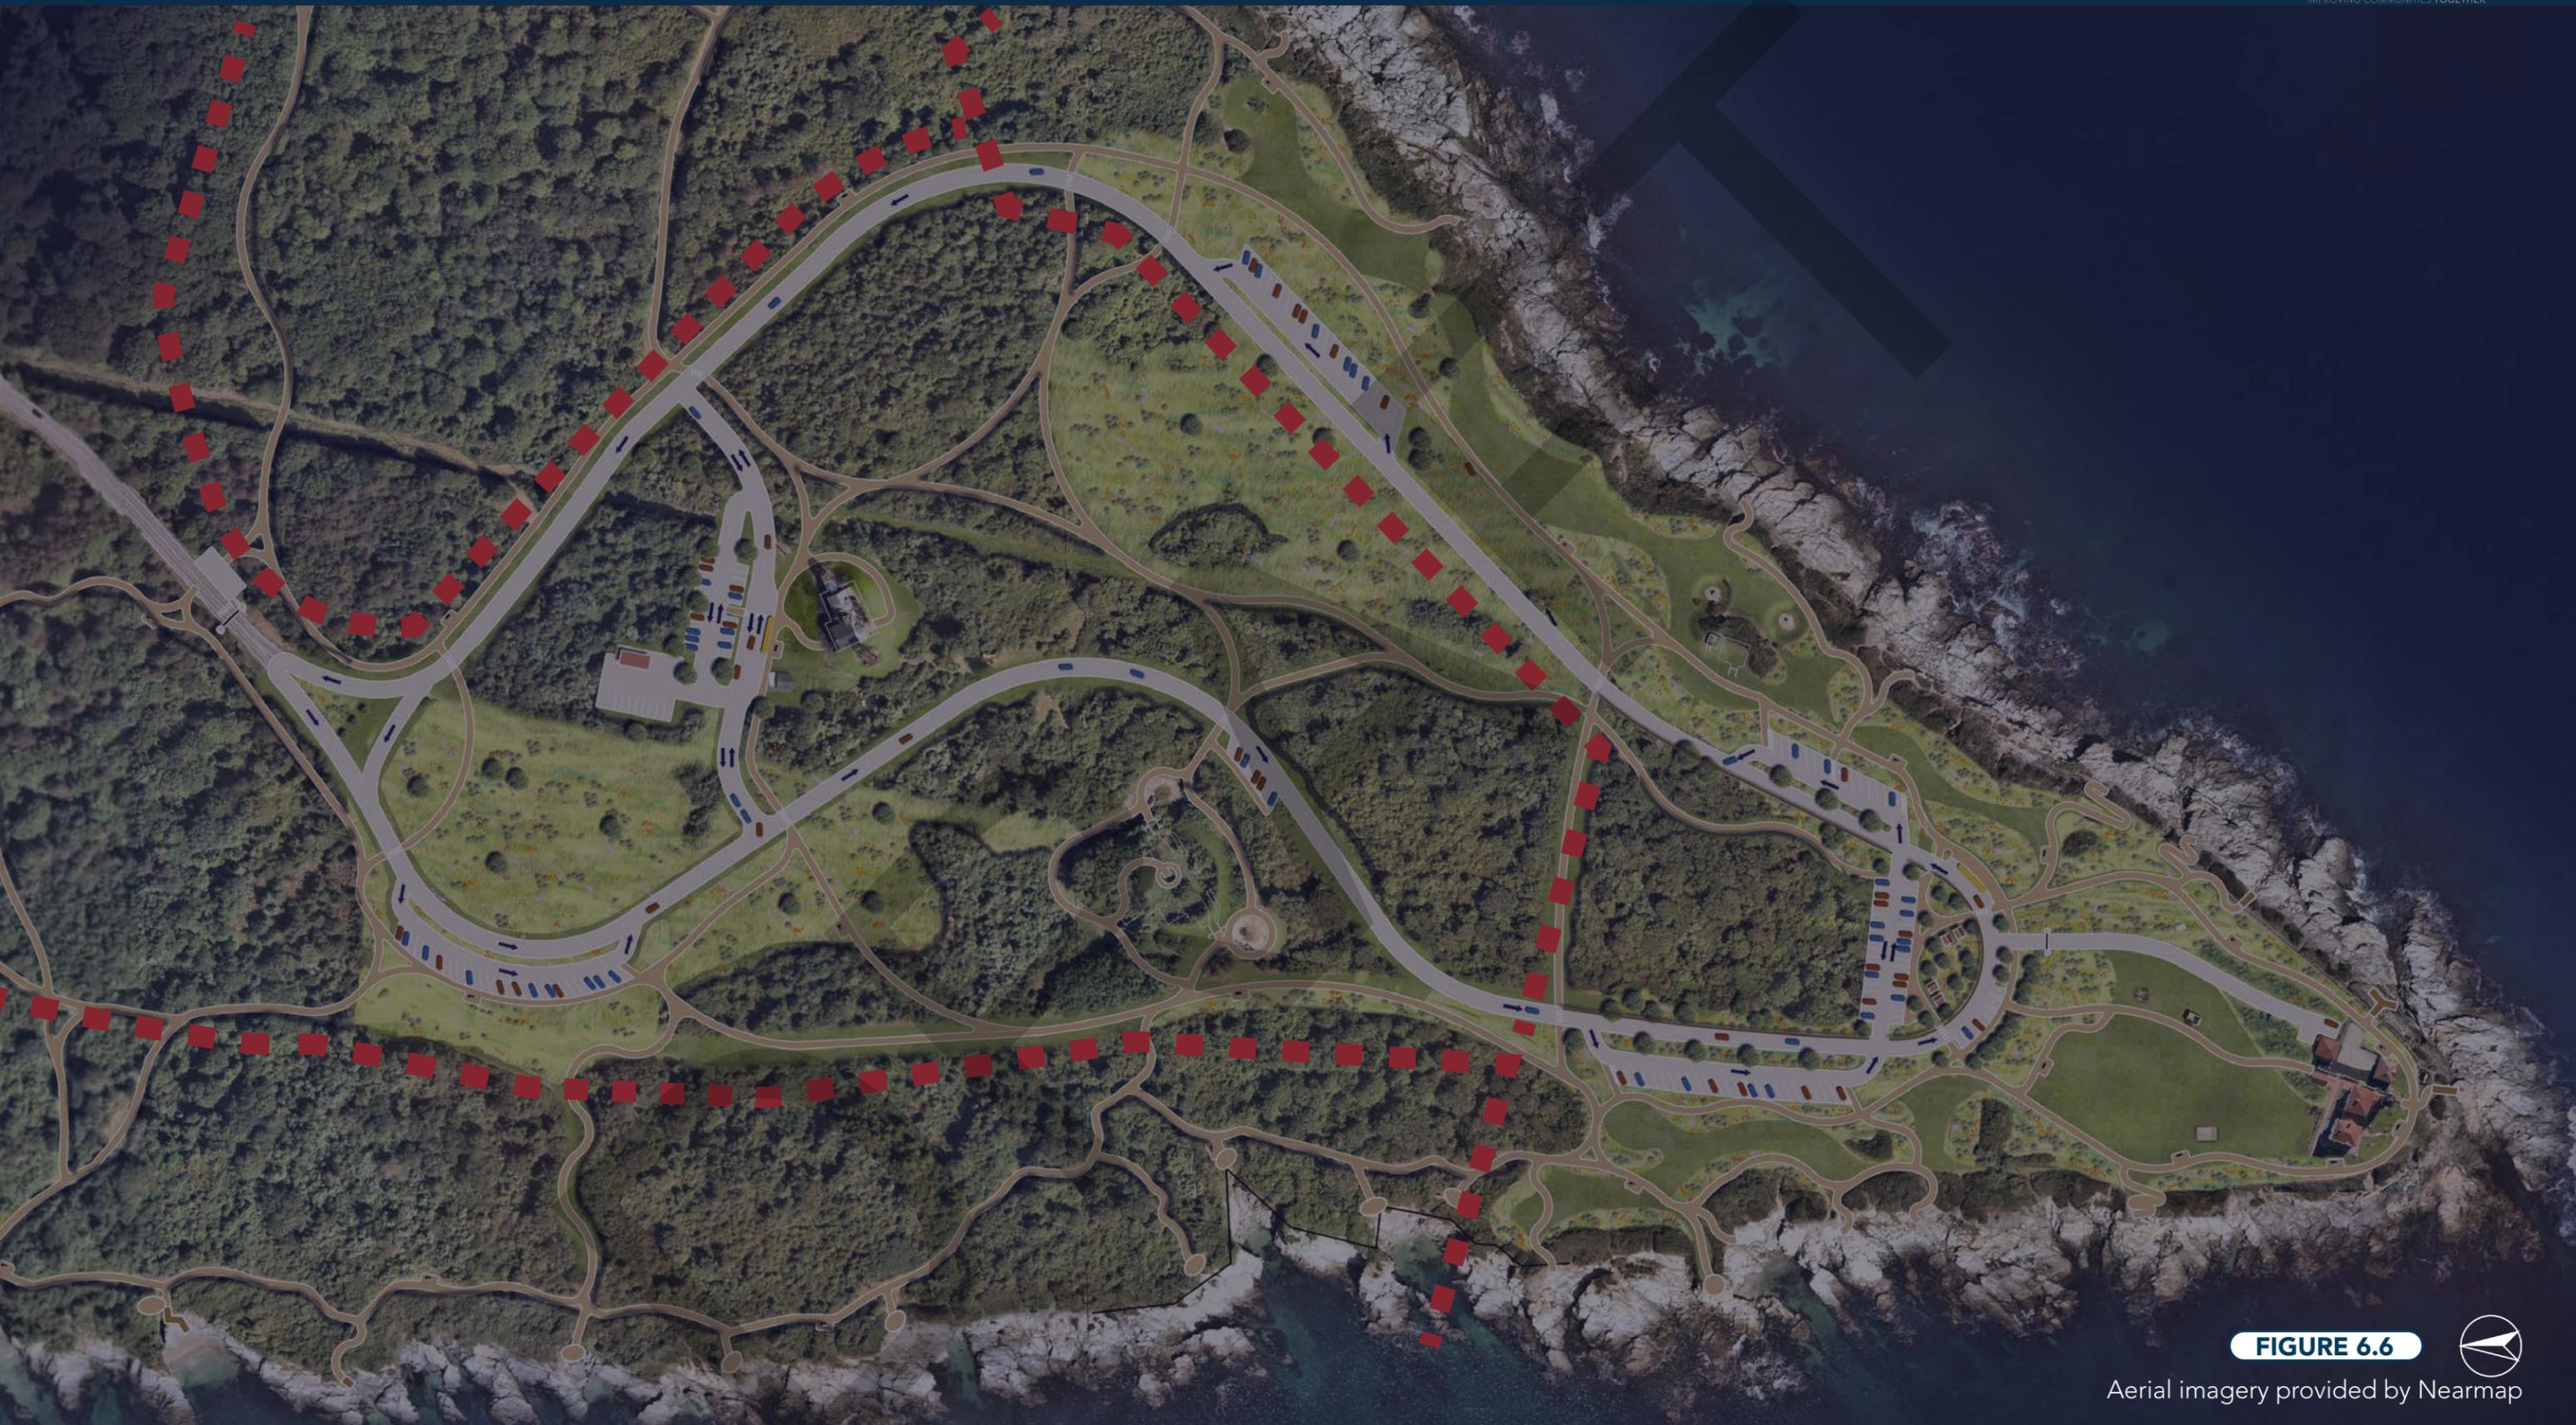
FIGURE 6.6

- 1,250 linear feet of west-facing coastal bank stabilization/reevegetation.
- Introduce one stairway to the intertidal zone
- Revegetate two walking paths to the intertidal zone
- North visitor parking lot
- New & improved trails
- Spraycliff Interpretive Site
- Habitat creation for Upland Meadows
