This presentation will focus on the salt marsh restoration component of the habitat restoration project being conducted at the Ninigret barrier and salt marsh complex in Charlestown, RI.

In 2024, the Rhode Island Department of Environmental Management (RIDEM) in cooperation with Save The Bay received an America the Beautiful grant from the Department of the Interior to conduct salt marsh and coastal habitat restoration projects on three RIDEM owned and two U.S. Fish and Wildlife Service (USFWS) owned coastal properties: the Ninigret barrier in Charlestown, Galilee Marsh in Narragansett, the Narrow River in Narragansett and South Kingstown, Sachuest Marsh in Middletown and Sapowet Marsh in Tiverton.

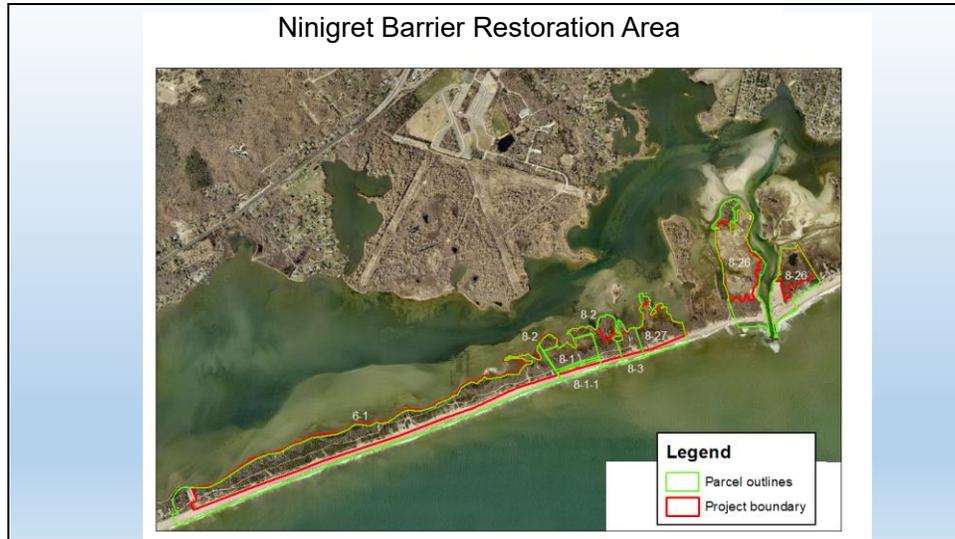
The Ninigret barrier beach restoration area includes the RIDEM and USFWS owned barrier beach and salt marsh on the west side of the Charlestown breachway and the RIDEM owned salt marsh on the east side of the breachway.

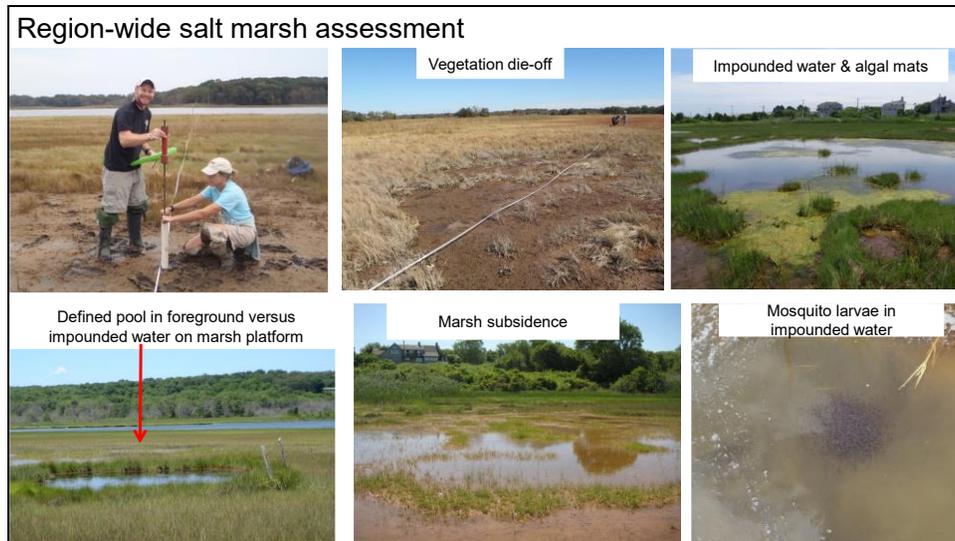
Save The Bay conducted a region wide study to assess the extent of marsh degradation by monitoring vegetation and the stability or bearing capacity of the marsh peat. The majority of the 40 marshes assessed had impounded water and either stunted and stressed *Spartina alterniflora* and bare peat that had once been vegetated based upon evidence of root fragments and on the marsh platform. Also we found mosquito larvae in many of the impounded water areas that are too shallow and warm to support marsh fish species such as mummichogs that eat mosquito larvae.

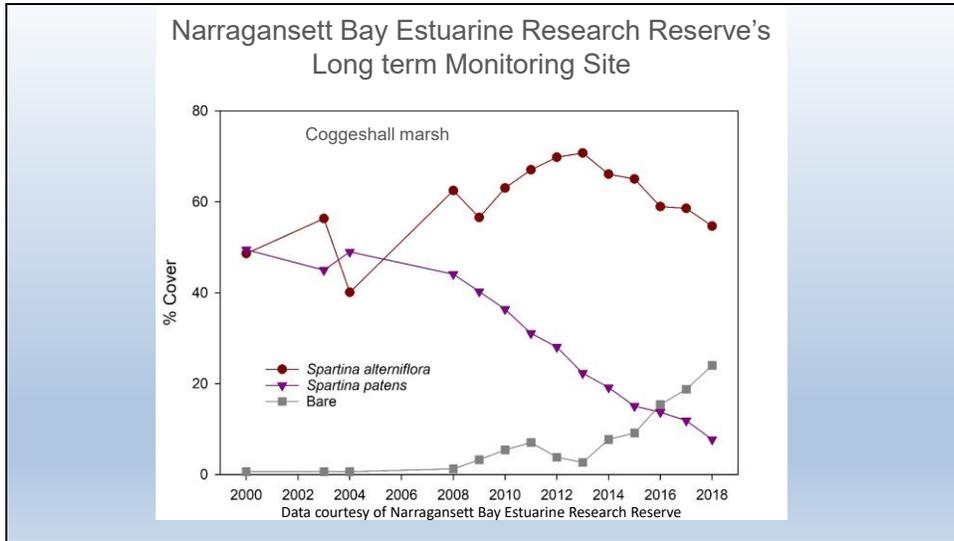
Long term salt marsh data collected by the Narragansett Bay National Research Reserve at Coggeshall marsh on Prudence Island documented a similar change in marsh composition over a 20 year period as Save The Bay's region-wide assessment. The high marsh species, *Spartina patens* in purple, less tolerant to flooding, declined from 50% to ~10% of total marsh cover and bare areas with no vegetation increased from 0 to over 20% of total marsh cover.

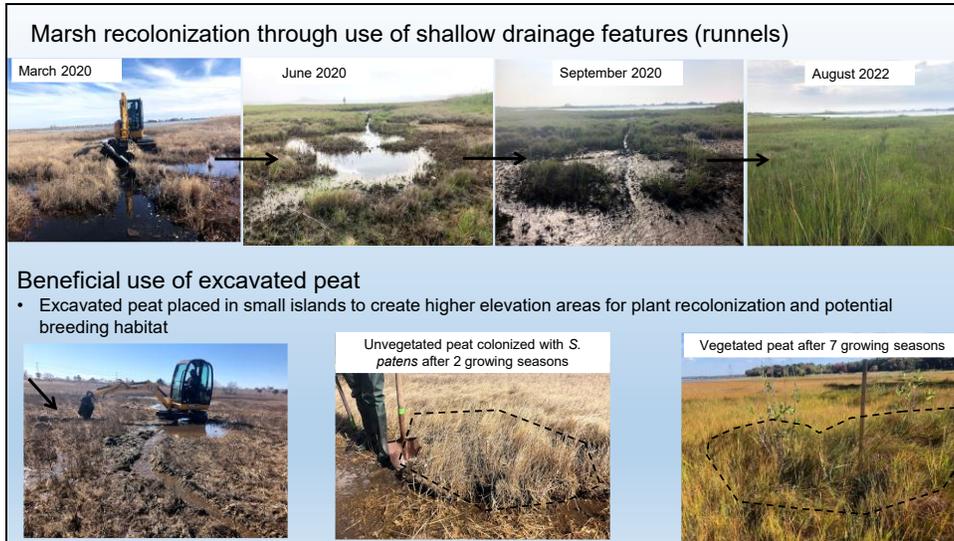
Save The Bay digs the runnels and maintains the ditches either by hand or with the RI Department of Environmental Management's low ground pressure excavator which is designed with large tracks to minimize impact on the marsh. The photos above show a runnel being dug by the excavator into impounded water at Winnapaug Marsh. As the water drained, Save The Bay extended the runnel by hand. After hydrology was restored, the bare areas or soft, unconsolidated sediment began to revegetate. The plants stabilized the peat and the vegetation colonized the bare sediment after 2 growing seasons.

The peat, excavated by hand or excavator, is beneficially used to create small higher elevation areas from 3 to 8 feet wide and up to 12 inches on the marsh platform. The photos highlight the peat being placed by the excavator and revegetation of bare peat in 2 growing seasons at Winnapaug Pond marsh and revegetation with high marsh grasses of a peat island after 7 years on the Narrow River.

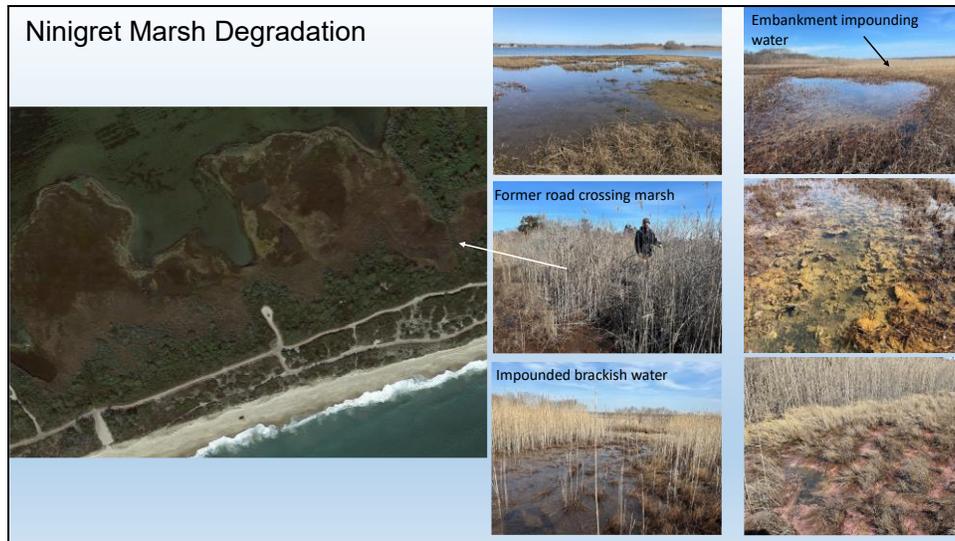
At the salt marsh on the north side of the Ninigret barrier beach, the marsh shows similar signs of degradation as marshes throughout the state. There are large areas of shallow impounded water that have caused the vegetation to die-off, algal mats to grow and *Phragmites* to expand. Agricultural embankments and a former road on the marsh impound both salt and brackish water on the marsh surface. The brackish water has caused *Phragmites* to expand and outcompete native marsh grasses. These degraded conditions have resulted in loss of salt marsh and resulted in poor quality habitat for salt marsh nesting birds.

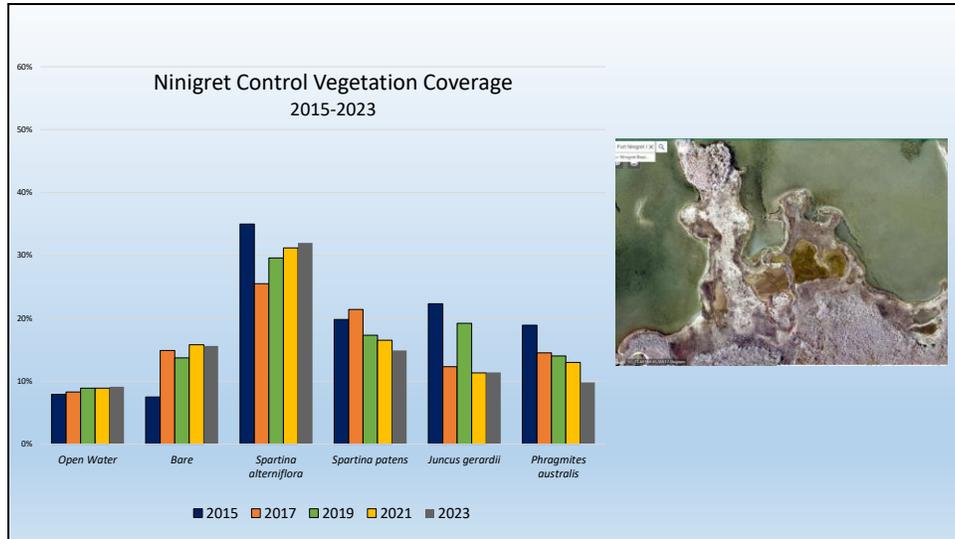
On the USFWS marsh on the north side of the Ninigret barrier, Save The Bay collaborated with USFWS to monitor the marsh vegetation since 2015 prior to restoration. This chart documents the decline in high marsh grasses (*Spartina patens* and *Juncus gerardii*) less tolerant to flooding and the increase in bare areas during that 8 year period.

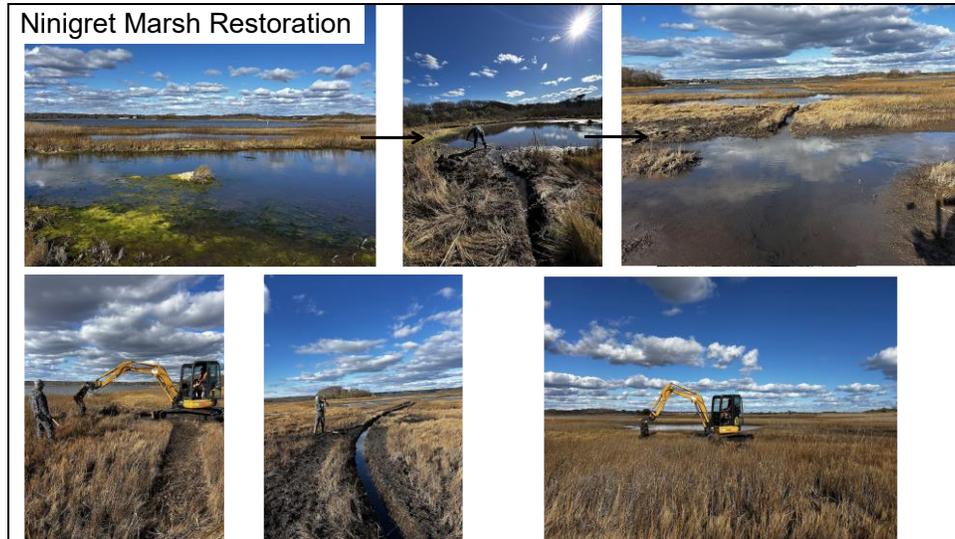
After state and federal permits were received, the marsh restoration project began in November of 2025. Save The Bay's Restoration Ecologist operated RIDEM's Division of Mosquito Abatement's low-ground pressure excavator to dig shallow runnels to drain impounded water. In areas not accessible for the excavator, staff and interns dug the runnels by hand. Save The Bay will continue to conduct this work in phases in 2026 to allow the unconsolidated sediment in the impounded water areas to drain and stabilize through revegetation.

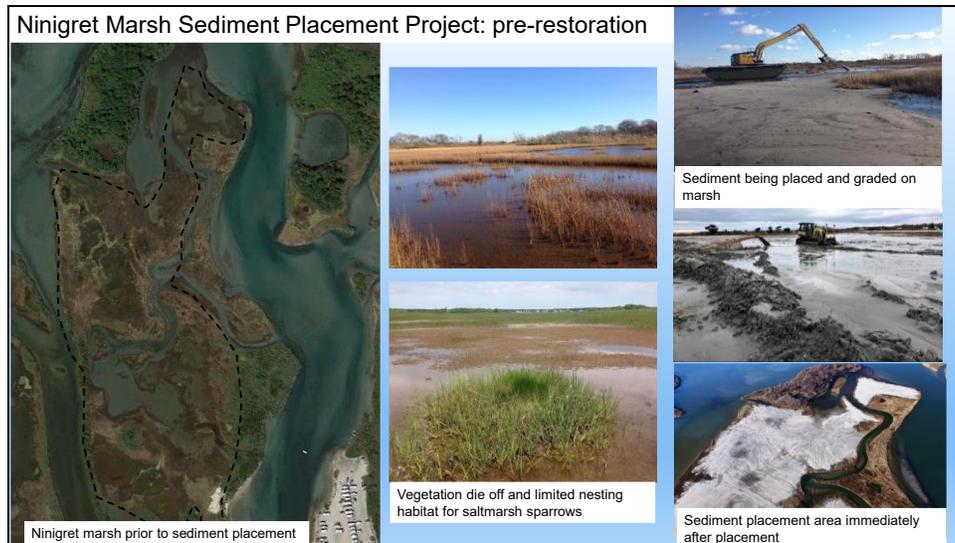
As part of this collaborative restoration project, Save The Bay will maintain the salt marsh restoration project on the far eastern end of the Ninigret barrier beach to the west side of the Charlestown breachway. The Coastal Resources Management Council working in conjunction with RIDEM and Save The Bay elevated the severely degraded marsh in 2017 using sand dredged from the breachway that was pumped onto the marsh and graded.

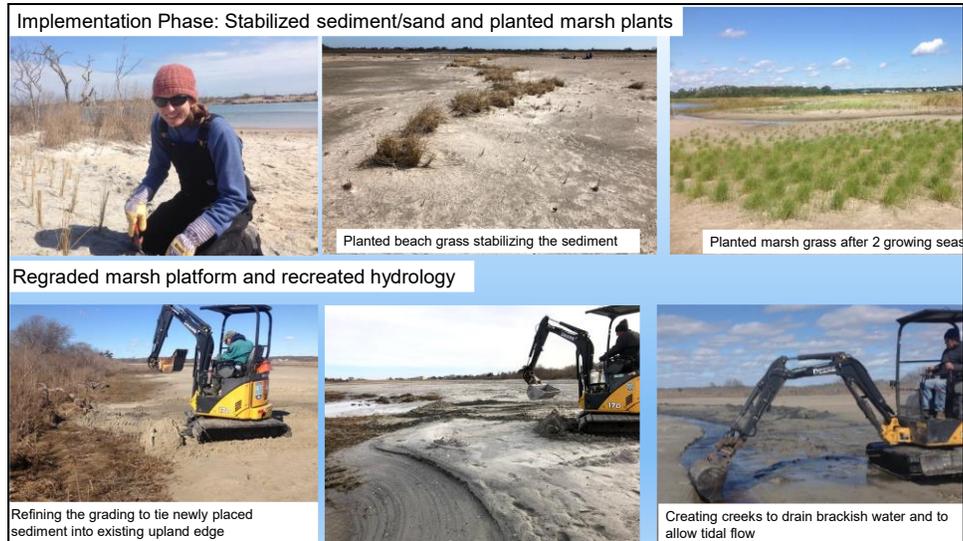
Once the sediment was placed on the marsh, Save The Bay continued the next phase by refining the grading and creating creeks to allow tidal flow onto to the newly placed sediment and to drain freshwater from the upper edges of the marsh.

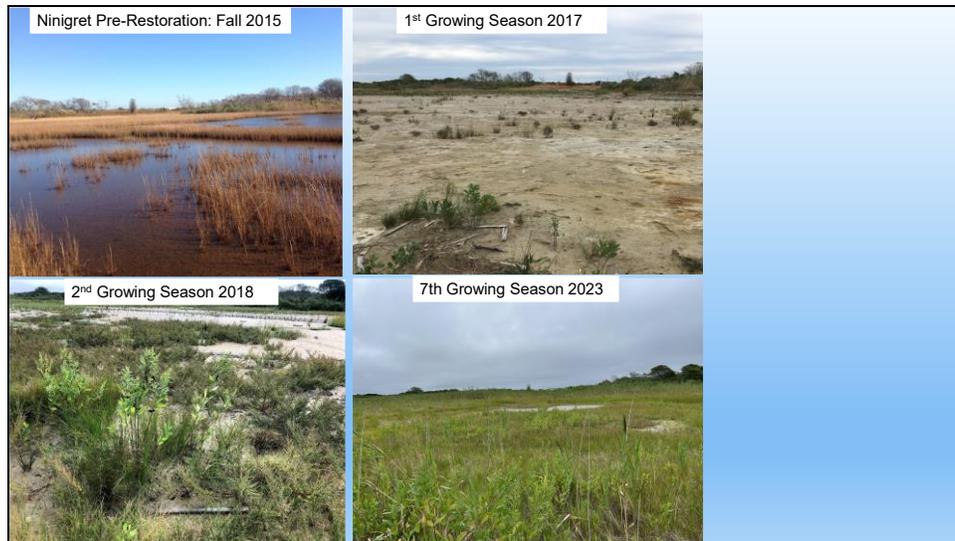
These photos taken from the same location document the degraded marsh with impounded water before the restoration occurred, the bare sand after the first growing season, and recolonization during the 2nd and 7th growing seasons. Salt marsh seeds from adjacent marshes were brought in with the tides and allowed natural recolonization of marsh plants. In higher elevation areas that were designed to provide area for salt marsh habitat to migrate as sea level rises, upper marsh plants including groundsel tree, bayberry, and *Phragmites* have become established.

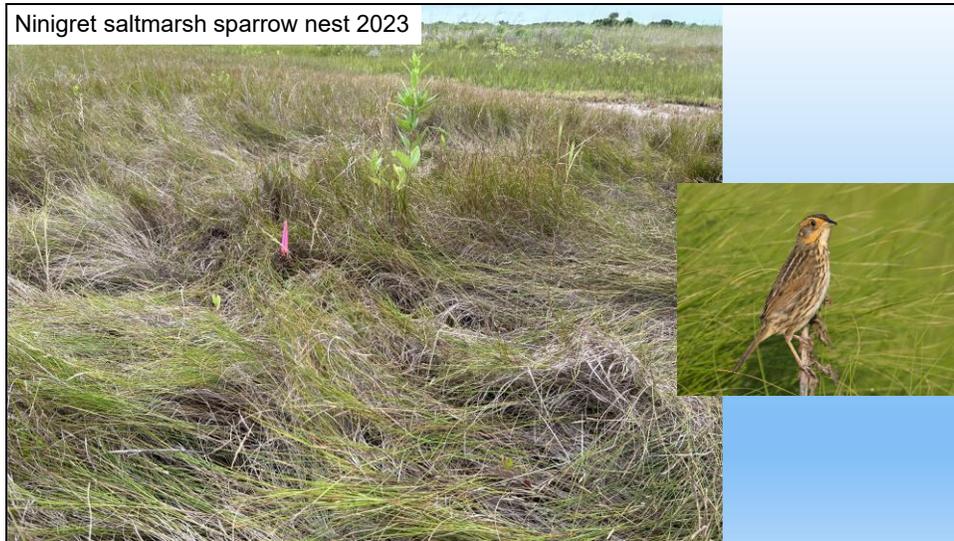
Ongoing monitoring of the salt marsh recovery by USFWS, RIDEM and Save The Bay has documented saltmarsh sparrows successfully nesting in the sediment placement restoration area, a target species for this collaborative restoration effort.

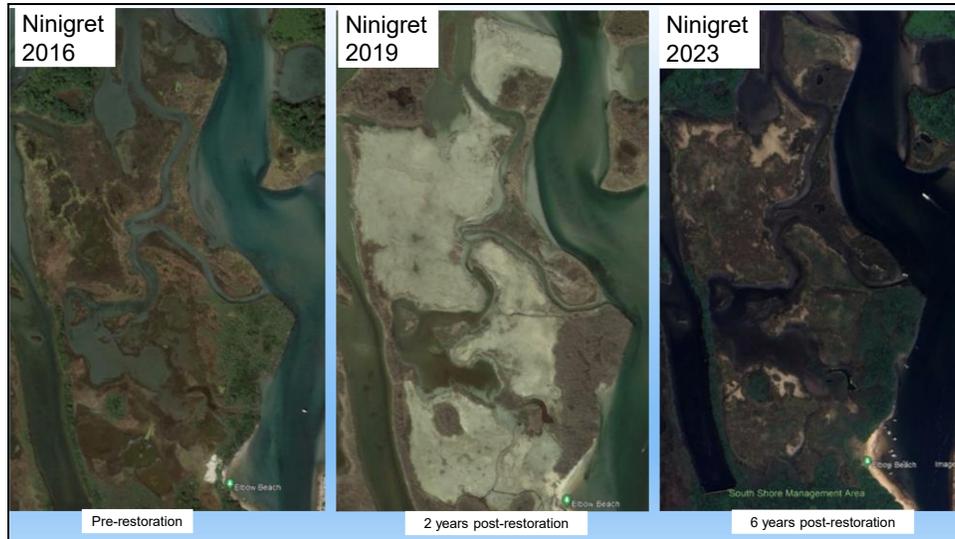
These aerial images show the change in the marsh from pre restoration in 2016 to 2 years and 6 years post restoration. In 2016 and 2027, Save The Bay and RIDEM will maintain the creeks installed after the sediment was placed as part of this grant project.
